May 28, 1945.

ORE DRESSING AND METALLURGICAL LABORATORIES.

Investigation No. 1876.

Examination of a Broken Steel Mould.

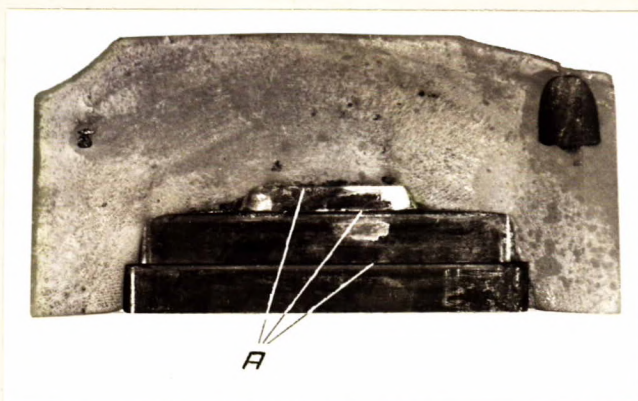
Figure 1.

FRACTURE OF BROKEN STEEL MOULD.

All radii of machined sections (marked "A") of the mould appeared to be quite sharp. The fracture of the steel is fine-grained.

It was noted that there were a number of sharp radii at the point of fracture. This condition should be avoided if possible. It was also observed that the die had several holes in the section which failed in service. Sharp radius and uneven sections may cause cracks to occur in the heat treatment operation unless special precautions are observed. Even if cracking does not occur in the heat treatment, sharp radii may lead to high internal stress conditions which may lead to failure in service. The following precautions in heat treatment should be observed.

- 1) That the composition and structure of the steel were satisfactory.
- 2) That the radii of the machined sections of the die were too sharp.
- 3) Failure may have been initiated by a heat treatment defect or as the result of maltreatment in service.

- (1) Preheat slowly and uniformly to 1200° F.
- (2) Heat slowly to the hardening temperature, 1450 to 1500° F.
- (3) Quench in a good quantity of a reliable quenching oil, which should be at a temperature of 100 to 125° F., but do not cool the steel below the temperature of boiling water.
- (4) The tempering (temperature 325 to 500° F.) should

be carried out immediately after quenching, to avoid internal stresses in the die.

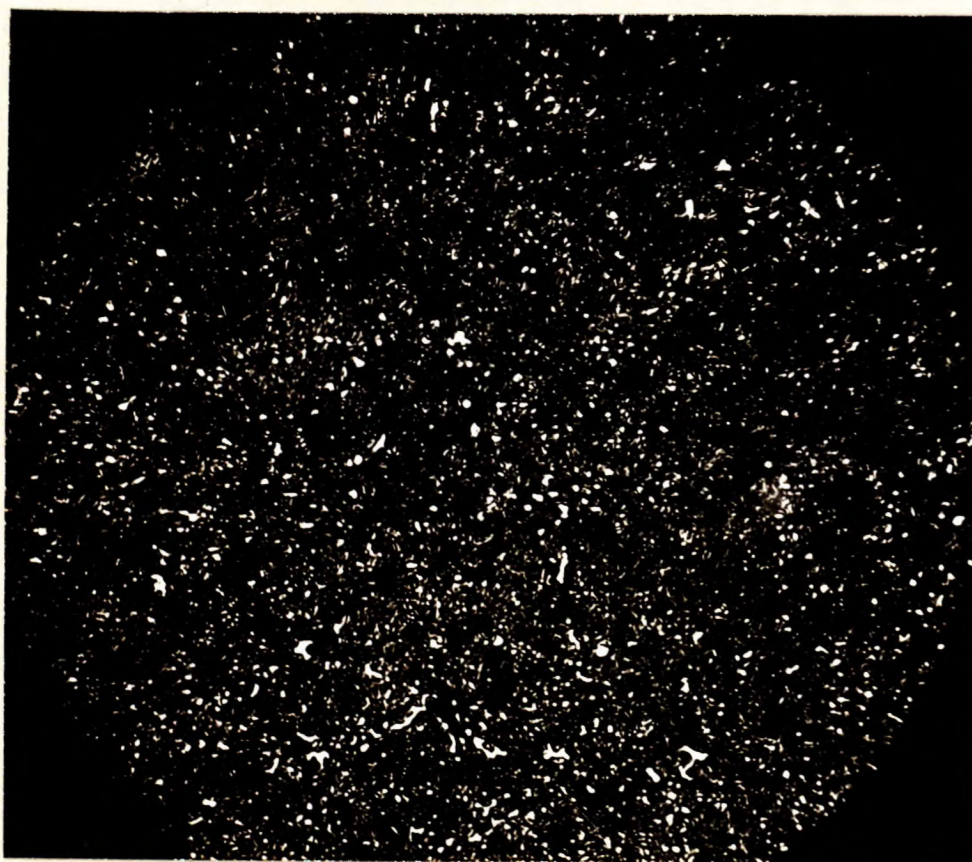
Figure 2.

A specimen cut from the broken mould was mounted in bakelite, polished, and examined under the microscope in the unetched condition. The steel was found to be fairly clean. After etching in a solution of 2 per cent nitric acid in alcohol the steel was re-examined. The structure was found to consist of tempered martensite with small carbides uniformly distributed throughout the matrix.

Rockwell
Hardness
Number:
"C" Scale,
59.

X500, etched in
2 per cent nital.
(Overetched to show up carbides, the
white etching material.)

The broken steel die submitted had a chemical composition similar to that of an oil-hardening, non-deforming tool or die steel. Carbon in the amount found to be present should give optimum hardening properties. Manganese in the range of 1.00 to 2.00 per cent will cause the steel to harden readily, therefore such steels should be oil-quenched. Manganese adds soundness to the steel and improves its casting and forging properties. The silicon addition is made to the steel as a deoxidizer. The amount present and the low sulphur and phosphorus contents indicate that the steel was properly made. The chromium increases the depth hardening of the steel. With chromium present it is necessary to heat the steel to slightly higher temperatures to obtain maximum hardening. The microstructure and hardness of the metal indicate that the heat treatment used was satisfactory.
