May 29, 1945.

Investigation No. 1884.

Metallurgical Examination of Failed
Lever Arm Tubing from Control
System of a Crane Aircraft.

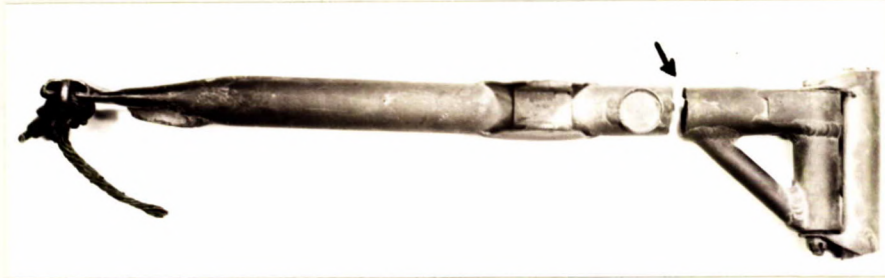
Figure 1.

FAILED LEVER ARM TUBING.

Visual examination indicated that the fracture had occurred at the toe of several welds (see Figures 1 and 2). The brittle nature of the fracture is shown in Figure 3.

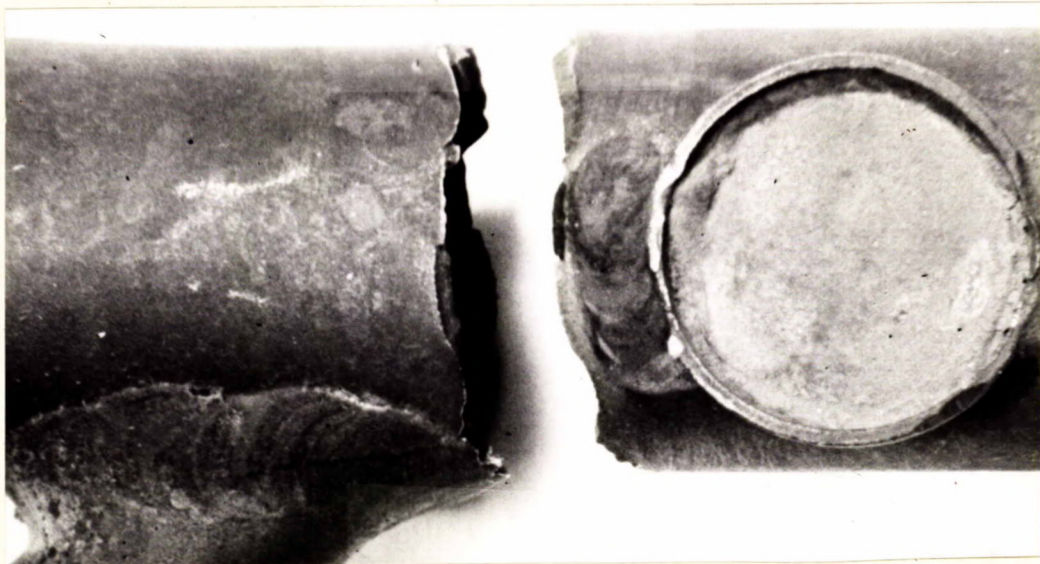
Figure 2.

SHOWING POSITION OF FRACTURE.

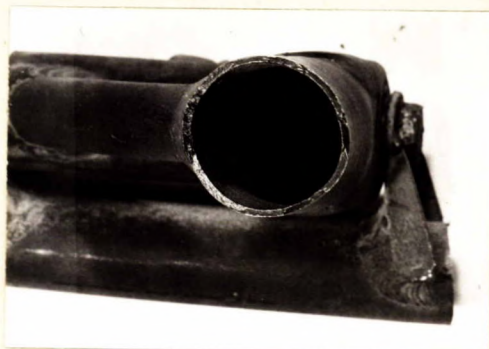
Figure 3.

Note fracture suggesting brittle failure.

The brittle nature of the fracture suggests that failure could have resulted from either of two causes:

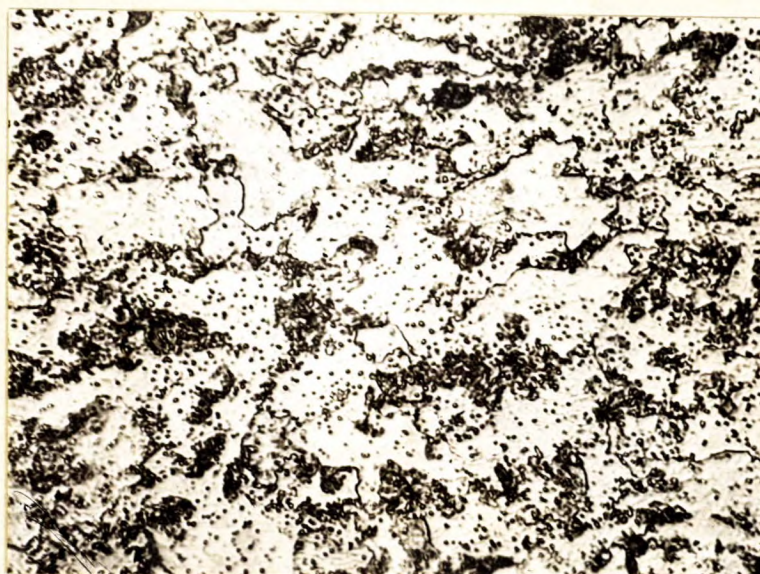
Figure 4.

Figure 4, taken at X1000 magnification, shows the microstructure of the tubing as supplied to the welder. The structure consists of partially spheroidized carbides in a ferrite groundmass.

The spheroidized or partly spheroidized condition of the tubing as supplied to the welder is evident from the photomicrographs (Figure 4 and 5), and also by the hardness (24 to 25 Rockwell "C"). It is thought that tubing in this condition would be considerably weaker in fatigue strength (because of the ferrite matrix) than tubing that had been normalized, or normalized and then drawn to a temperature below that resulting in spheroidization.

MICROSTRUCTURE OF TUBING AS
SUPPLIED TO WELDER.

Note partially spheroidized condition.

1. The tubing should be supplied to the heat treater in a condition so heat-treated as to avoid spheroidization.
2. Special care during heat treatment should be taken to avoid decarburization.
3. The welding technique must be of the highest quality in order to prevent the occurrence of deep notch effects and the resultant highly stressed areas.

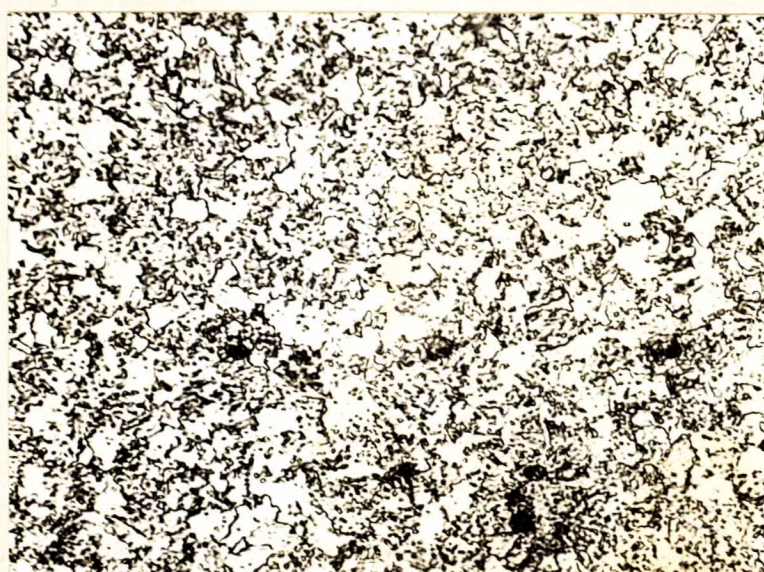
Figure 5.

Figures 5 and 6, at magnifications of X1000 and X500 respectively, are photomicrographs of sections immediately adjacent to the fracture. The structure shown in Figure 5 is spheroidized and has not been affected by the welding heat, while that in Figure 6 is martensitic in appearance and is caused by a high welding heat followed by fairly rapid cooling.

MICROSTRUCTURE OF TUBING IMMEDIATELY
ADJACENT TO FRACTURE.

Note spheroidized condition similar to Figure 4.

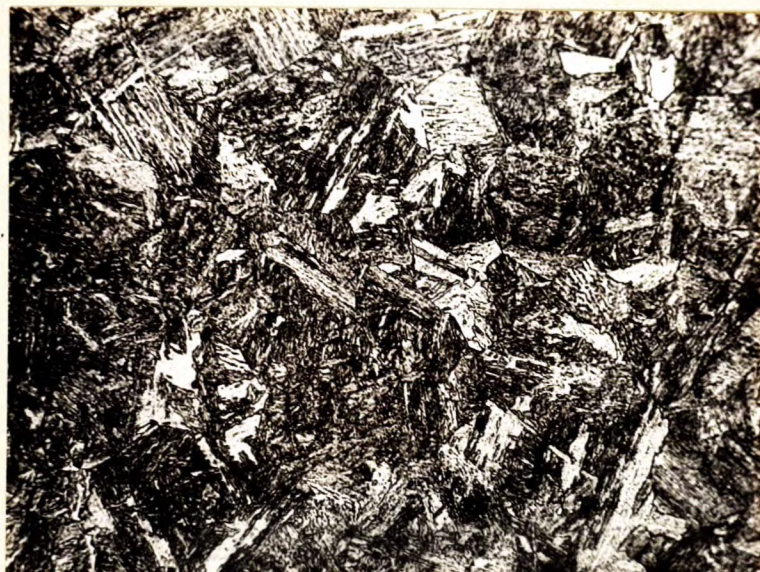
Figure 6.

MICROSTRUCTURE OF TUBING IMMEDIATELY
ADJACENT TO THE FRACTURE.

Note martensitic appearance of structure.

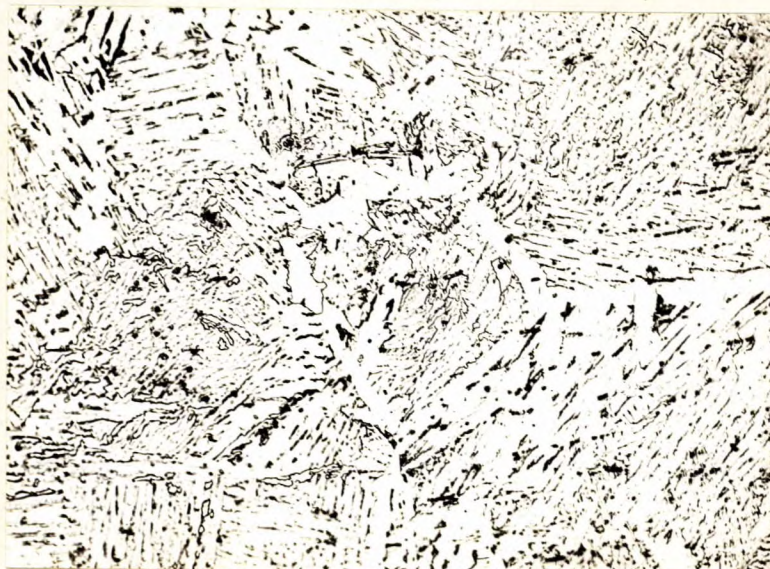
Figure 7.

Figure 7, taken at X200 magnification, indicates the structure of the weld metal.

MICROSTRUCTURE OF WELD METAL.

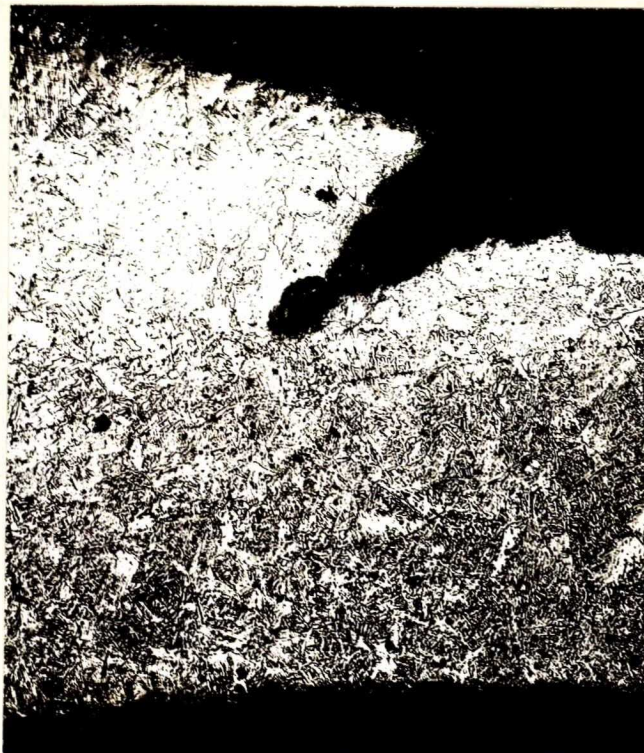
Figure 8.

Figure 8 shows the deep notch effect produced at the toe of the weld by improper fusion. This would lead to high stress concentration.

The deep notch effect noted in Figure 8, resulting from improper welding technique, acts as an area of high stress concentration, thus seriously decreasing the tensile strength of the tubing. This type of defect must be avoided in aircraft components.

NOTCH EFFECT AT TOE OF WELL,
PRODUCED BY IMPROPER FUSION.

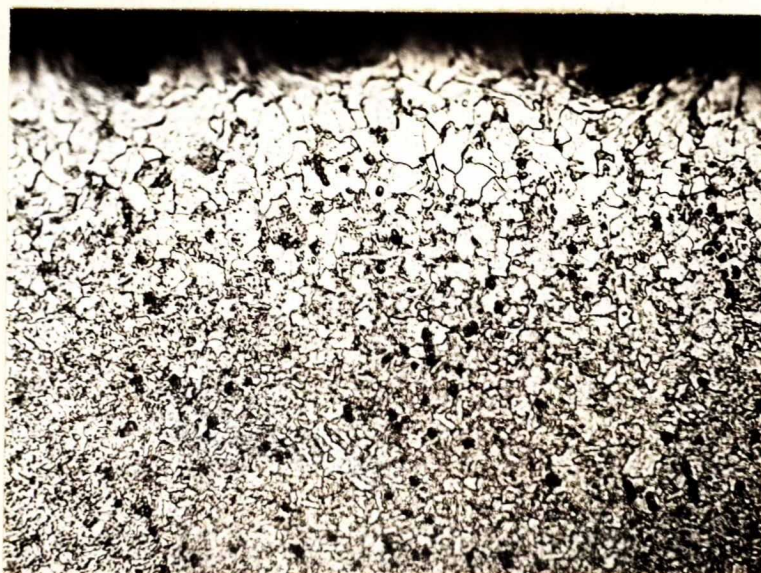
Figure 9.

Figure 9, taken at X500 magnification, shows the degree of decarburization evident in the tubing under examination.

The decarburization observed (see Figure 9) occurring both on the inside and outside surfaces of the tubing, and which must have resulted during the heat treatment (the presence of the spheroidized structure proves this), contributes very considerably to a decrease in the fatigue strength of the metal.

SHOWING DECARBURIZATION.

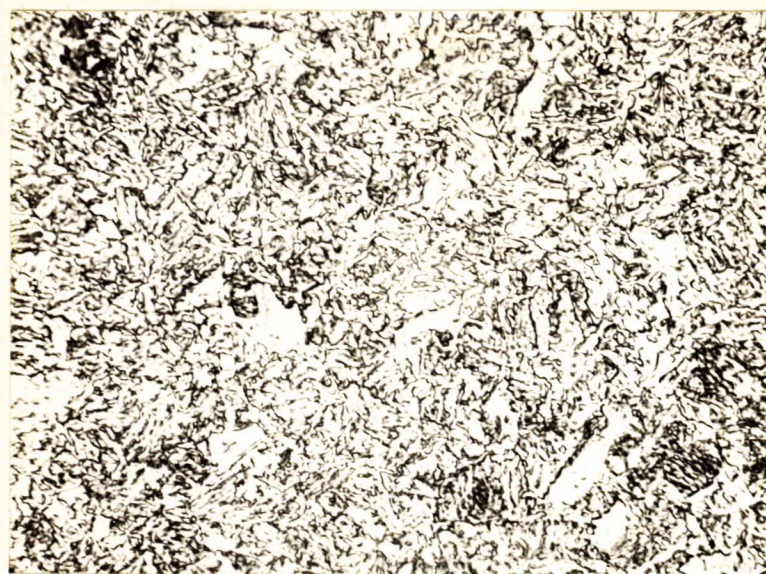
Figure 10.

Figure 10, taken at X1000 magnification, indicates the microstructure obtained by normalizing, that is, heating at 1650° F. and cooling in air. The structure is martensitic.

MARTENSITIC STRUCTURE
OBTAINED BY NORMALIZING.
