June 12, 1945.

ORE DRESSING AND METALLURGICAL LABORATORIES.

Investigation No. 1886.

Behaviour of Foot Valves and Steam Cocks for  
60-Ft. Phoenix Steel Nesting Barges S/4  
Under Corrosive Conditions.

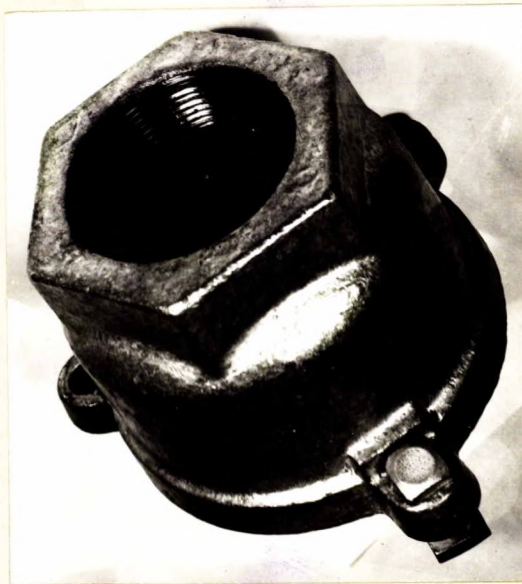
Figure 1.

The threads which were covered with the black removable organic coating showed spots of iron rust.

ZINC-COATED STEEL FOOT VALVE BEFORE THE  
CORROSION TEST, SHOWING THE BLACK REMOV-  
ABLE ORGANIC COATING ON THE THREADS.

4. Removable protective organic coatings should not be relied on under the more severe corrosive conditions.

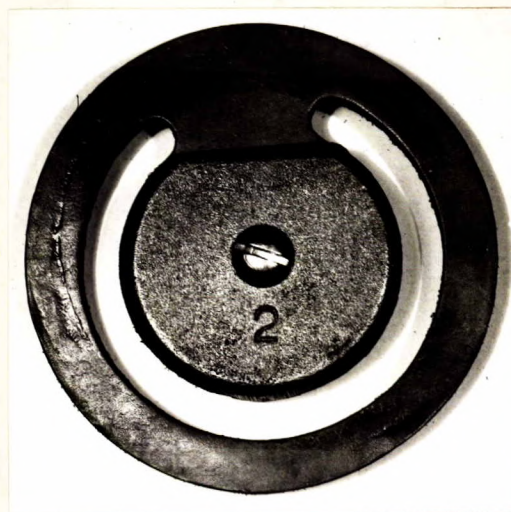
Figure 2.

LEATHER PART WITH BRONZE PLATE ATTACHED  
BY STEEL NUT AND BOLT, BEFORE THE CORRO-  
SION TEST.

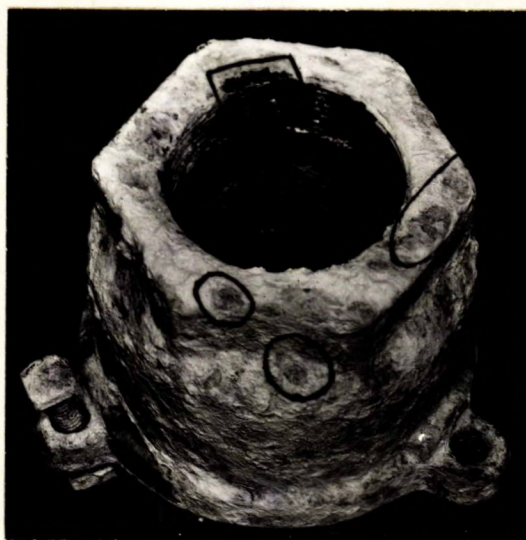
The condition of the exterior of the largest part is shown in Figure 3.

EXTERIOR OF LARGEST PART OF THE ZINC-  
COATED STEEL FOOT VALVE, AFTER 280  
HOURS IN THE SALT SPRAY CABINET.

The white material is zinc corrosion product. The large patches of iron rust on the white material are much less evident in the photograph than on the actual sample. A few of them are encircled.

The considerable amount of rusting on the threads is shown inside the rectangular area.

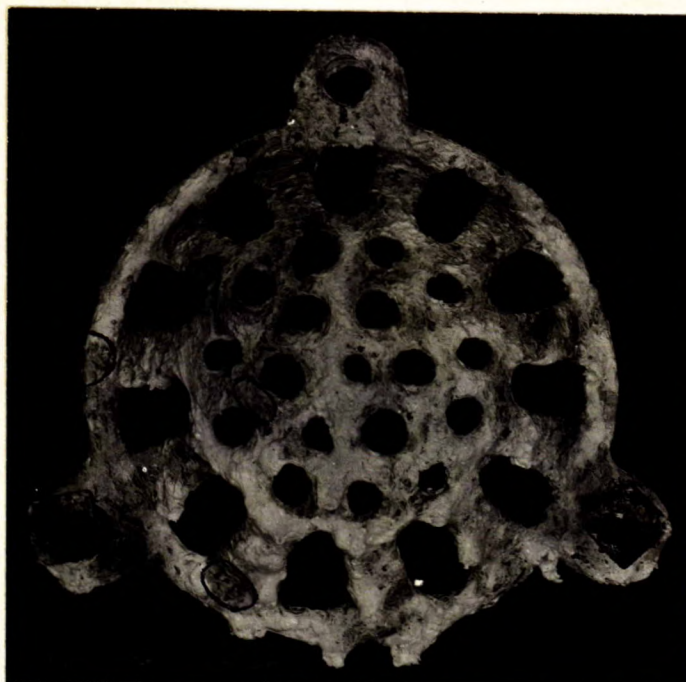
The condition of the exterior of the large perforated part is shown in Figure 4. The heads and threads of the two bolts were badly rusted.

EXTERIOR OF THE LARGE PERFORATED PART OF  
THE ZINC-COATED STEEL FOOT VALVE, AFTER  
280 HOURS IN THE SALT SPRAY CABINET.

The white material is zinc corrosion product.  
Several of the large patches of iron rust on the white  
material are encircled.

The heads of both bolts are badly rusted.

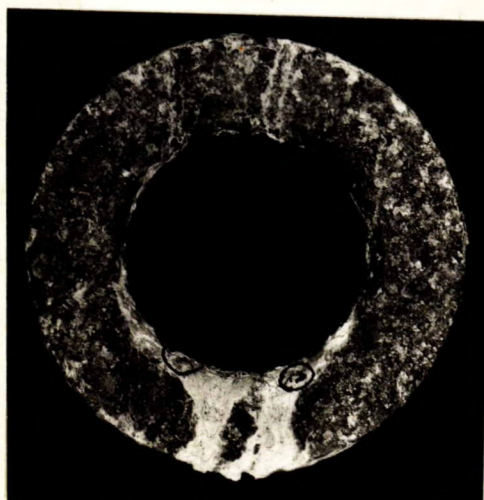
The condition of the large washer is shown in Figure 5. Rust spots are encircled.

LARGE ZINC-COATED STEEL WASHER AFTER  
280 HOURS IN THE SALT SPRAY CABINET.

The white material is zinc corrosion product.  
Patches of iron rust are encircled.

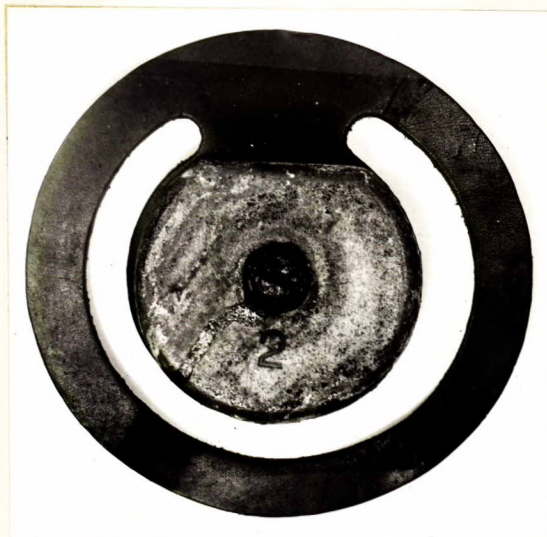
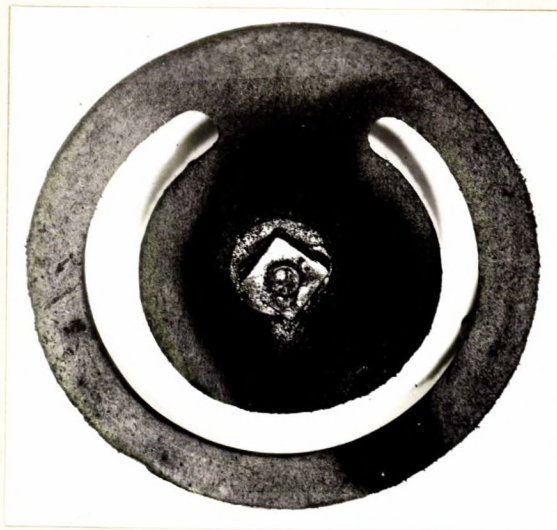
Figure 6.

The bolt and nut which were attached to the leather were considerably corroded.

The condition of the steel and bronze parts attached to the leather is shown in Figures 6a and 6b.

3. It is considered bad practice, from the standpoint of corrosion, to have two different metals, such as bronze and ordinary steel, in contact with one another. This is borne out by the results of this test as shown in Figures 6a and 6b.

LEATHER PART WITH BRONZE PLATE ATTACHED  
BY STEEL NUT, BOLT AND WASHER, AFTER  
280 HOURS IN THE SALT SPRAY CABINET.

The steel parts are badly corroded. The small  
amount of corrosion on the bronze plate may not be  
serious.

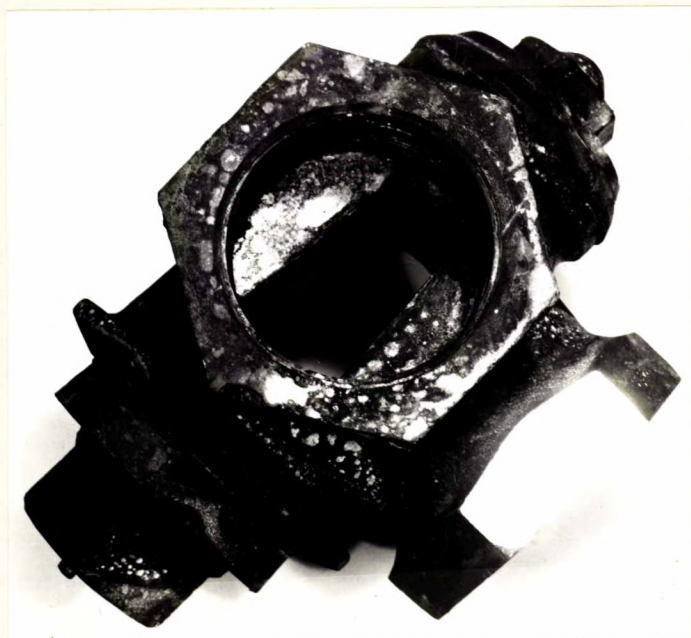
Figure 7.

Serious corrosion outside and especially inside of the valve.

One flat surface was rubbed with emery cloth to expose the fresh metal for comparison.

BRONZE THREE-WAY STEAM COCK AFTER  
200 HOURS IN THE SALT SPRAY CABINET.

The bright surface at the lower right was emiered to expose fresh metal in order to obtain a comparison with the corroded surface.

The corrosion of this Cock is more serious than is indicated by the photograph.

2. In order to prevent corrosion of this kind the salt spray should be prevented from coming in contact with the metal surfaces.
