June 11, 1945.

ORE DRESSING AND METALLURGICAL LABORATORIES.

Investigation No. 1887.

Metallurgical Examination of Broken
Track Reinforcing Cleats from
Armoured Snowmobile.

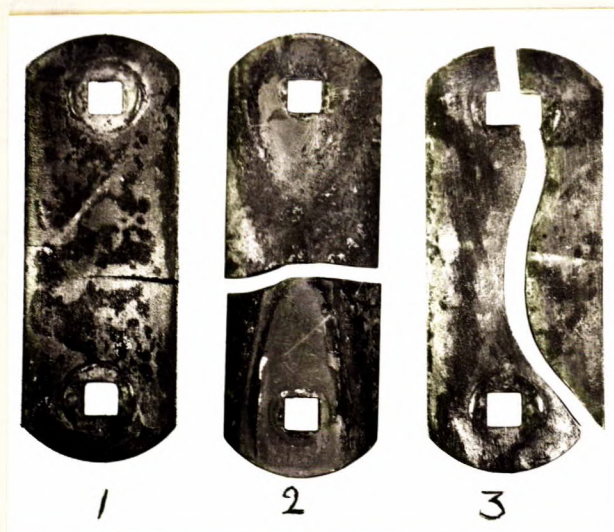
Figure 1.

On April 17, 1945, three broken armoured snowmobile track reinforcing cleats (see Figure 1) were submitted for metallurgical examination, under Requisition No. 693, A.E.D.B. Lot No. 586, Report No. 107, Section D, Test No. 29, by the Division of Metallurgy, Army Engineering Design Branch, Department of Munitions and Supply, Ottawa, Ontario.

For purposes of identification, the cleats have been assigned the numbers 1, 2 and 3 (see Figure 1).

BROKEN ARMoured SNOWMOBILE
TRACK REINFORCING CLEATS.

The hardness values obtained on the three cleats, varying from $46\frac{1}{2}$ to 56 Rockwell "C", are considerably higher than the 42 Rockwell "C" specified and indicate a too low draw temperature, or an absence of drawing after quenching. It is almost certain that Cleat No. 3, the hardness range of which was 55 to 56 Rockwell "C", was not tempered and was placed into service in the "as quenched" condition.

Because SAE 4130 steel has lower impact strength at high hardness ranges, it is thought that failure resulted because of the brittle condition of the steel.

The complete absence of decarburization means that the steel would have its full fatigue strength. The haphazard location of the failures also indicates that failure was not by fatigue.

In summary, failure resulted because of the excessive brittleness caused by either the complete absence of a draw after quenching, or by drawing at too low a temperature.

It is recommended that the SAE 4130 cleats be so heat-treated as to produce a hardness of 37 ± 3 Rockwell "C". This may be accomplished by resorting to the following heat treatment:

Heat at 1600° F.,
Quench in oil, and
Draw at 800° F.

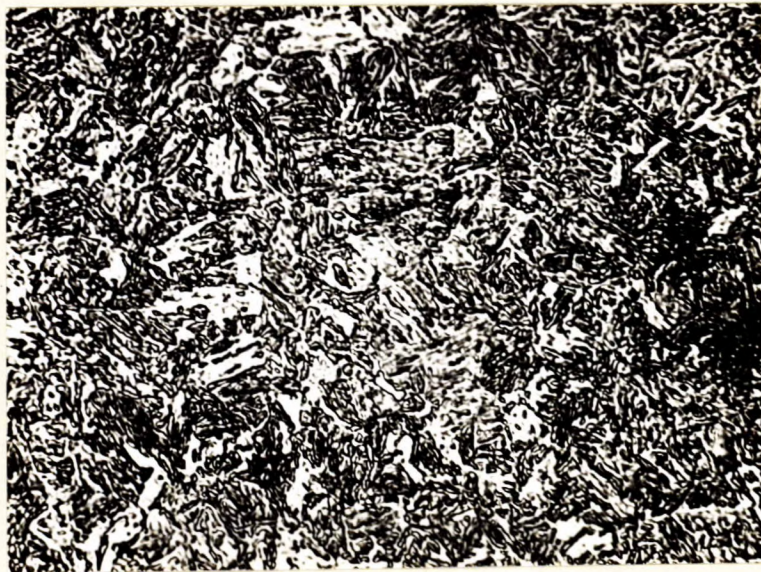
Figure 2.

Photomicrographs (Figures 2, 3, and 4), taken at X1000 magnification, show the microstructure of Cleats Nos. 1, 2 and 3 respectively. The structure in all three cases is martensite, with ferrite evident in Figure 3.

CLEAT NO. 1.

Martensite.

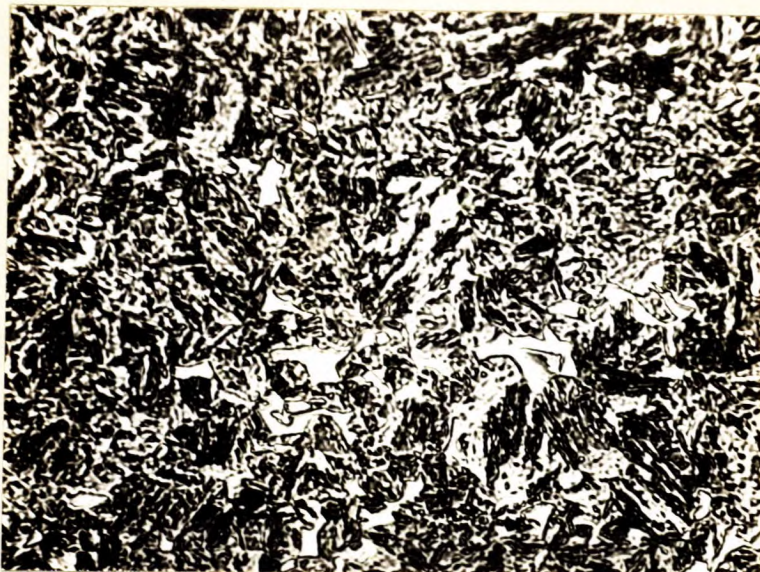
Figure 3.

CLEAT NO. 2.

Martensite and ferrite.

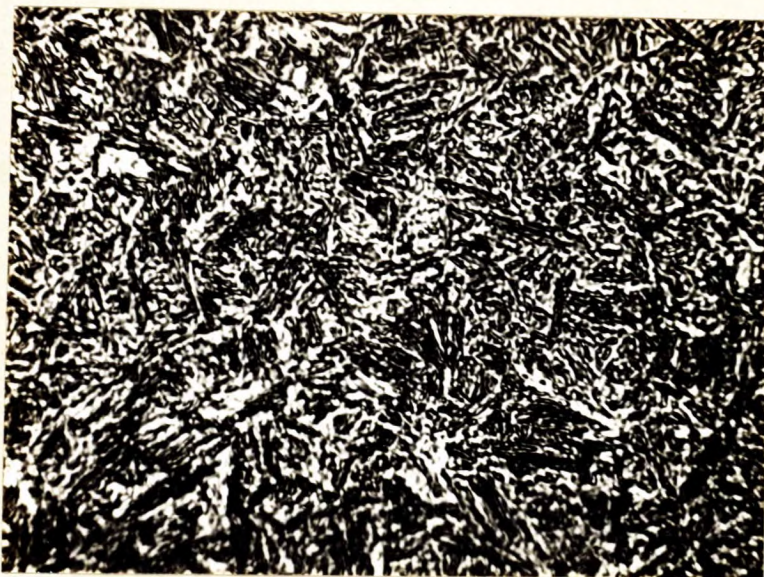
Figure 4.

CLEAT NO. 3.

Martensite.
