ORE DRESSING AND METALLURGICAL LABORATORIES.

Investigation No. 1891.

Corrosion Resistance of Anti-Corrosion
Compound for Aircraft Engines
(Specification C-27-587).

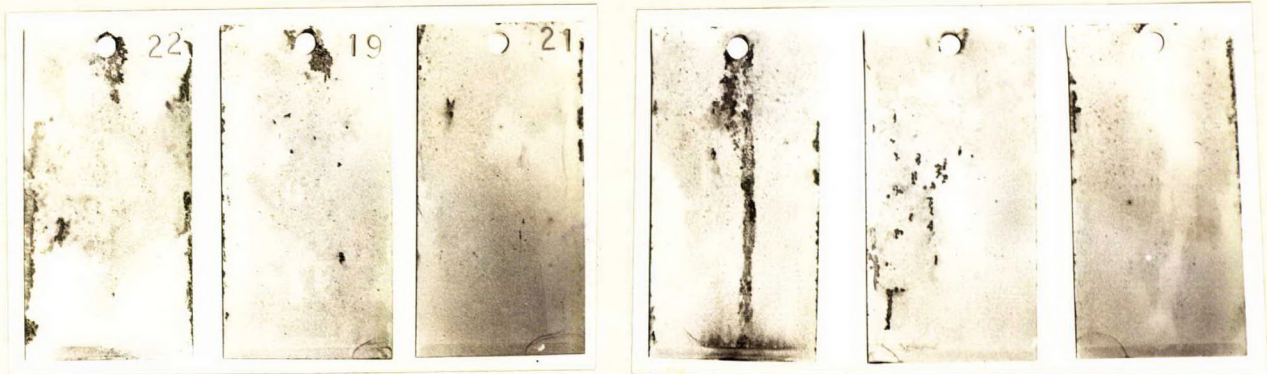
Figure 1.

The steel panels corroded rather badly in the Protection Test (Paragraph 2m in the specification). See Figures 1a and 1b.

The anti-corrosive compound failed to meet the specification requirements with regard to:

STEEL PANELS COATED WITH COMPOUND-LUBRICATING OIL MIXTURE, AFTER 150 HOURS IN THE HUMIDITY CABINET.

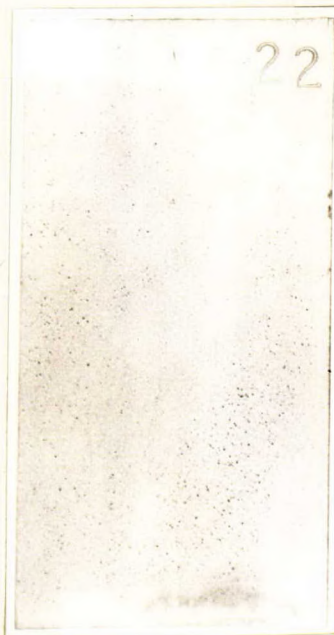
The steel panels corroded in the Hydrobromic Neutralization Test (Paragraph 2n in the specification). See Figure 2.

TYPICAL STEEL PANEL AFTER THE HYDROBROMIC ACID NEUTRALIZATION TEST.
