O T T A W A June 25, 1945.

ORE DRESSING AND METALLURGICAL LABORATORIES.

Investigation No. 1895.

Metallurgical Examination of an Aircraft
Crankcase Centre Section.

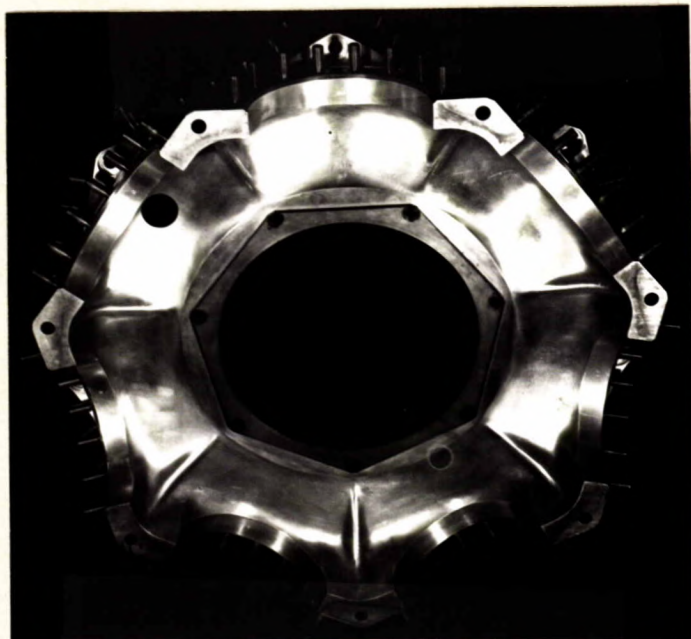
The crankcase centre section as received is illustrated in Figure 1. The location of the cracks, indicated by punch marks, is shown in Figure 2. Figure 3 is a full-sized view of the crack between cylinder parts 3 and 4.

PRATT & WHITNEY CRANKCASE CENTRE SECTION, TOP VIEW.

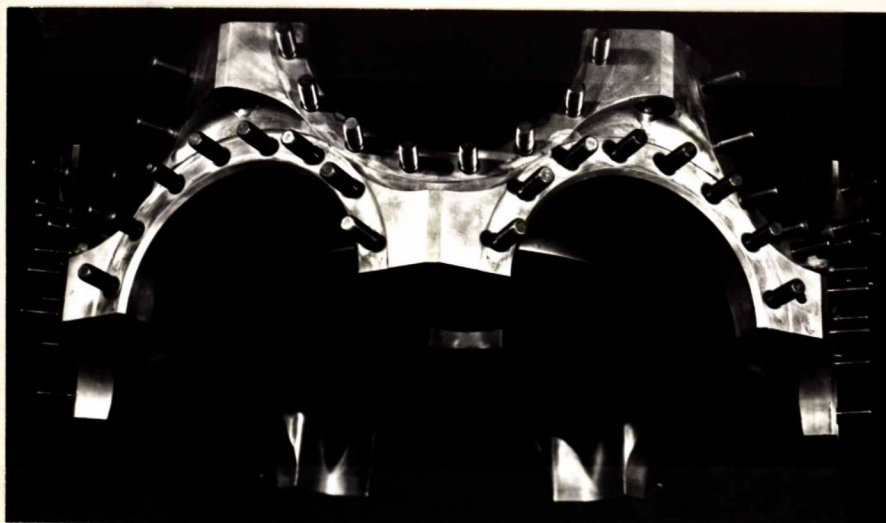
Figure 2.

SIDE VIEW OF CRANKCASE CENTRE SECTION, SHOWING
LOCATION OF CRACKS.

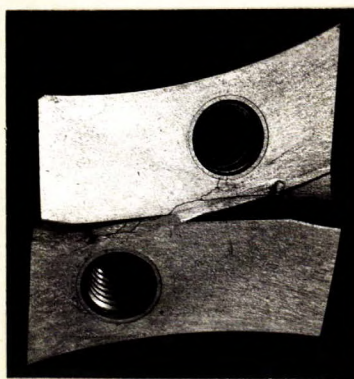
Figure 3.

CRACKS BETWEEN STUDS
BETWEEN CYLINDERS 3 AND 4.

2. Stress concentration caused by the adjacent positions of cylinder hold-down studs for the front and rear rows of cylinders. This condition is illustrated by Figure 3 which shows the short distance between the studs. The geometry of the part, that is, the merging of one cylinder pad face into an adjoining one in the other row, does not appear to have had any effect because the cracks do not follow the demarkation line between the cylinder pad faces.

The aircraft engine centre section developed shallow fatigue cracks at locations of stress concentration between adjacent cylinder studs after an extended service life. Redesign of the part to reduce the stress concentrations and substitution of an aluminium alloy of higher fatigue strength would be required if it is contemplated to operate all crankcases for this period.

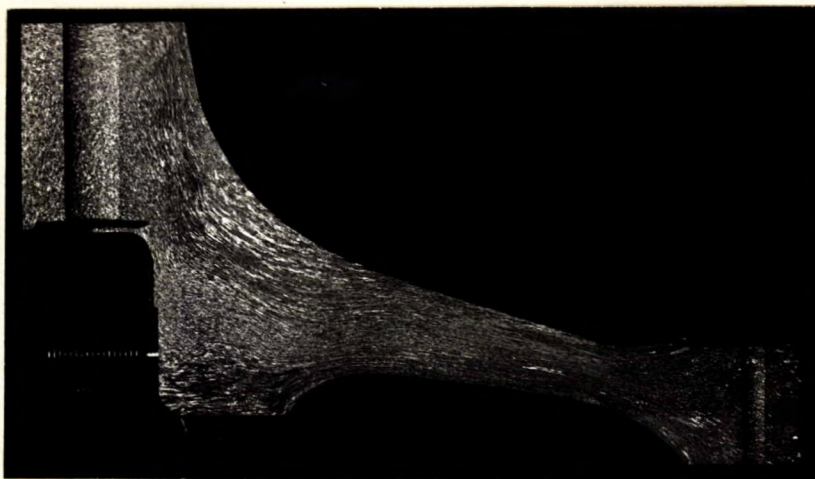
The flow lines of the forging as they appear in a radial section are shown in Figure 4. Because of the symmetry of the crankcase centre section, the flow lines are similar in all radial sections. The area in which the cracks occurred is beside the stud on the face machined for the cylinder flange. It can be seen that this is an area of dead flow where the top and bottom flow lines diverge.

X5/6, Tucker's etch;
GRAIN FLOW IN RADIAL SECTION.

The tensile properties combine a high yield strength with low elongation. The elongation falls to particularly low values in directions perpendicular to the forging grain flow. The region where the cracks occur has not a favourable grain flow to resist tensile forces between adjacent cylinders.

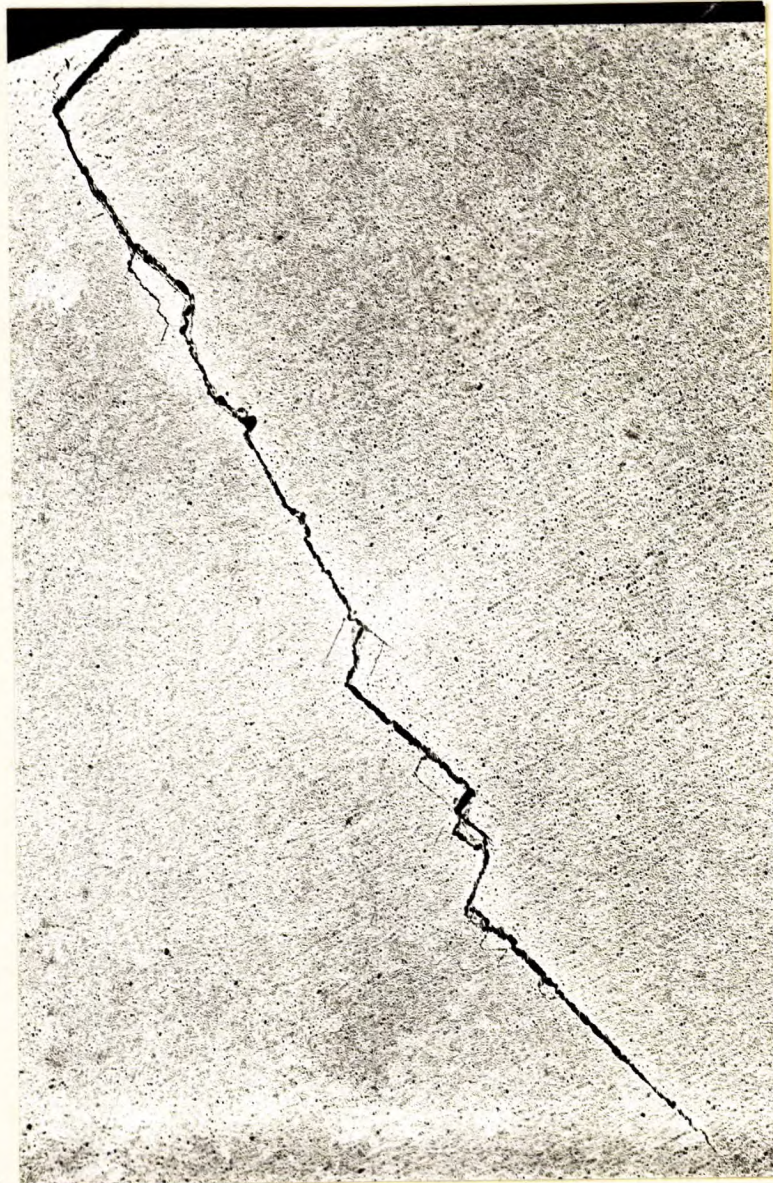
Figure 5.

Sections through a number of the cracks were polished and examined microscopically. Figure 5 illustrates the nature of the cracks. This section was taken from between cylinder pads 4 and 5. This crack is about $3/8$ of an inch deep. Figure 6 is a photomicrograph of a shallower crack ($1/32$ -inch deep) between cylinder pads 7 and 8. Figure 7 is a photomicrograph of the same crack as in Figure 6 but at four times the magnification.

X18, Keller's etch.
DEEP CRACK BETWEEN CYLINDERS 4 AND 5.

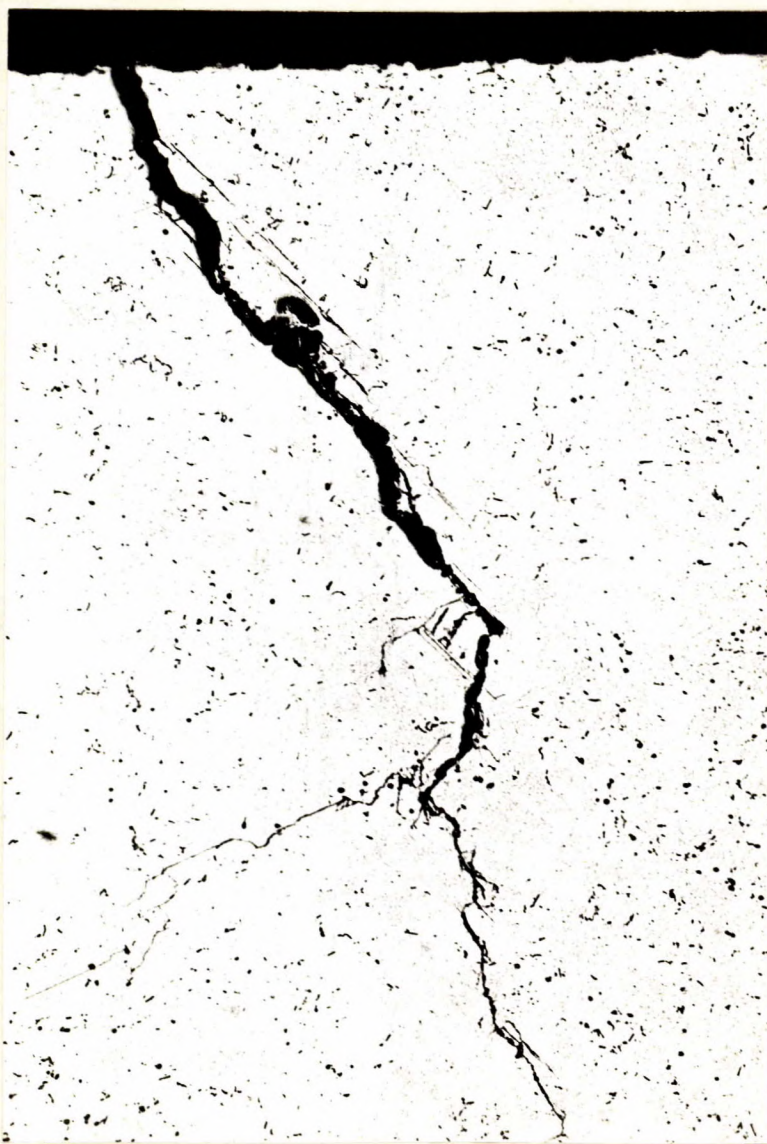
Figure 6.

X150, etched in 0.5 per cent hydrofluoric acid.
CRACK BETWEEN CYLINDERS 7 AND 8.

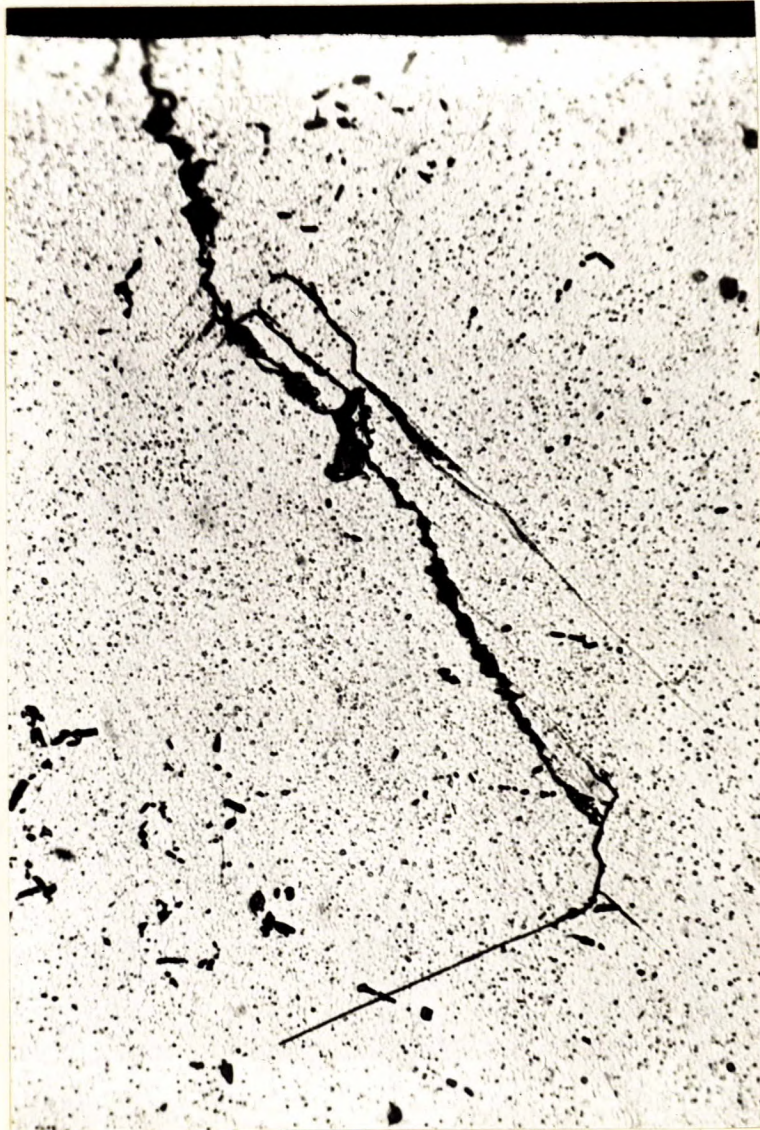
Figure 7.

Figure 7 illustrates the fine size of the constituents but shows the tendency of the cracks to follow the constituents.

X600, etched in 0.5 per cent hydrofluoric acid.
ENLARGED VIEW OF LOWER PART OF CRACK IN FIGURE 6.
