R E P O R T
of the
ORE DRESSING AND METALLURGICAL LABORATORIES.

Investigation No. 1903.

Metallurgical Examination of a Damaged
Aluminium Alloy Truck Wheel.

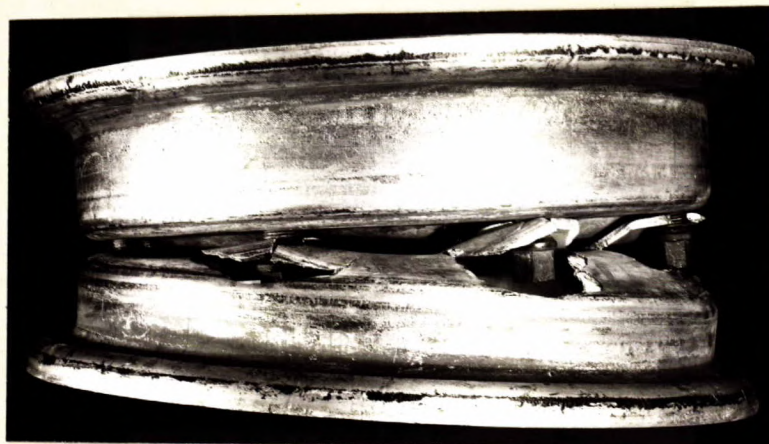
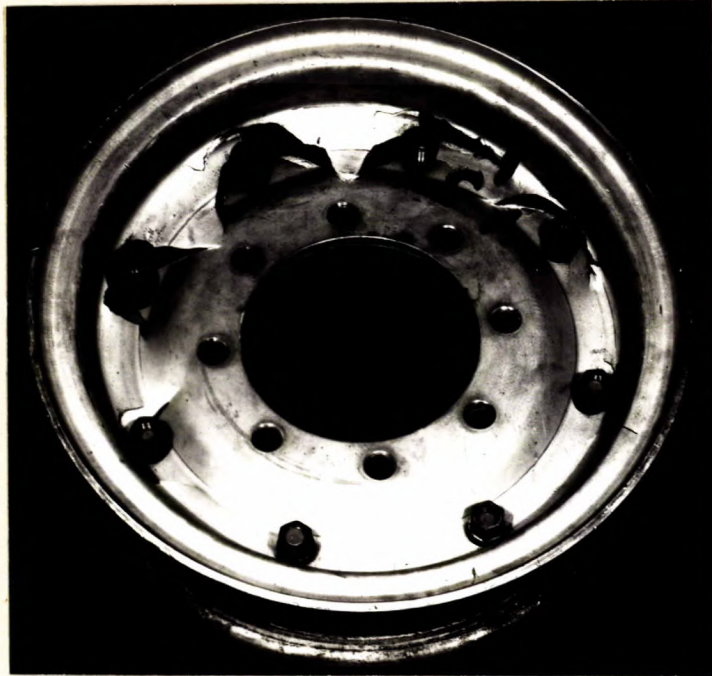
Figure 1.

SIDE VIEW OF DAMAGED ALUMINIUM
ALLOY TRUCK WHEEL.

This experimental truck wheel, shown in Figures 1 and 2, was a 6.00 x 1 $\frac{1}{2}$ W.D. divided type. It was formed from AC.65S-0 alloy of 0.320-inch gauge and heat-treated to the S-T condition. The usual material for this component is hot-rolled, low carbon open hearth steel suitable for deep drawing. The wheel failed after some 3,000 miles of service conditions. The actual load was approximately 5,000 pounds, slightly less than the 5,375-pound rated service load for the regular steel wheel.

Figures 1 and 2 show the severe tearing which occurred at the location of the connecting bolts. Figure 3 shows the type of failure before tearing had occurred. These failures are characterized by radial cracks from the connecting bolt hole extending in the direction of the bend at the rim, and a circumferential crack at the rim bend extending in the direction of the main curvature of the wheel. The more severely damaged locations are extensions of these cracks by tearing.

The wheel component failed because of stress concentrations at the outer bolt holes and at the rim bend. This condition was aggravated by reduced metal thickness, particularly at the rim bend, and low strength of the material.

1. Reduction of stress at outer bolt holes by redesign or increased number of bolts.
2. Increase in the rim bend radius from the present 1-1/3 times the sheet thickness (0.40 inch) to 2 or 3 times the sheet thickness. This would allow easier forming and avoid "necking down" at this point.
3. Increasing the metal thickness or using an alloy of higher strength, such as 17S-T.

For this application the component should be redesigned for better stress distribution. Consideration of ease of forming in the design of the part and the forming dies would allow a higher strength alloy to be used.

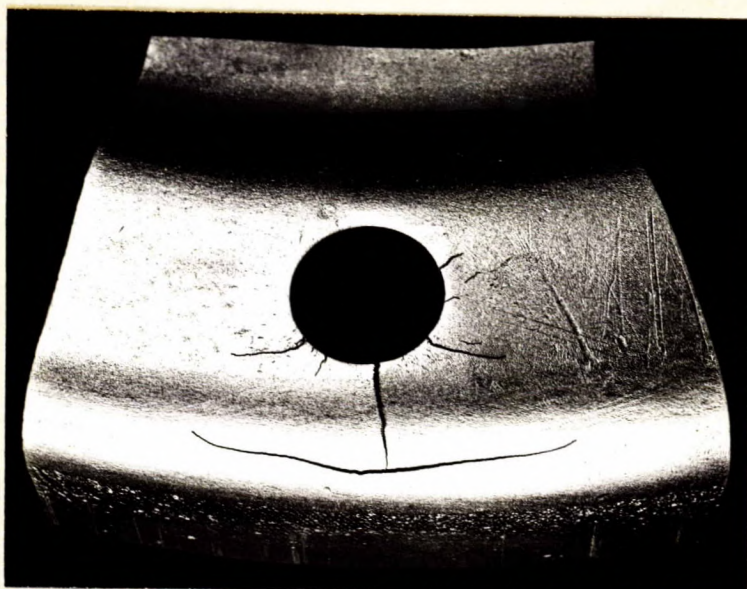
Figure 3.

CRACKS AT BOLT HOLE AND RIM BEND.
(Approximately $\frac{3}{4}$ actual size).

The stress concentration in the rim bend section due to the small thickness and the stress concentration at the outer bolt holes of the wheel both appear to have started a crack of the fatigue type. Once the section had been reduced by a penetration of the crack, failure occurred rapidly by tearing. The stresses to cause the fatigue crack at the rim bend would be from direct loading of the wheel, and the stresses to cause tearing

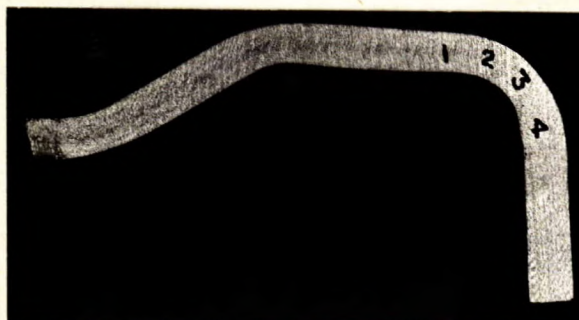
The metal thickness was measured at various locations on the damaged half of the wheel. The variations in thickness at the rim bend radius are listed in Table I; the measurement points are shown in Figure 4.

Other locations on the bend had thicknesses of about 0.260 inch. The thickness of the metal of the main rim was about 0.294 inch. The metal thickness at points near the hub attachment bolt holes, where little deformation would have occurred in forming, was about 0.300 inch. The corresponding thickness on the undamaged half of the wheel was 0.310.

MEASUREMENT POINTS ON THE RIM BEND.

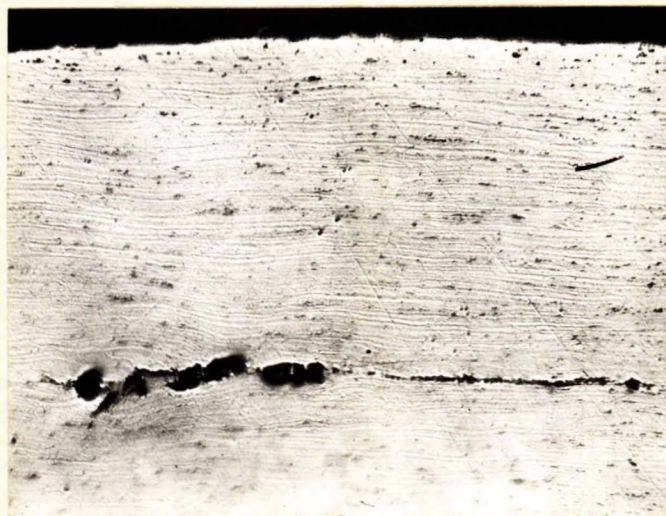
Figure 5.

The microstructure of the failed wheel was normal, with no indications of coarse recrystallization after forming. There were some indications of internal and surface defects. Figure 5 shows a subsurface blister or inclusion. There was evidence of blistering at scattered locations on the wheel.

SUBSURFACE DEFECT AT RIM BEND.

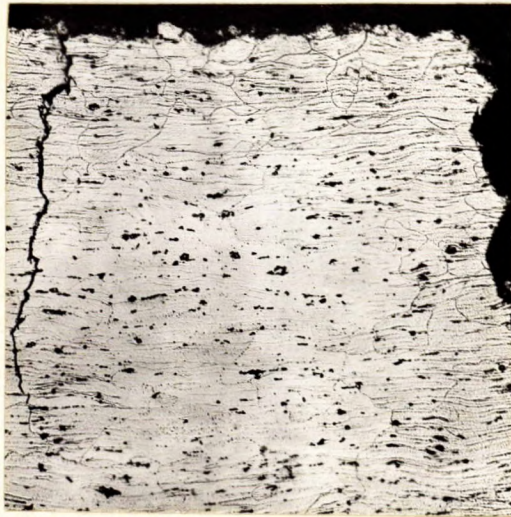
Figure 6.

There was some evidence of mild corrosive attack which had not progressed to any extent. Figure 6 shows a crack near the actual point of failure. The crack is of the transcrystalline type.

CRACK NEAR POINT OF FAILURE.
