ORE DRESSING AND METALLURGICAL LABORATORIES.

Investigation No. 1907.

Metallurgical Examination of a Broken Spring Leaf.

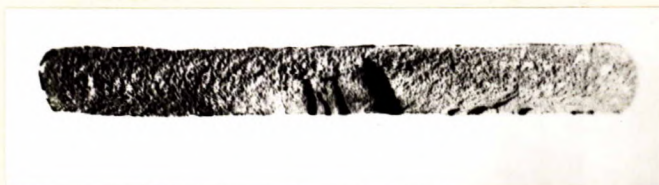
Figure 1.

Figure 1 is a photograph showing the fracture of the spring leaf.

SHOWING FRACTURE OF THE SPRING LEAF.  
(Approximately 1½ times actual size).

The fracture shown in Figure 1 is of the duplex type and is typical of a fatigue failure.

The results of this investigation would indicate that the spring leaf failed in fatigue as a result of surface decarburization. It is recommended that these springs be heat-treated in a controlled atmosphere, in order to prevent reduction of the endurance limit of the spring by decarburization. Some consideration should also be given to shotblasting as this procedure has been demonstrated to increase materially the fatigue life of such parts as springs, crankshafts, etc.

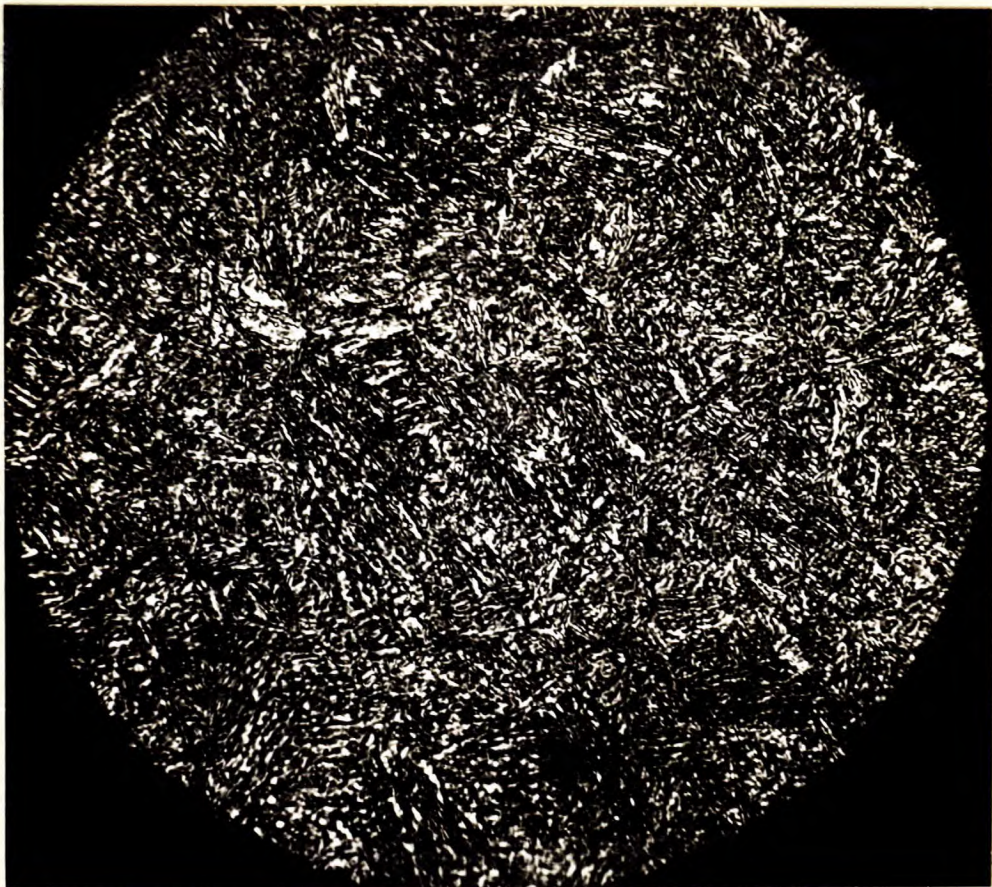
Figure 2.

X1000, etched in  
2 per cent nital.

STRUCTURE OF STEEL IN THE "AS RECEIVED" CONDITION.

The micro-examination revealed that the steel was fairly clean and that the structure was typically tempered martensite. A Tukon hardness survey indicated that the steel was slightly decarburized on the surface. This was confirmed in the micro-examination. According to the General Motors drawing for this part, 0.010 inch of decarburization is allowed. However, it has been demonstrated by many investigators that decarburization will materially reduce the endurance value of spring steels. From theoretical considerations, any decarburization is undesirable and should be avoided if possible.

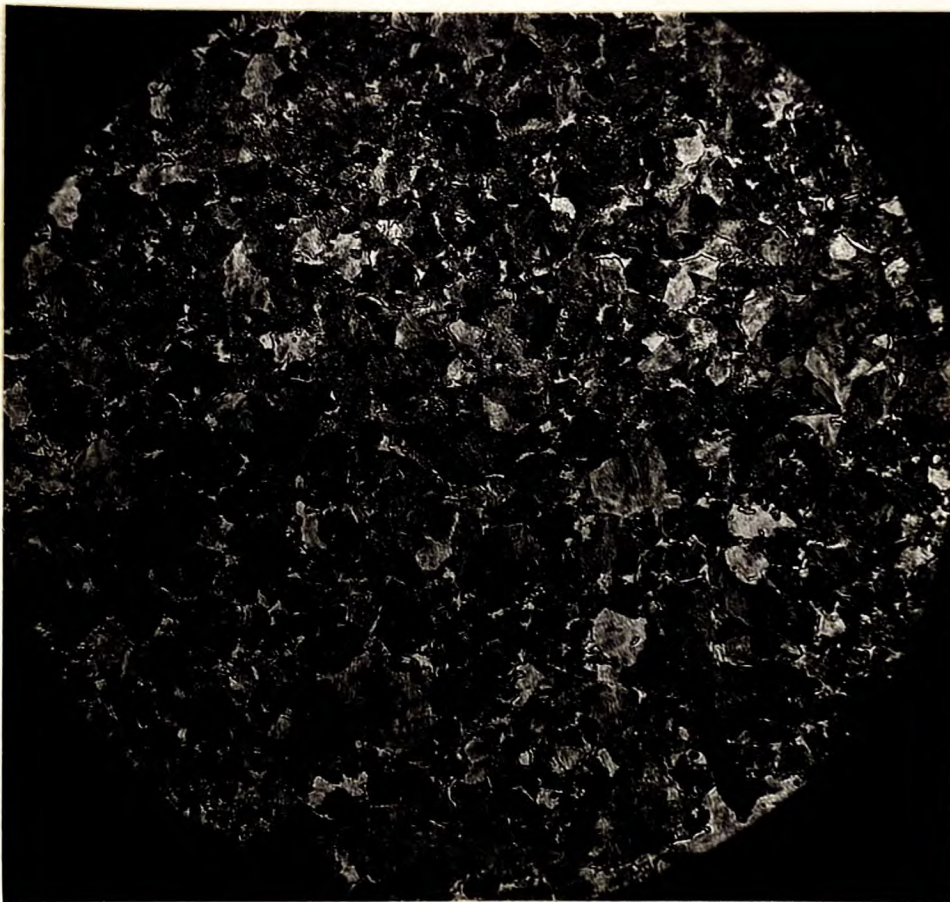
Figure 3.

UNDECARBURIZED AREA AFTER ANNEALING IN LEAD  
AT 1600° F.

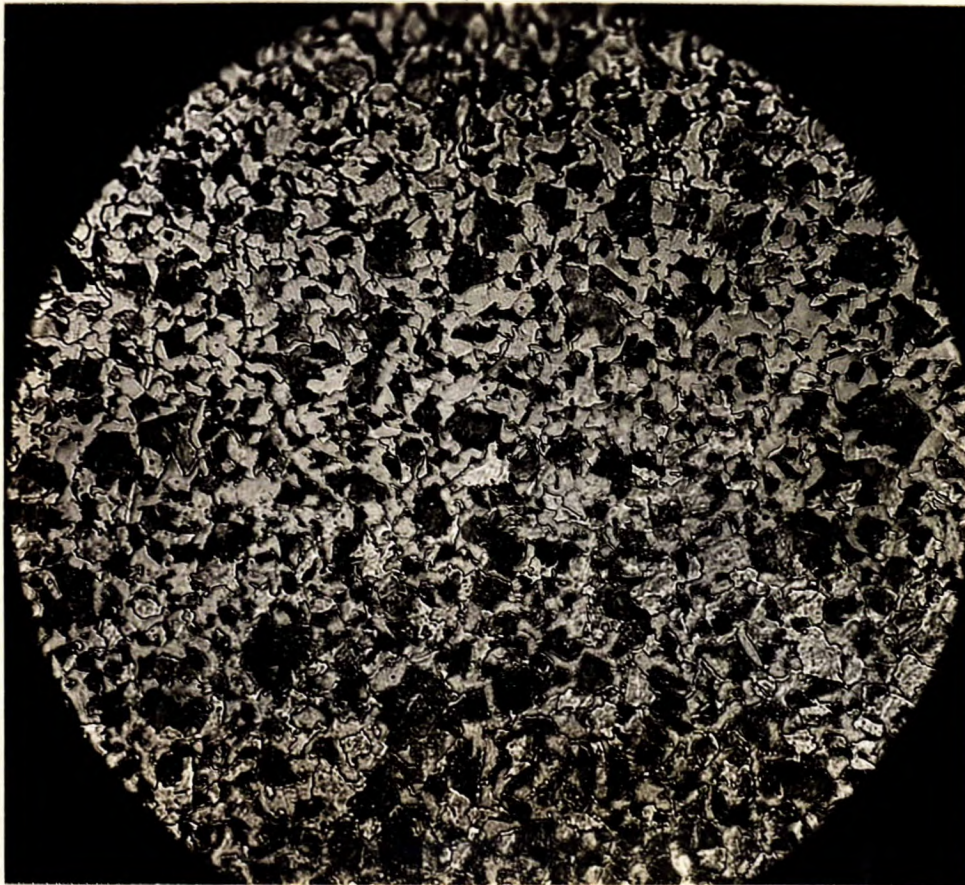
Figure 4.

Extreme  
outer sur-  
face of  
spring leaf.

DECARBURIZED AREA AT SURFACE OF SPRING LEAF  
AFTER ANNEALING IN LEAD AT 1600° F.
