R E P O R T
of the
ORE DRESSING AND METALLURGICAL LABORATORIES.

Investigation No. 1912.

Corrosion Resistance of Presstico Sealer
for Spot-Welded Joints.

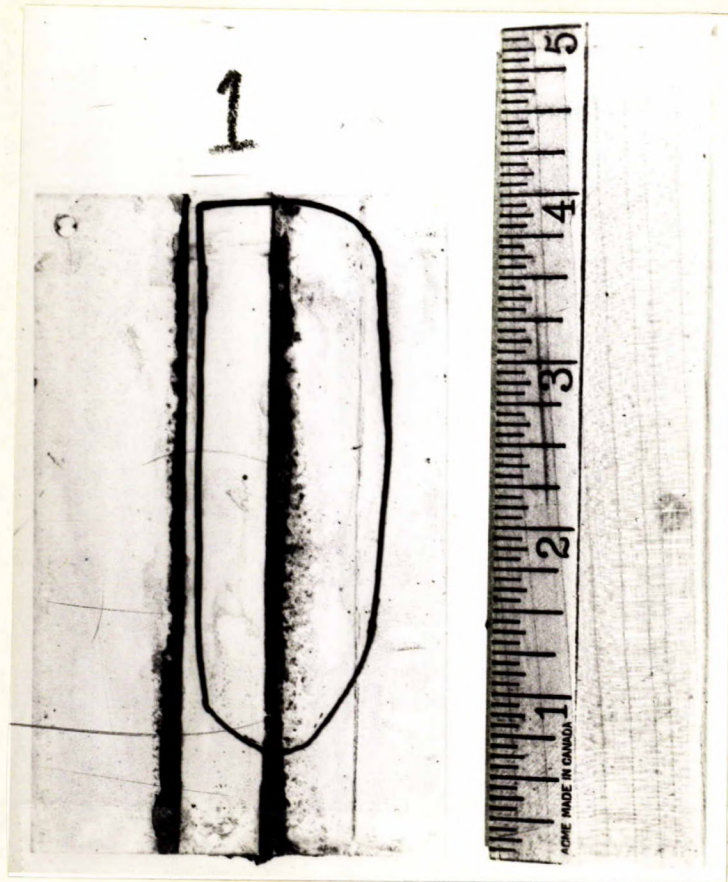
Figure 1.

- After 64
hours: White corrosion product (obviously not iron rust) down the centre of Sample P3B. Also some rust at the sealing compound near the bottom.

Small amount of rusting in the scratch
on Sample P1B. Still no rusting in the
scratch on Sample P3B.

1. All samples showed a certain amount of failure
due to the action of the salt spray. No appreciable amount of
blistering was noted on any of the samples. Sample P3B had no
rusting on the scratch.

P3B - Best.
P1B
O2B
P2B
P4B - Worst.

SAMPLE P3B AFTER EXPOSURE TO
20 PER CENT SALT SPRAY.

Rusted areas are encircled. The scratch
itself was uncorroded.

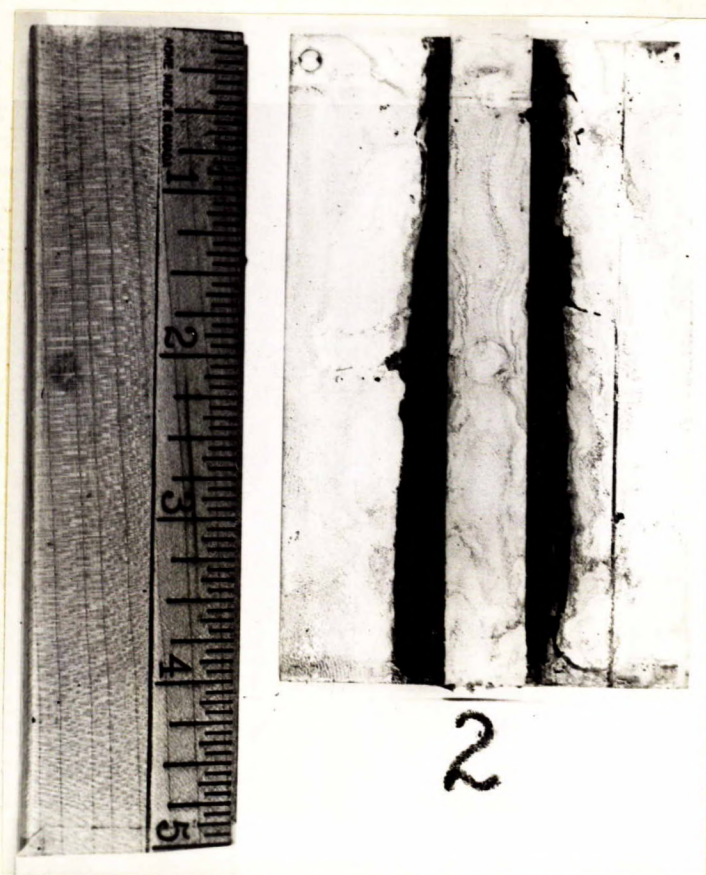
Figure 2.

- After 17
hours: A spot of rust was observed on Sample P1B at the sealing compound near the bottom.
- After 40
hours: One spot of rust observed in the paint on Sample P4B.

- More white corrosion product on Sample P1B than on Sample P3B. Rust spots were scattered along the sealing compound. Rust on edges of strip on Sample P4B. Rust on one edge of strip on Sample O2B.

- After 110
hours: Samples P1B and P3B had more white corrosion product but no more rust. Signs of rust on surface of Samples P4B, P2B and O2B, P4B being the worst.

SAMPLE P1B AFTER EXPOSURE TO
20 PER CENT SALT SPRAY.

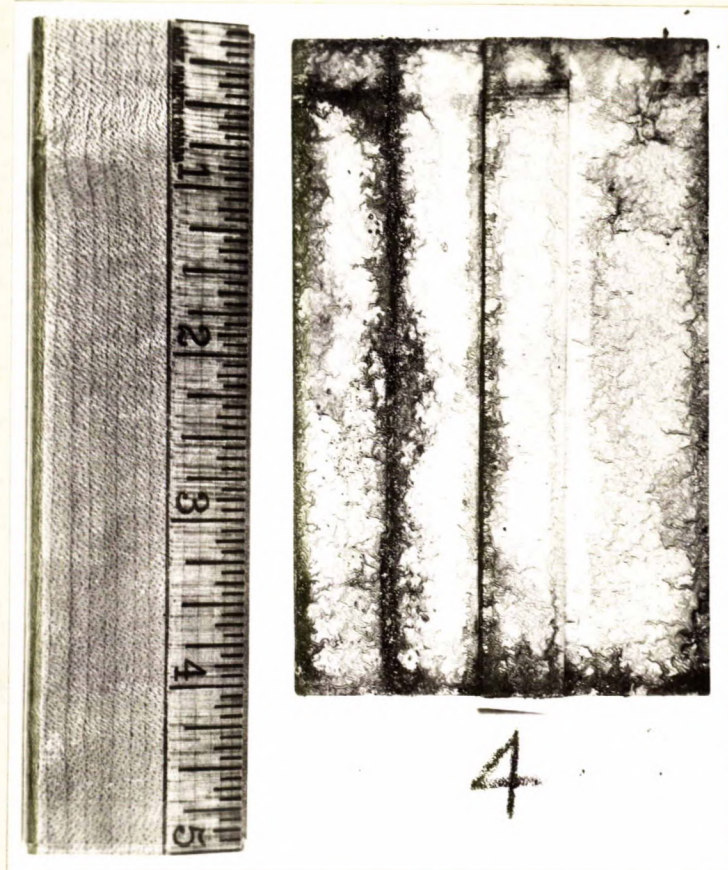
Figure 3.

- After 135
hours: All samples were given a deep vertical scratch.
- After 180
hours: Samples P4B, P2B and O2B were rusting at the scratches. Surfaces slightly worse than at the end of 110 hours. No rusting at scratches on Samples P1B and P3B.

Note: The outside edges of Samples P2B, P4B and
O2B were not very well protected. Rust from them drained down
over the surfaces and made these look considerably worse than
they really were.

SAMPLE O2B AFTER EXPOSURE TO
20 PER CENT SALT SPRAY.

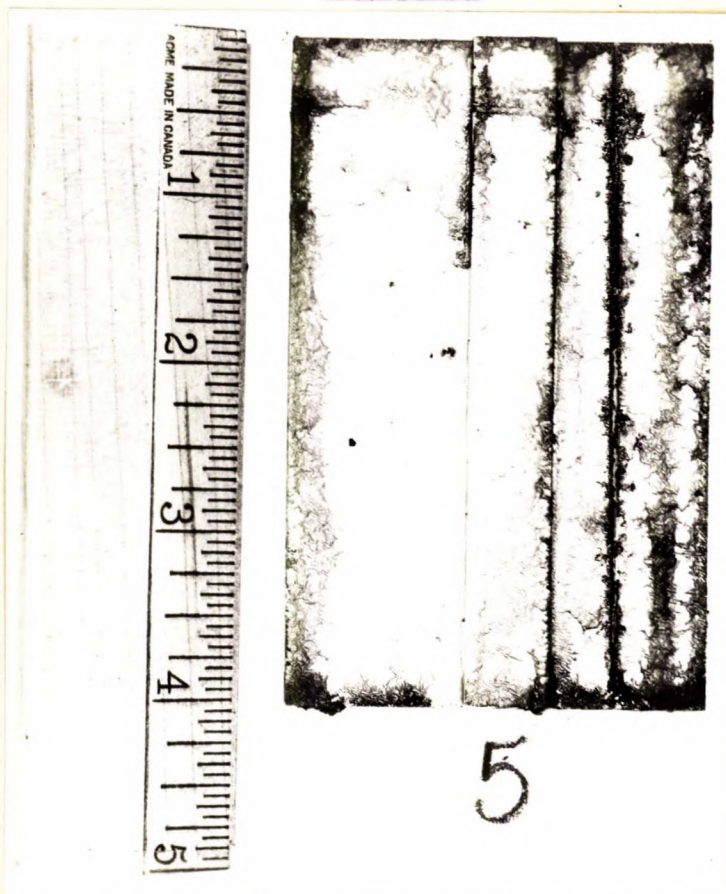
Figure 4.

SAMPLE P2B AFTER EXPOSURE TO
20 PER CENT SALT SPRAY.

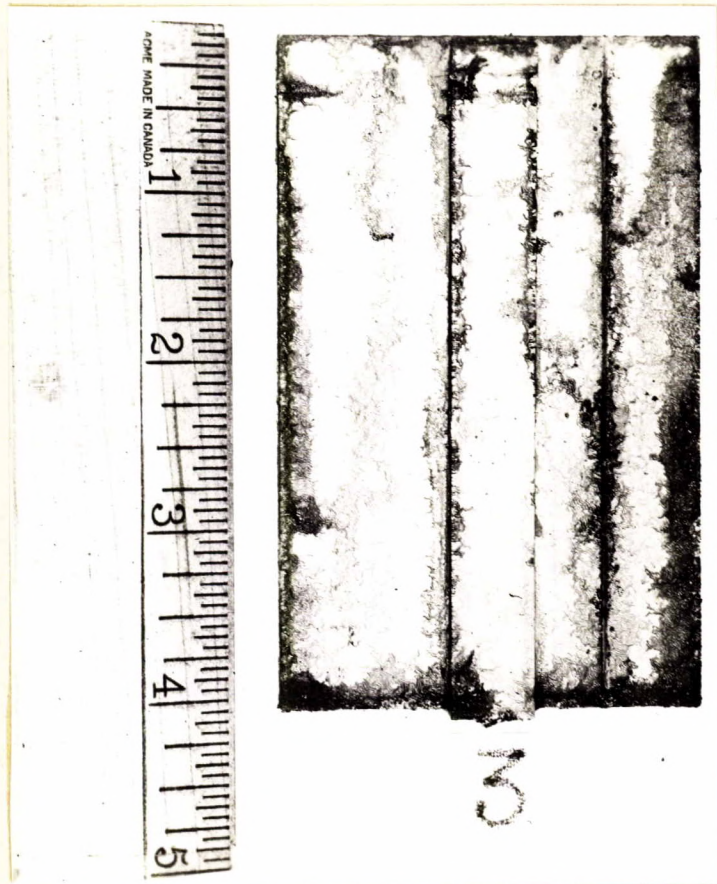
Figure 5.

SAMPLE P4B AFTER EXPOSURE TO
20 PER CENT SALT SPRAY.
