Investigation No. 1924.

Metallurgical Examination of Cracked Welds  
in 35% Ni-15% Cr Steel Retorts Used for  
Production of Magnesium.

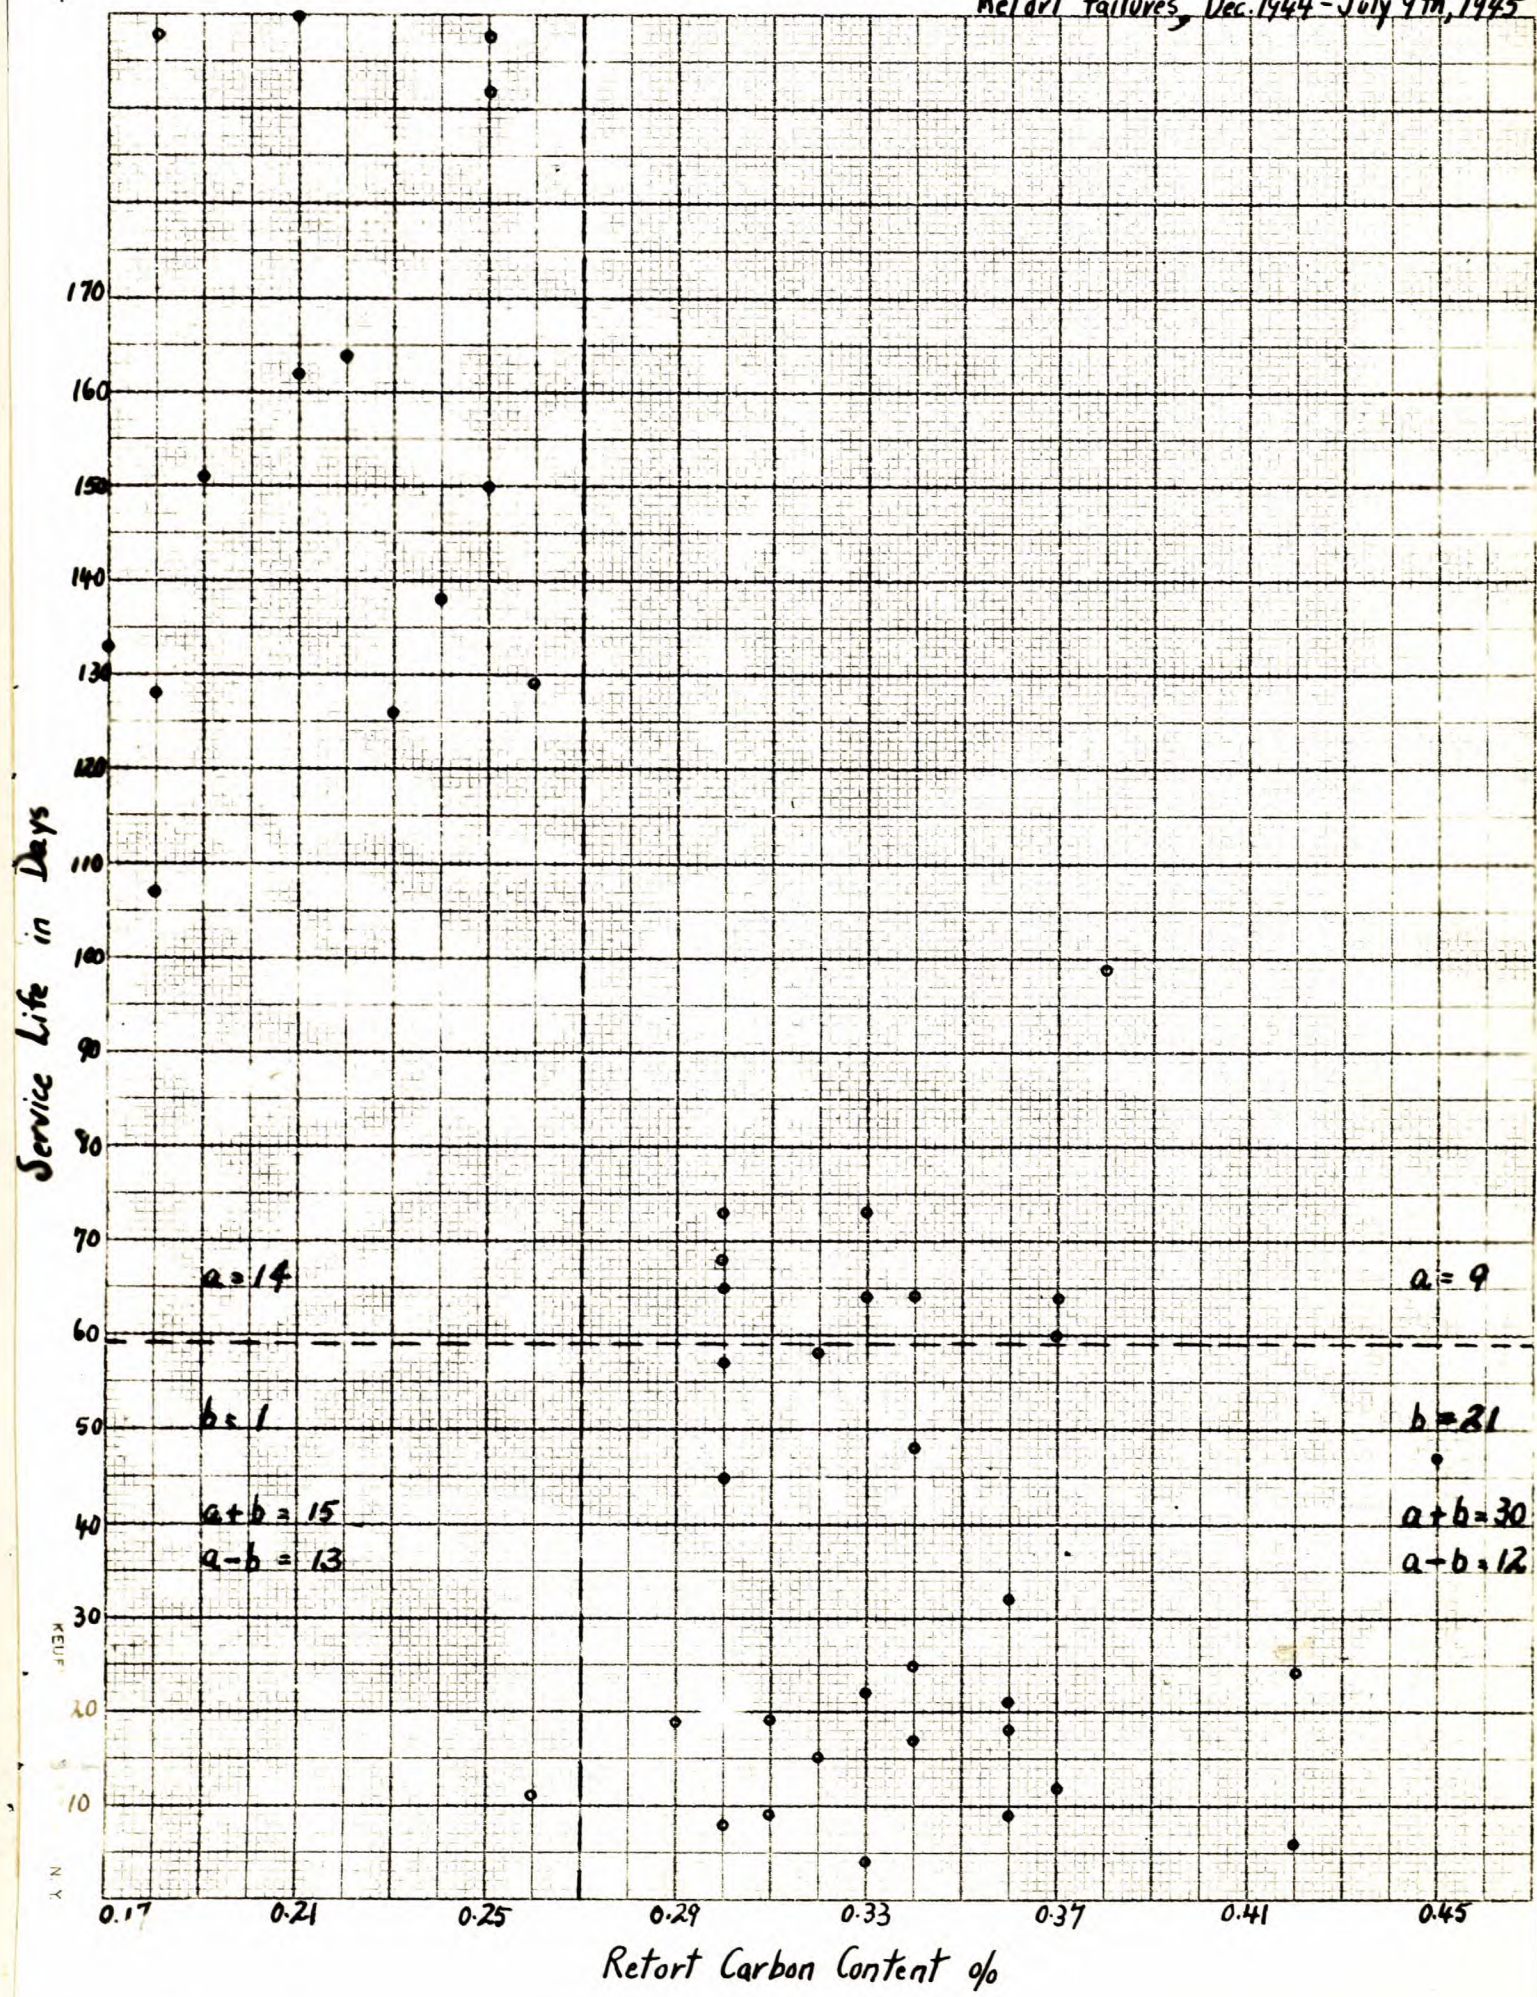
Figure I.

Using the data of Table I and the chart Figure 1, it can be shown mathematically that the chances of such a distribution of failures can be due to chance in only two out of 100 such samples. That is, it can be considered definitely proven that the high carbon content (above 0.27 per cent), or some property of the metal associated with it, is having an adverse effect on service life, under the conditions of operation to which the retorts in this sample were subjected. This being the case, it is natural to suspect that carbide precipitation may be in part responsible. With alloys of this composition it is known that carbide precipitation takes place when the metal is heated within the range 800-1600° F. An examination of Figure 2 reveals that this temperature range exists between 20.6 and 26 inches from the open end of the retort. Retort metal and condenser metal within this distance range will be subject to those conditions conducive to severe carbide

Retort Carbon Content Versus Service Life.

Retort failures, Dec. 1944 - July 9th, 1945

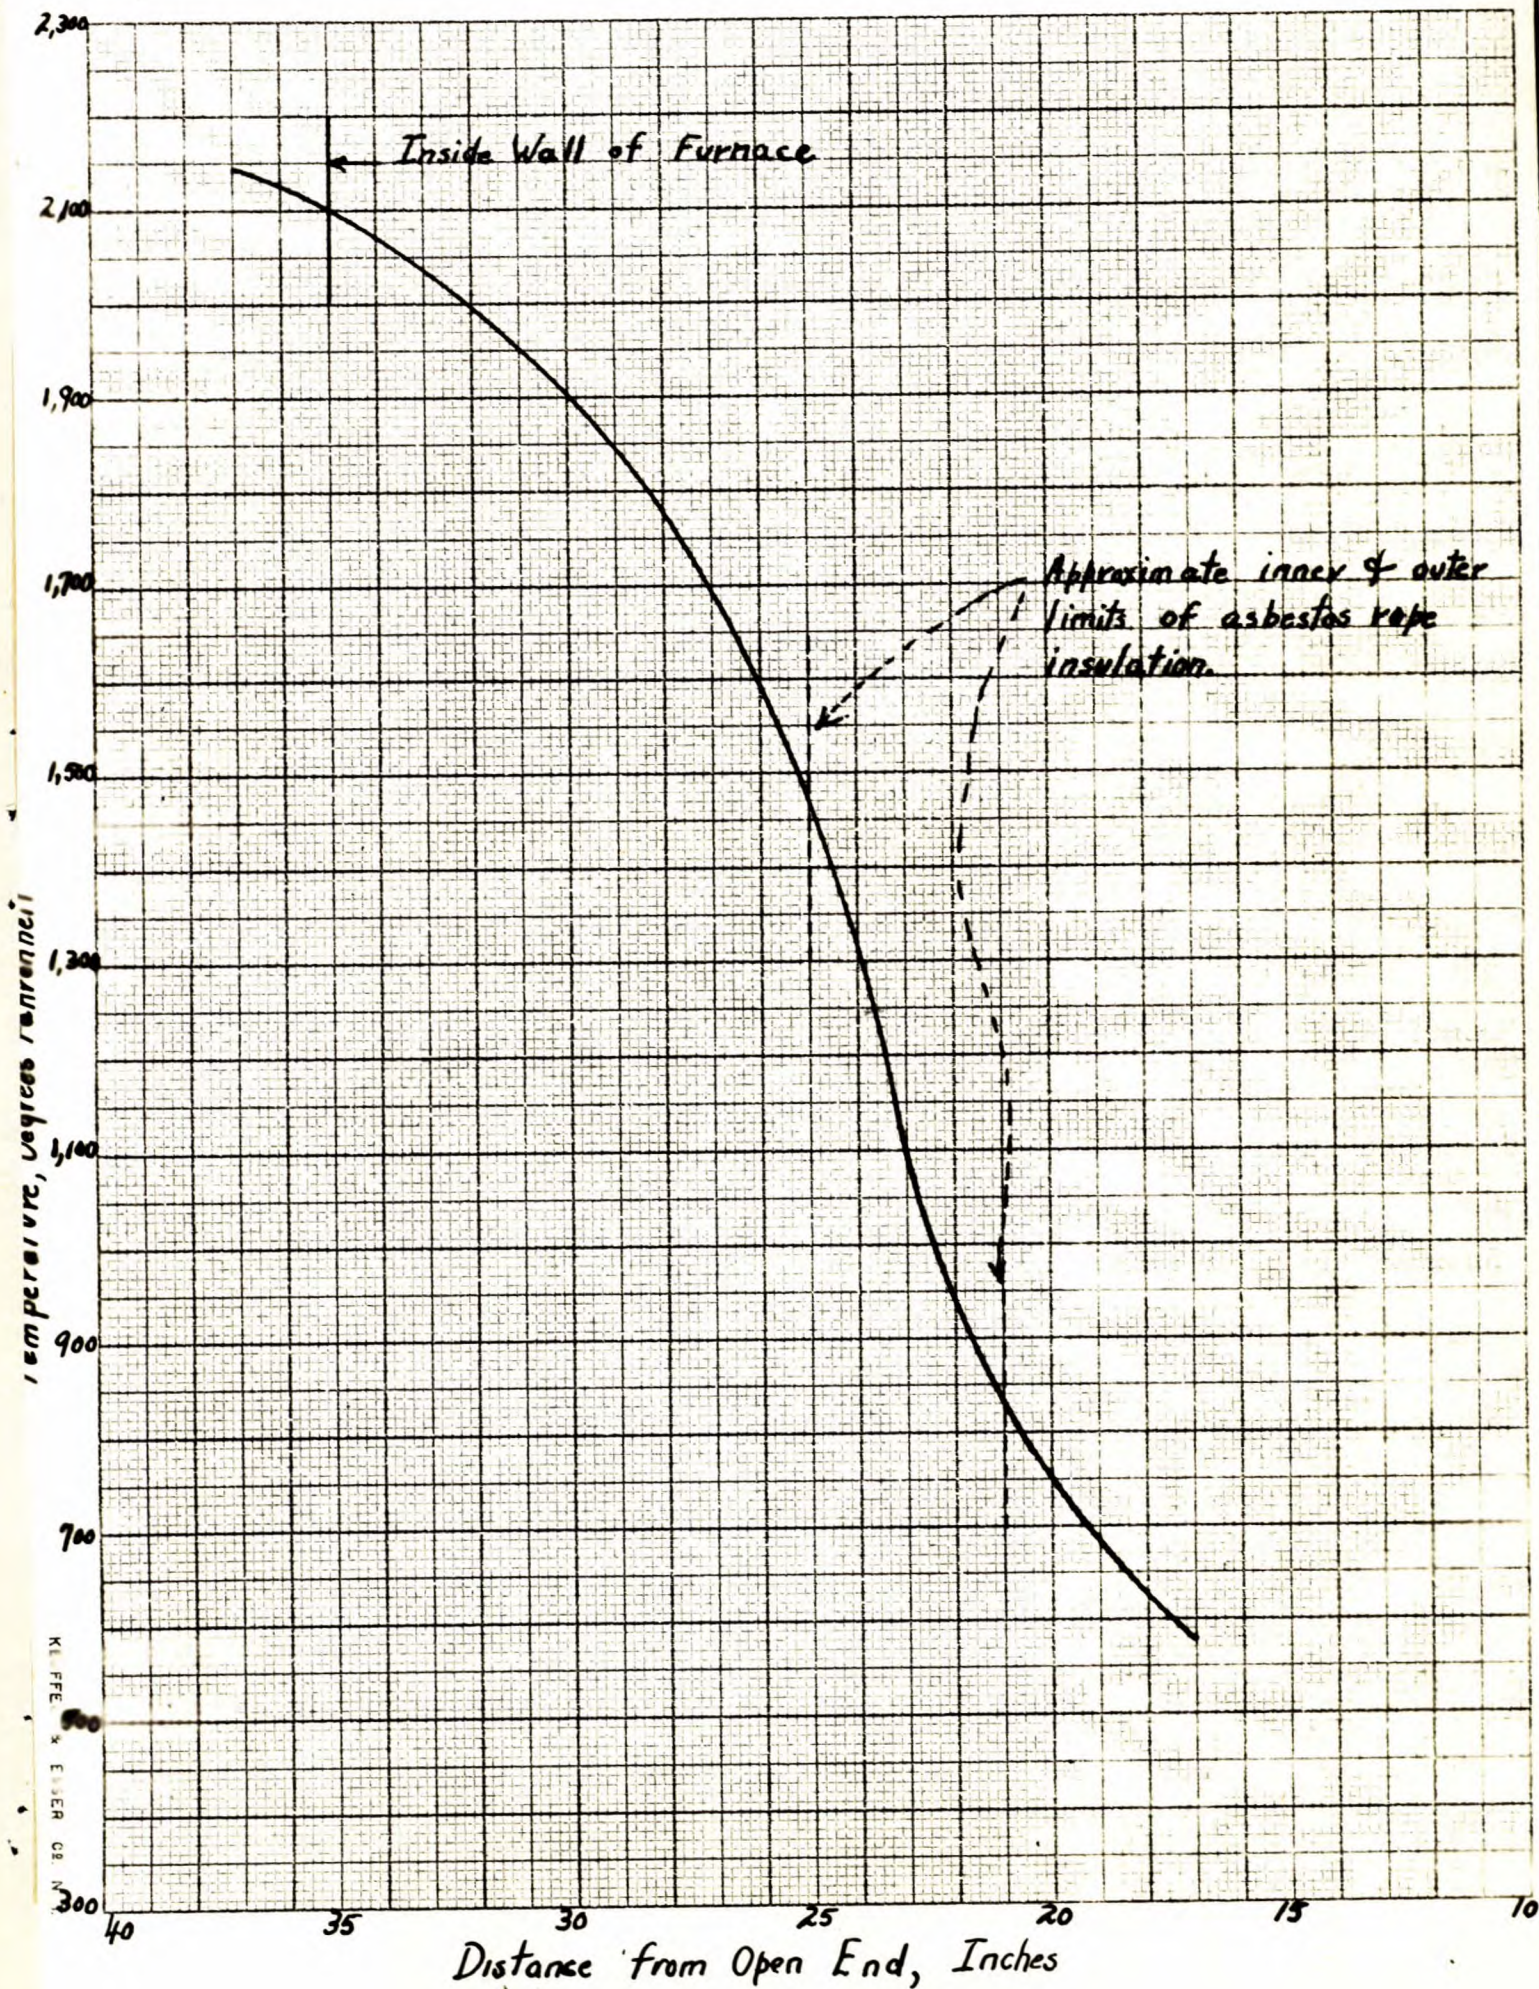
Figure 2.

Temperature of Outside Surface of Retort Versus Distance from Open End of Retort.

1. All welds should be so located as to fall either well within a zone above 1600° F. or well outside of the zone below 800° F. The latter location would be preferable in view of the higher yield strength at low temperatures.

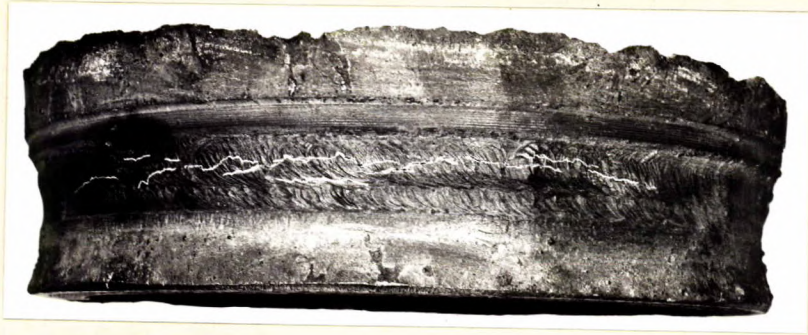
Figure 3.

(2). The section of retort showing typical failure by weld cracking was cleaned and examined visually. Figure 3 shows the appearance of the bottom of the retort weld and its severe cracking. Figure 4 shows the appearance of the top of the retort weld and its less severe cracking. No cracks were detected in the side positions of the weld. Figure 5 shows cracks at the root of the welds and running at right angles to the welds and apparently originating in casting flaws. For convenience, this sample will henceforth be referred to as Sample No. 1.

Figures 3 and 4 show that cracks in the welds occur in both the top and the bottom and are not entirely confined to the bottom area, at least in this particular sample. Figure 5 shows that cracks on the inside of the barrel have originated from casting defects. Figures 7 and 8 show that the cracking in the bottom areas of the weld are much more pronounced than the top areas of the weld. This lends weight to the theory of severe stress concentration in that area. It will be noted

BOTTOM OF WELD OF SAMPLE NO. 1.

Note cracks and sharp machined change of section above weld.

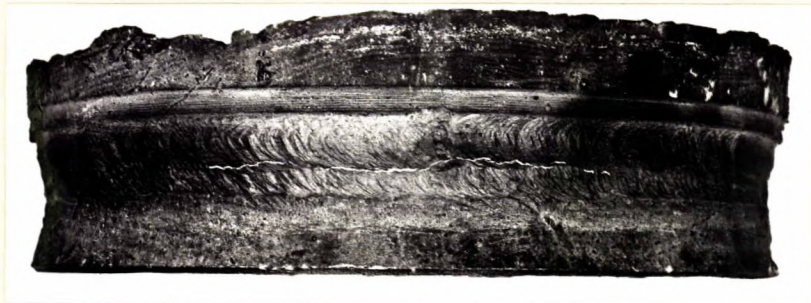
Figure 4.

TOP OF WELD OF SAMPLE NO. 1.

Note crack and sharp machined change of section above weld.

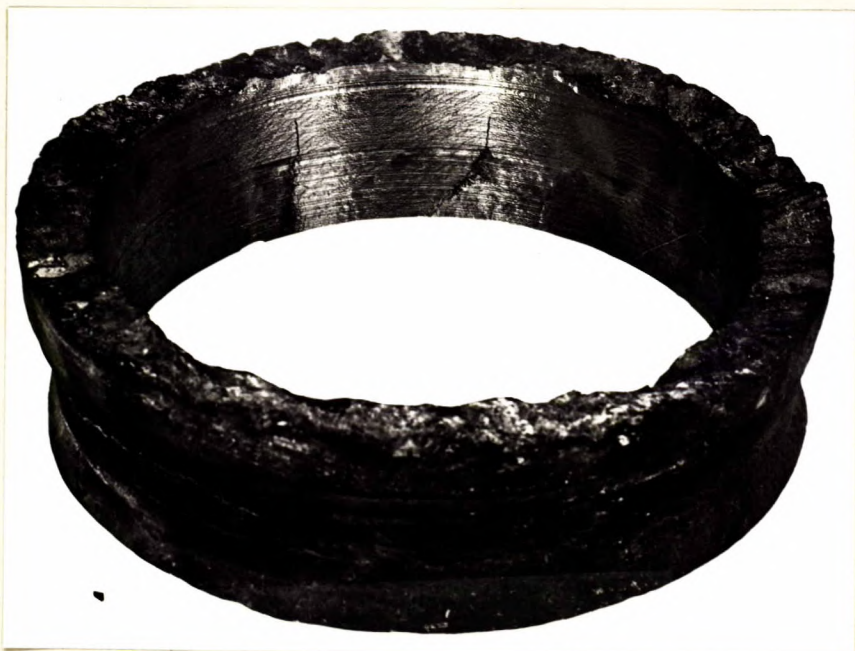
Figure 5.

SAMPLE NO. 1 AS RECEIVED.

Note cracks on inside, originating in casting defects.

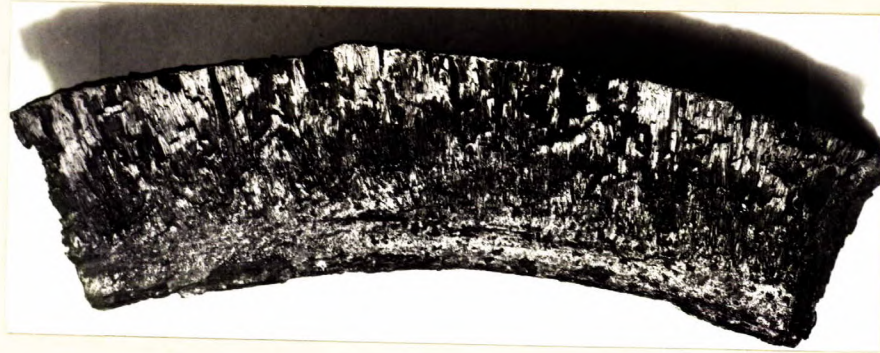
Figure 6.

(3). The weld section stated to be very brittle and removable by hammering was cleaned and visually examined. Figure 6 shows the peculiar woody structure of the fractured weld. This sample will be subsequently referred to as Sample No. 2.

SAMPLE NO. 2 AS RECEIVED.

Note "woody" type of fracture.

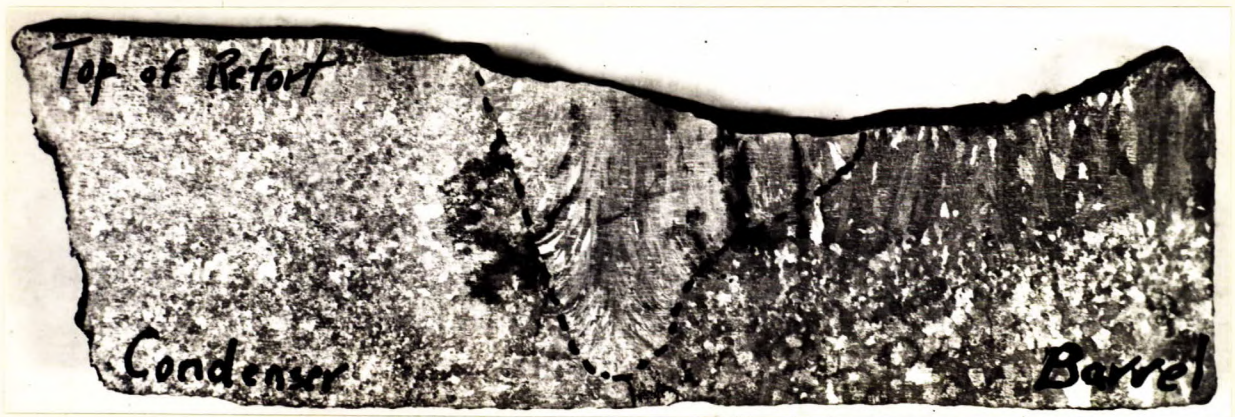
Figure 7.

SECTION OF TOP OF WELD OF SAMPLE NO. 1.

Note cracks in weld metal, extending down into barrel material. Dotted line is outline of weld. Note unfused root of weld.

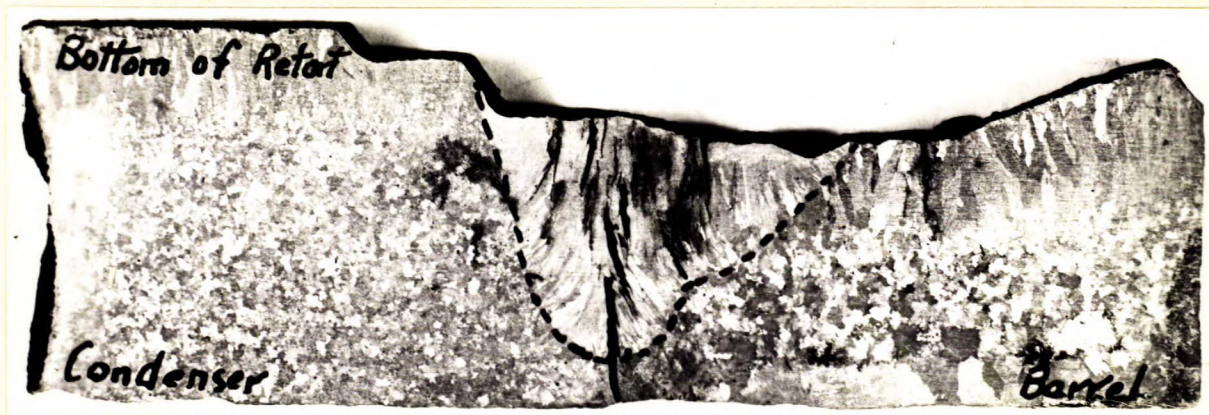
Figure 8.

that the heaviest crack in the bottom of the weld originates in an unfused root. This fact, together with cracking in the top area of the weld, indicates alternating stresses since when the weld at the bottom of the retort is in tension its root and the top areas of the weld at the top of the retort are in compression. These conditions would not cause cracking in these areas. It will also be noted from Figure 8 that there is a sharp change of section in the weld area and that cracking has occurred in the retort barrel material adjacent to the weld. Figure 9 shows a similar condition with regard to Sample No. 2.

SECTION OF BOTTOM OF WELD OF SAMPLE NO. 1.

Note profusion of cracks in weld metal, crack in barrel material adjacent to weld, and unfused root at which a heavy crack originates. Dotted line is outline of weld.

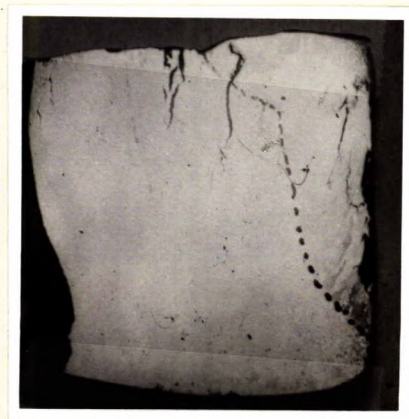
Figure 9.

SECTION OF WELD OF SAMPLE NO. 2.

Note cracks in weld metal and adjacent metal. Dotted line is outline of weld.

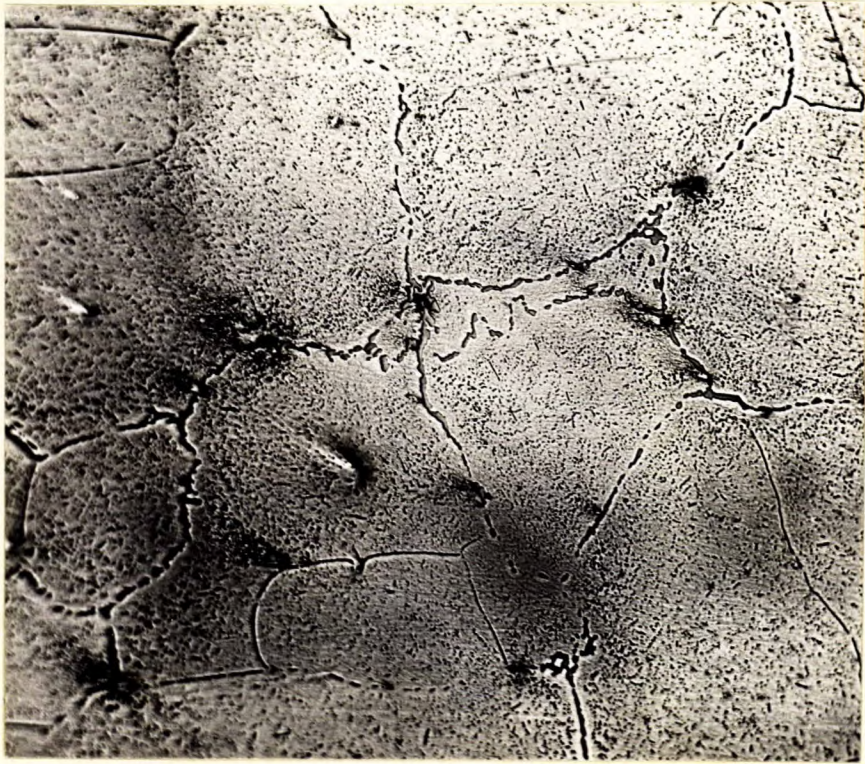
Figure 10.

CONDENSER MATERIAL - SAMPLE 1.

Note fine carbides in grains and heavier  
carbides in grain boundaries.

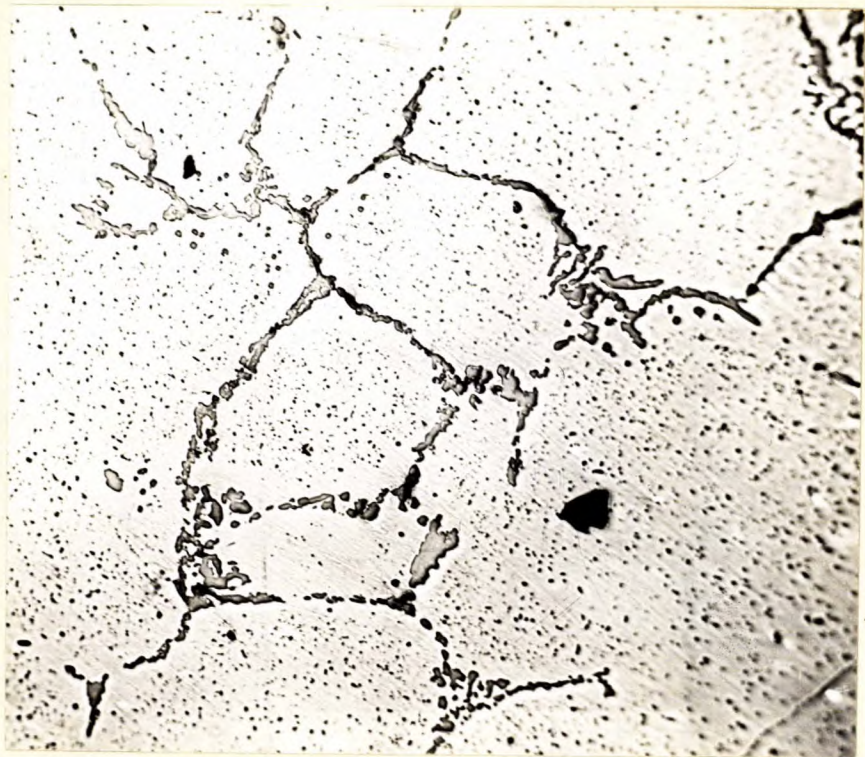
Figure 11.

RETORT MATERIAL - SAMPLE 1.

Note fine carbides in grains and heavier  
carbides in grain boundaries.

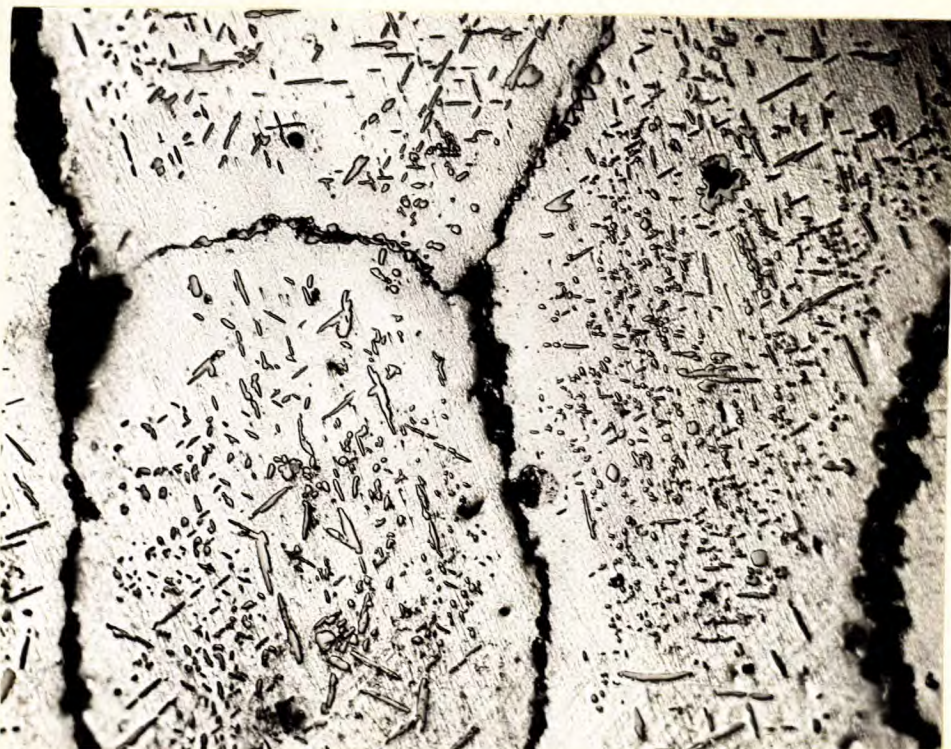
Figure 12.

Figures 10 and 11 show respectively the structures of the condenser and barrel materials. Both show fine carbides in the grains and fairly heavy grain boundary carbides. Figure 12 shows cracks in the barrel material adjacent to the weld and reveals that they follow grain boundaries containing precipitated carbides. Figures 13 and 14 show two types of carbides found in the badly cracked welds of both samples. These carbides are fine nodules in one case and somewhat acicular in the

BARREL MATERIAL ADJACENT TO WELD - SAMPLE 1.

Note heavy carbides in grains and grain boundaries.  
Note cracks following grain boundaries.

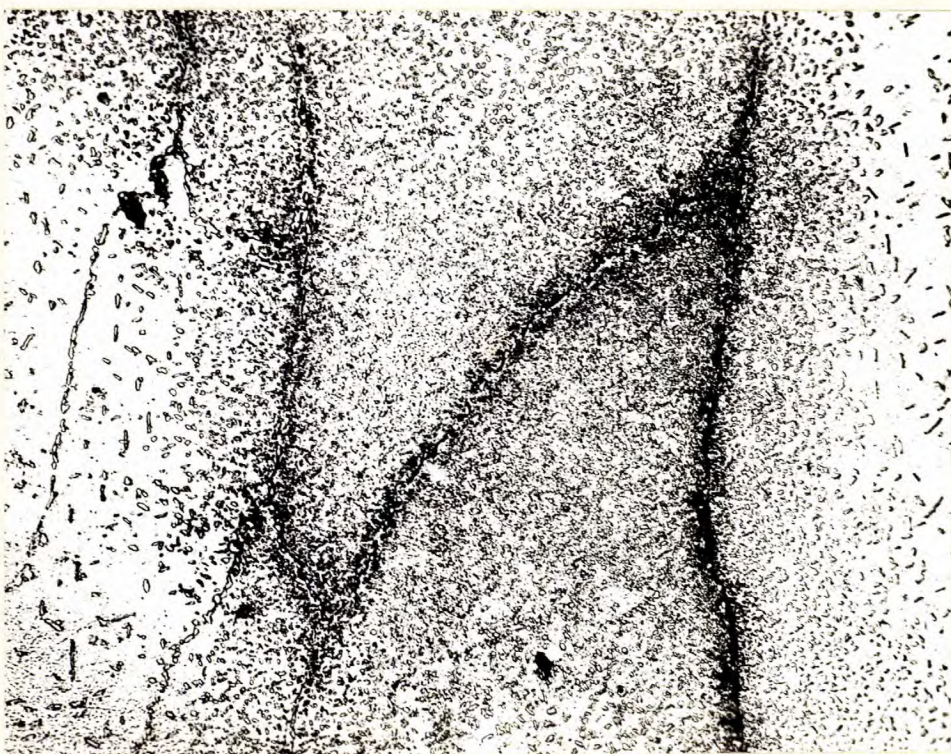
Figure 13.

ONE TYPE OF CARBIDE IN HEAVILY CRACKED AREAS OF WELDS.

Note fine carbides in grains and cracks fol-  
lowing grain boundaries.

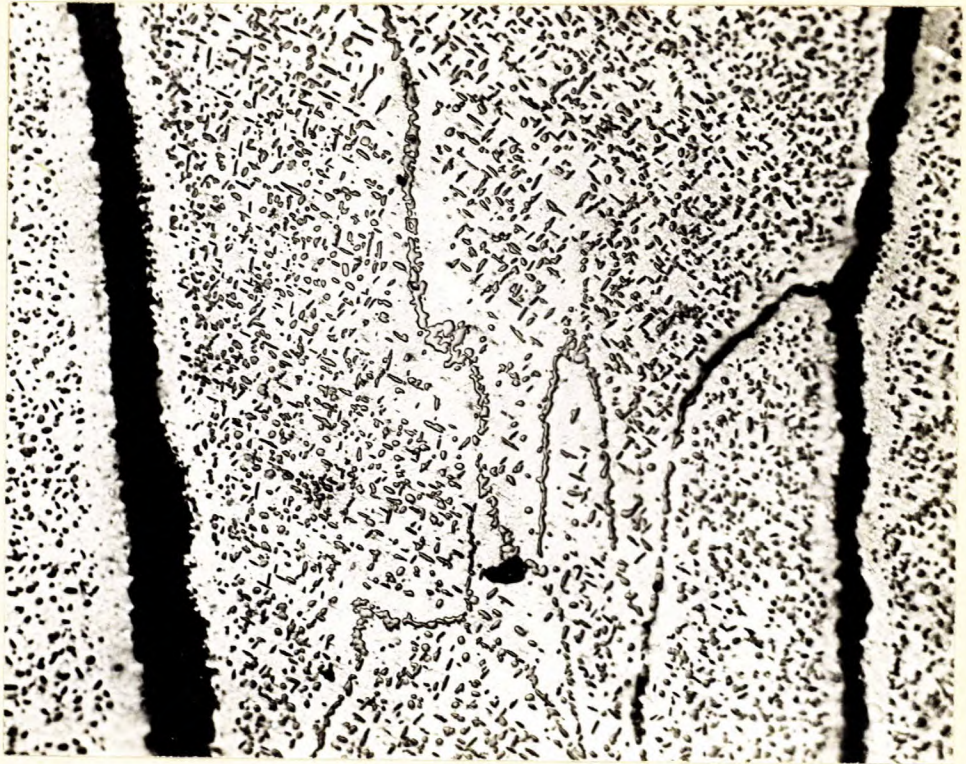
Figure 14.

other. In the latter case it will be noted that the orientation is  $90^\circ$  to one another. Where welds are not badly cracked they have the structure shown in Figure 15, in which there are some fine carbides in the grains and very light grain boundary carbides. The  $90^\circ$  orientation of the precipitate, shown in Figure 14, raised some doubts as to the nature of the precipitate. It is known that such orientation is the result of either hot or cold work and deformation of the material. In alloys of this nature the possibility of the precipitation of sigma-phase material cannot be ignored. Carbides may also exhibit the same orientation under the same conditions. X-ray diffraction patterns definitely fail to reveal the presence of sigma-phase material and give a general confirmation of the presence of carbides. The lack of precise identification of particular carbides is attributable to iron in the carbide.

A SECOND TYPE OF CARBIDE FOUND IN HEAVILY  
CRACKED AREAS OF WELDS.

Note 90° orientation of carbides and cracks  
following grain boundaries.

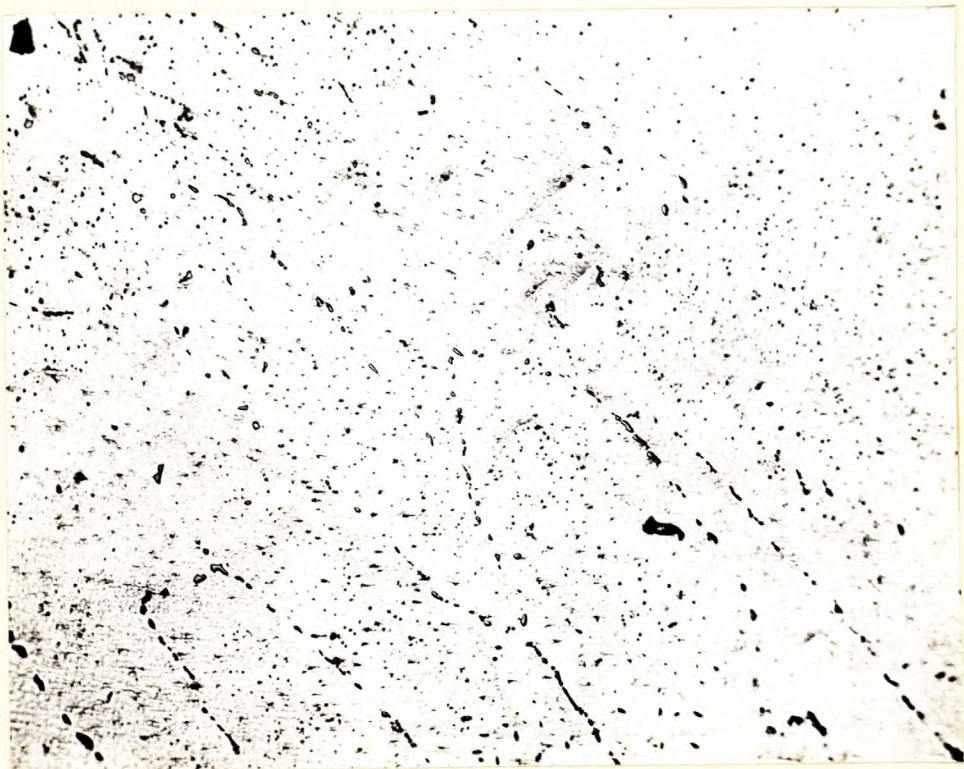
Figure 15.

TYPICAL STRUCTURE OF UNCRACKED WELDS.

Note paucity of carbides.

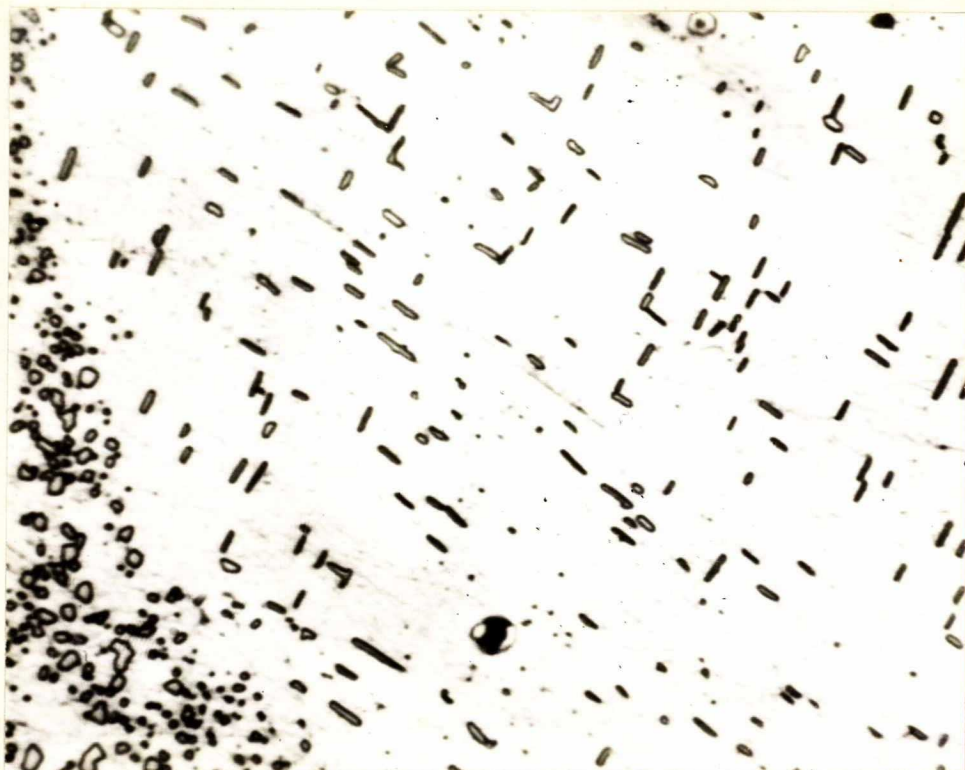
Figure 16.

Knowing the precipitate to be carbides, it should be possible to reproduce the structure showing the  $90^\circ$  orientation of carbide particles. This was done by the procedure outlined under "Procedure". Figure 16 shows this carbide particle orientation and was obtained by severely deforming material and then heating to the upper end of the carbide precipitation range of 18 days. Figure 16 shows the effect of the same heat treatment on undeformed material. It will be noted that the carbides are beginning to migrate to the grain boundaries but that there is no preferred orientation.

STRUCTURE OF DEFORMED 35/15 MATERIAL AFTER HEATING AT 1400° F. FOR 18 DAYS.

Note 90° orientation of carbide particles.

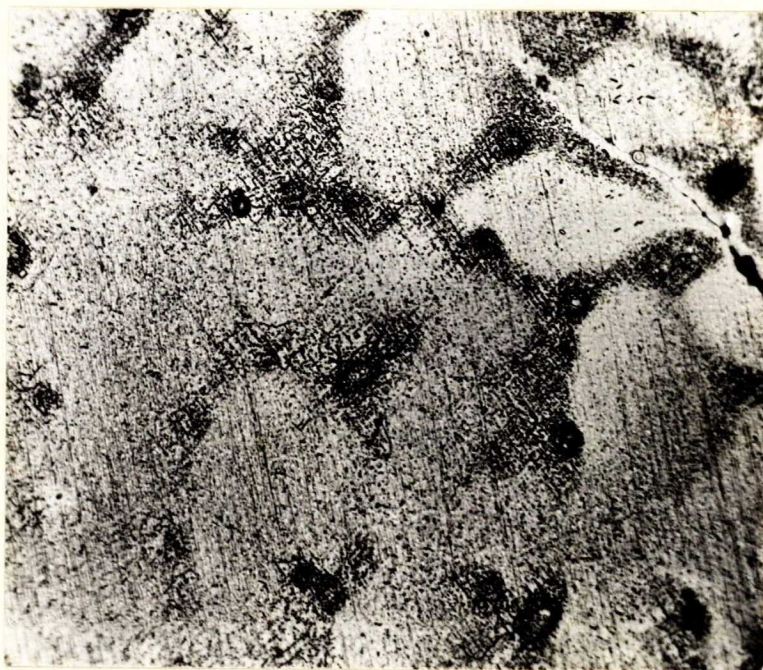
Figure 17.

STRUCTURE OF UNDEFORMED 35/15 MATERIAL AFTER HEATING AT 1400° F. FOR 18 DAYS.

Note that there is no preferred orientation of carbide particles and that carbides are migrating to grain boundaries.
