August 28, 1945.

ORE DRESSING AND METALLURGICAL LABORATORIES.

Investigation No. 1925.

Resistance of Painted Steel to
Salt Spray Corrosion.

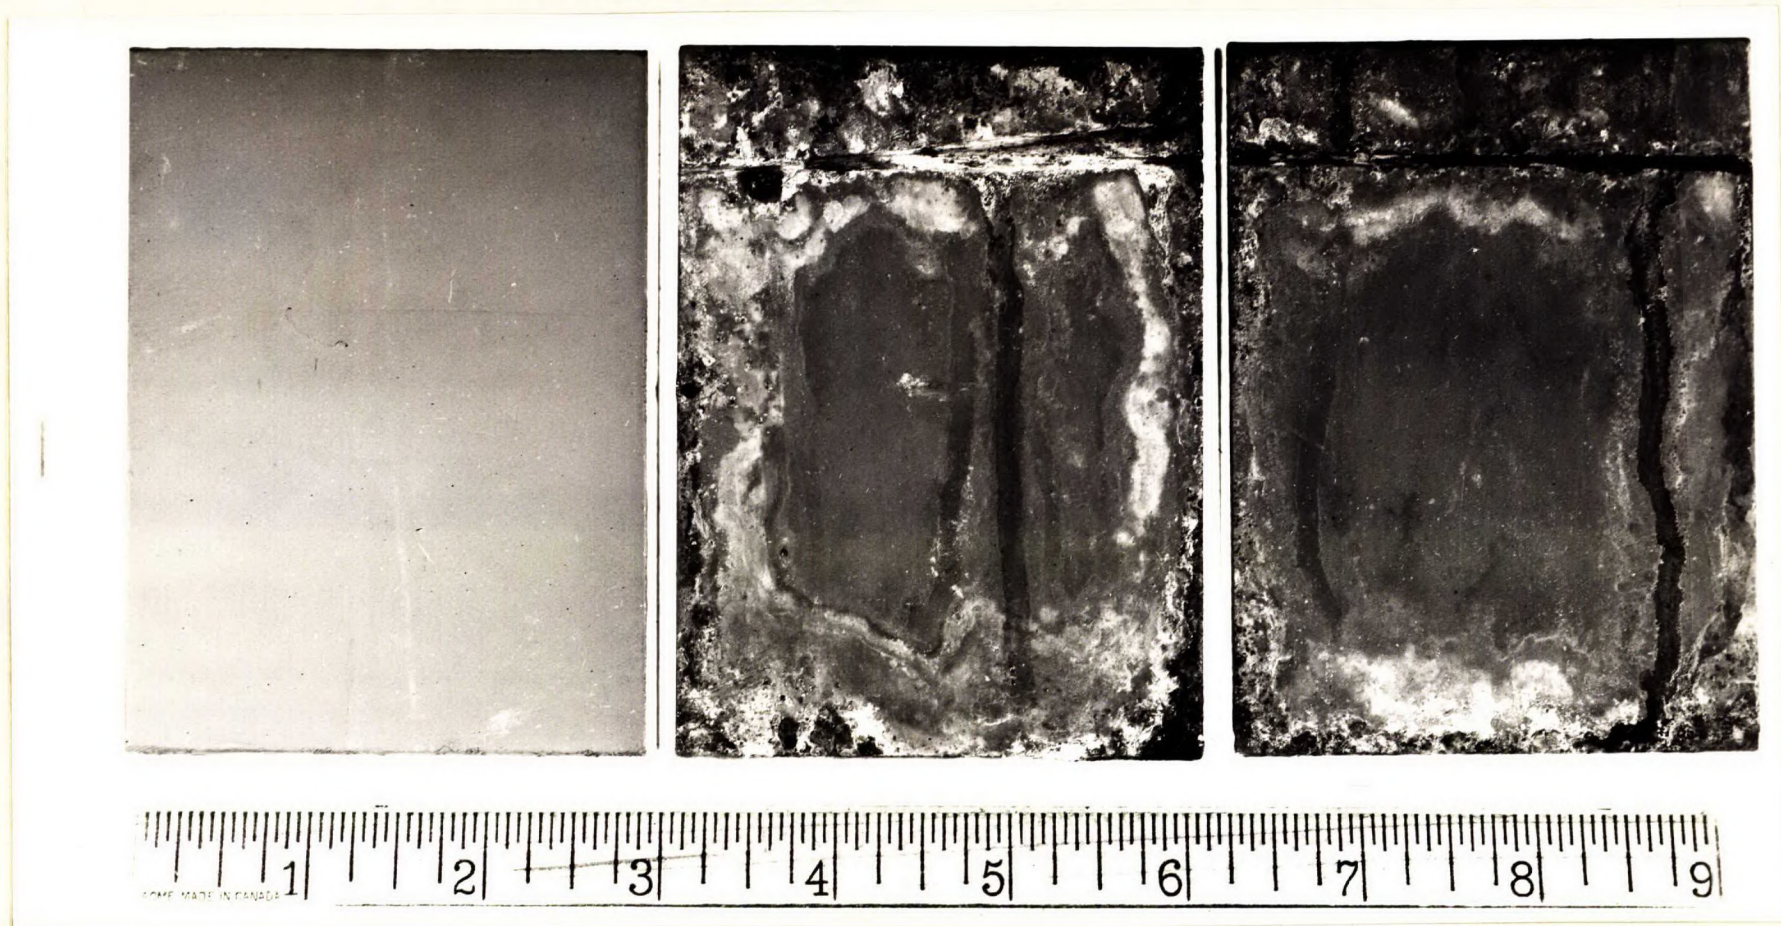
G. W. Reed & Co. - Central parts of panels were affected comparatively little. Considerable corrosion at the edges and the paint adjacent to the corroded areas contained many small blisters. See Figure 1.

PAINTED STEEL PANELS FROM G.W. REED & CO.

(a) Uncorroded; (b) and (c), After 64 Days in the Salt Spray Cabinet.

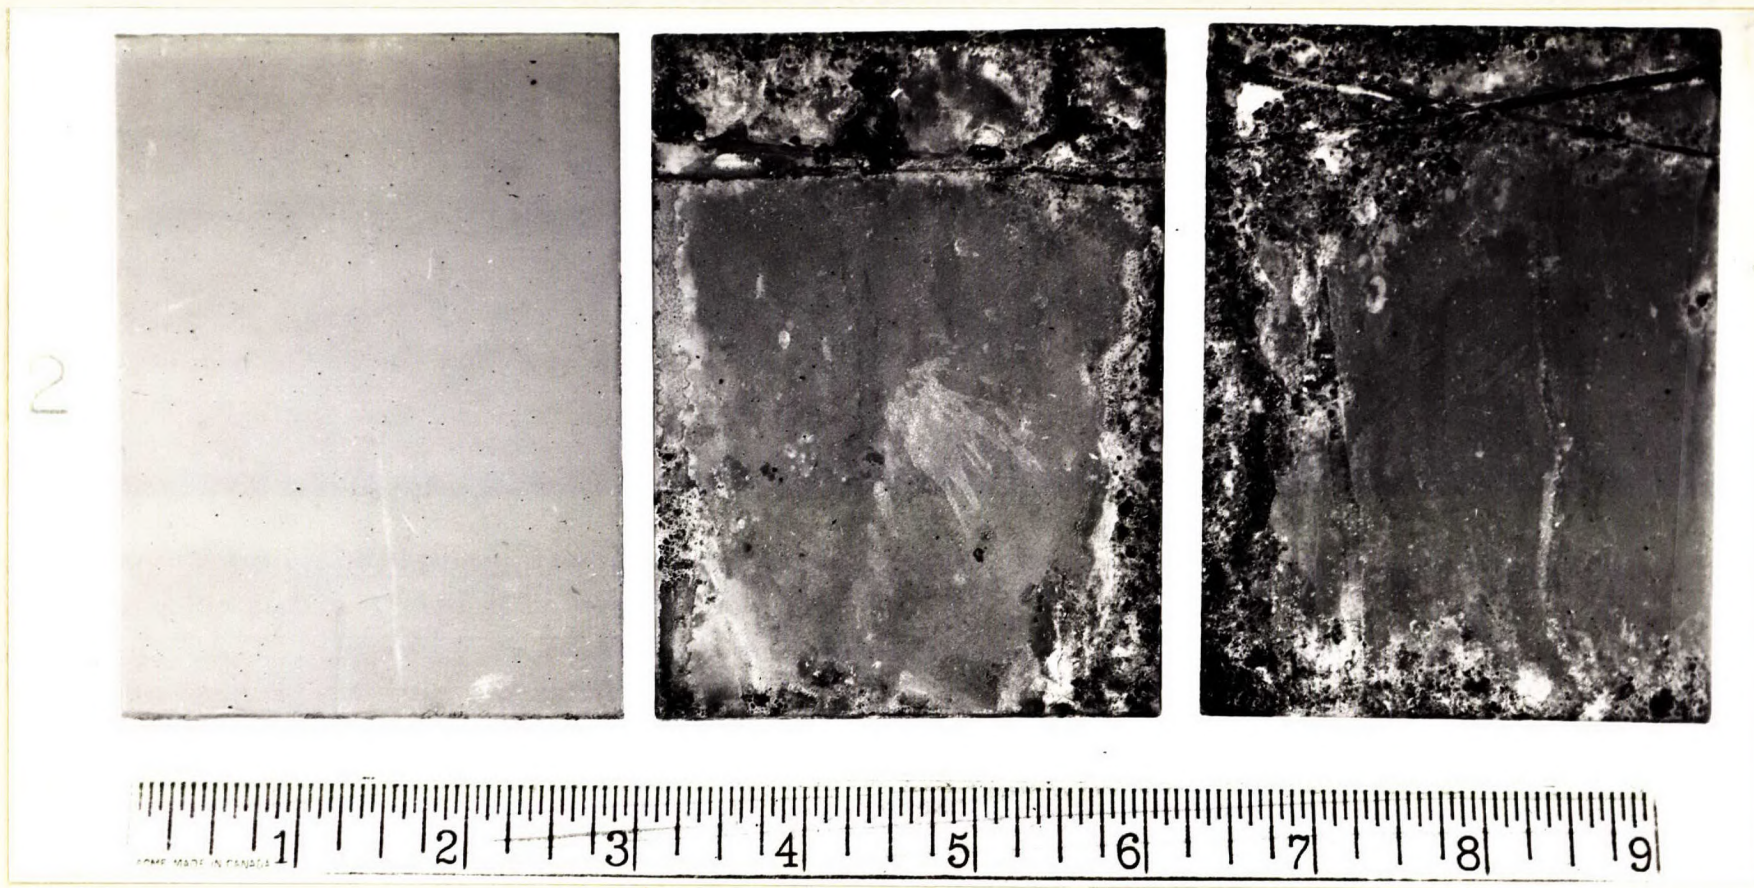
Motor Coach Industries - Considerable corrosion and blistering. Part of the surfaces comparatively unaffected except for a number of fairly small isolated rust spots on one of the panels. See Figure 2.

PAINTED STEEL PANELS FROM MOTOR COACH INDUSTRIES.

(a) Uncorroded; (b) and (c), After 64 Days in the Salt Spray Cabinet.

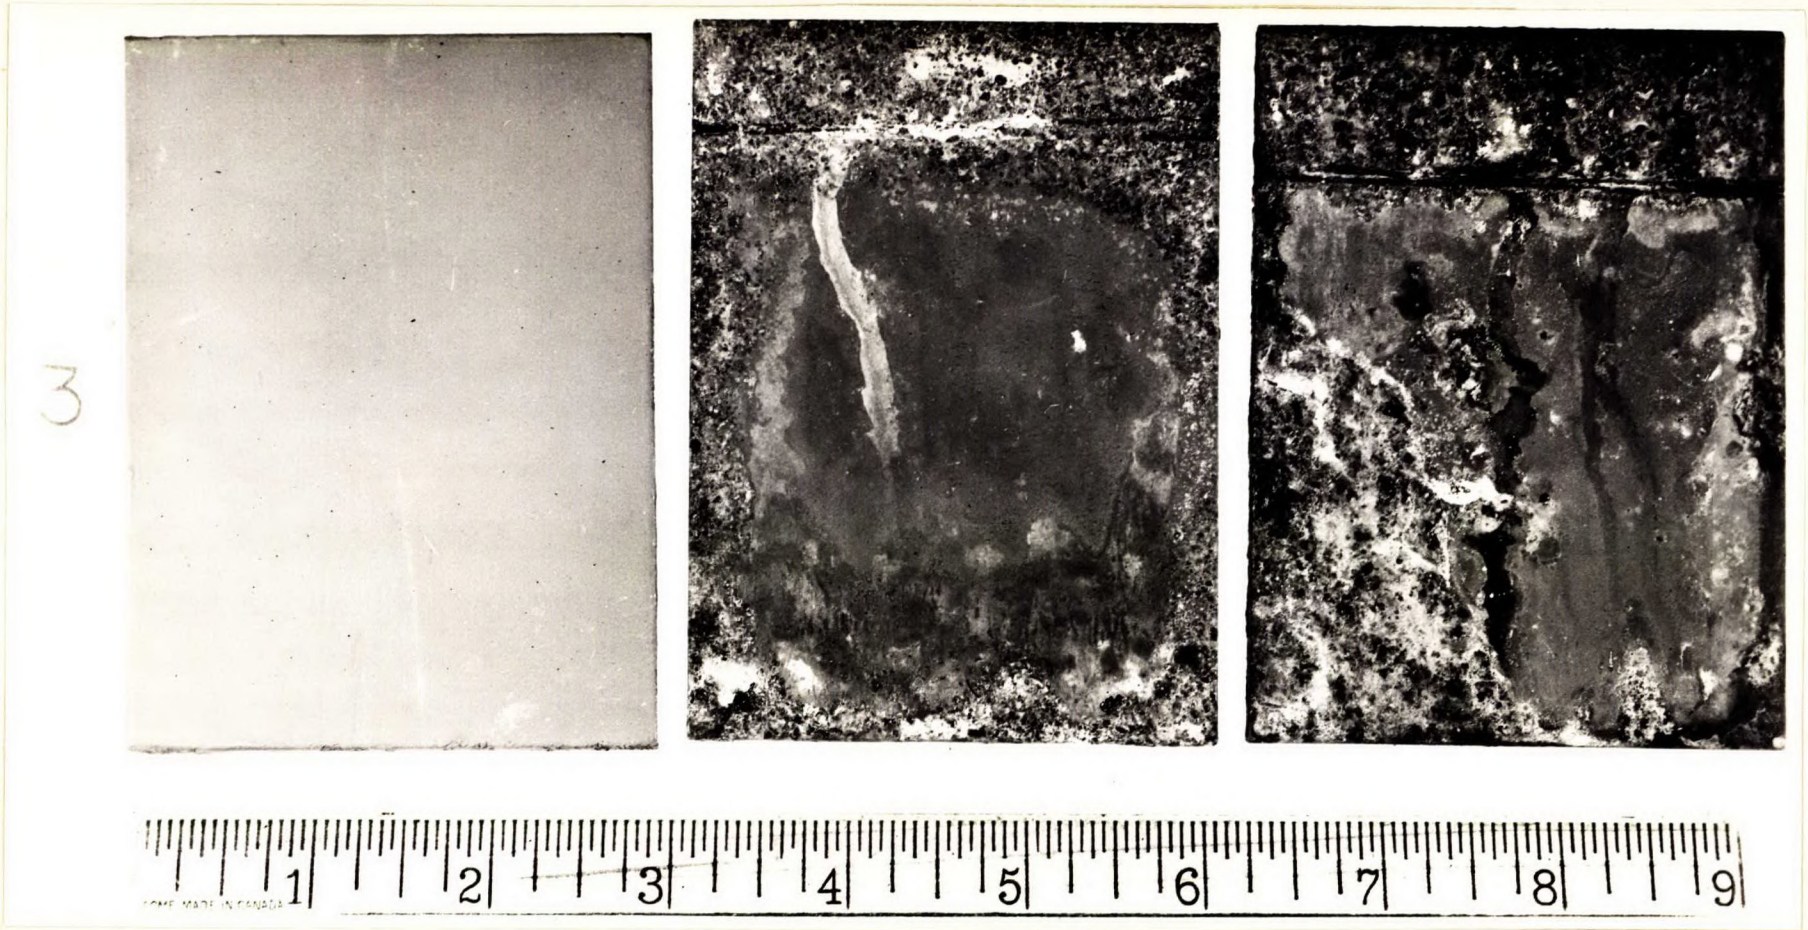
Western Auto and Truck Body Works - Most of surfaces corroded and blistered. See Figure 3.

PAINTED STEEL PANELS FROM WESTERN AUTO & TRUCK BODY WORKS.

(a) Uncorroded; (b) and (c), After 64 Days in the Salt Spray Cabinet.

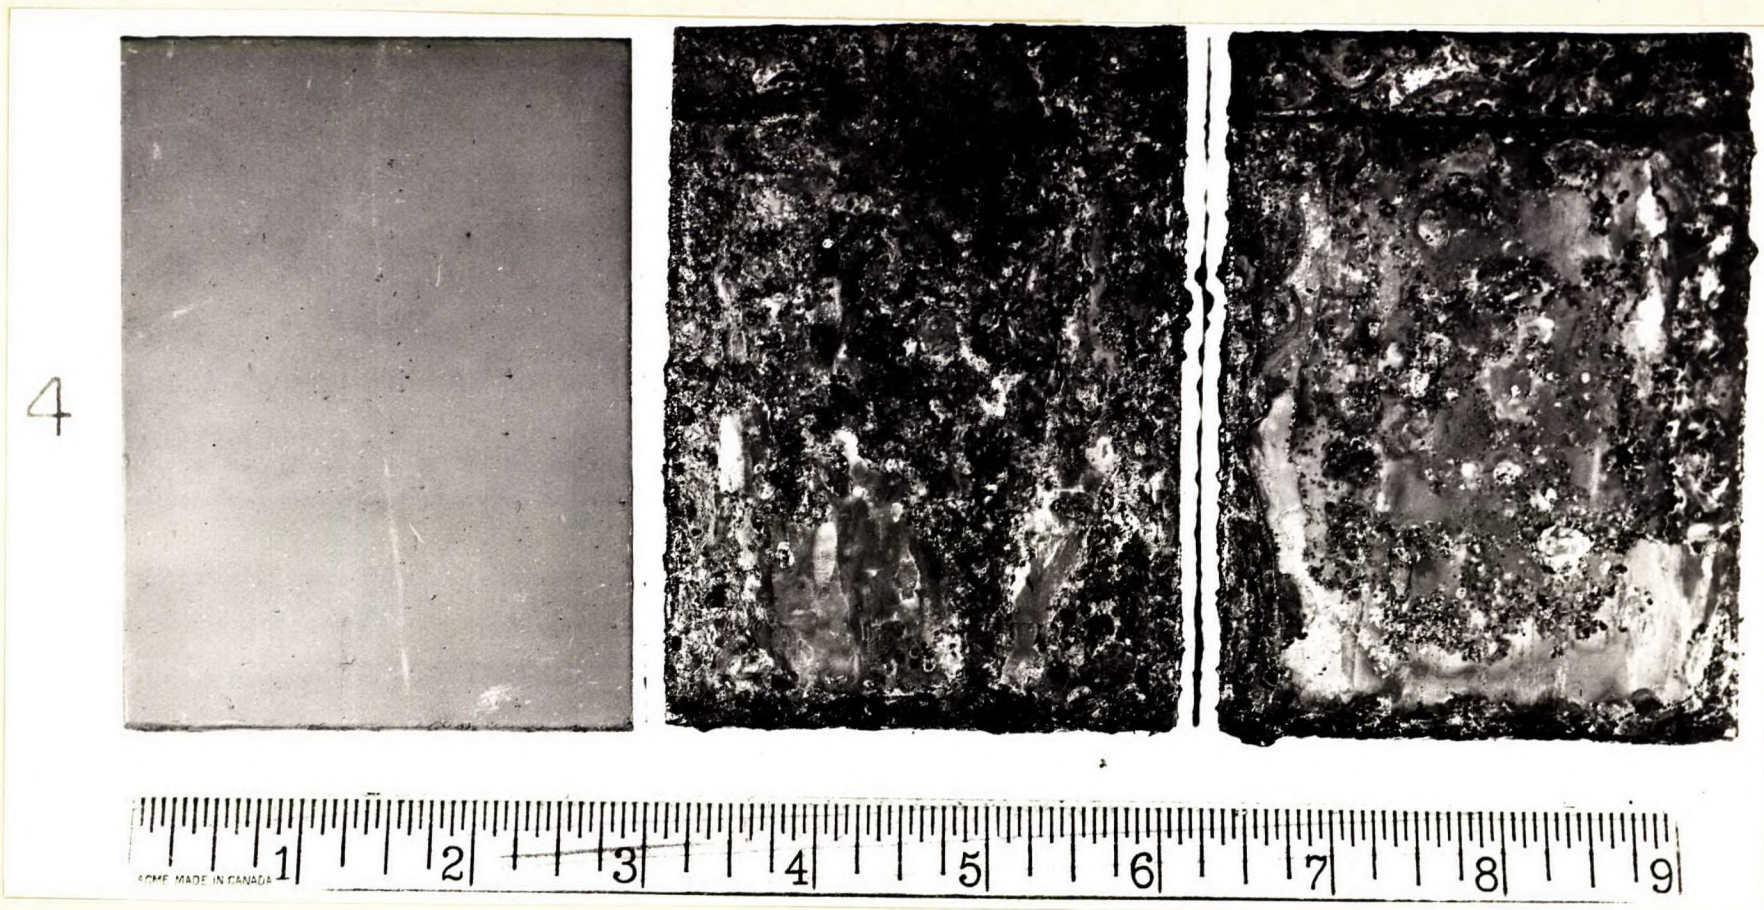
Frost & Wood Co. - General breakdown of surfaces due to corrosion and large and small blisters. See Figure 4.

PAINTED STEEL PANELS FROM FROST & WOOD CO.

(a) Uncorroded; (b) and (c), After 64 Days in the Salt Spray Cabinet.

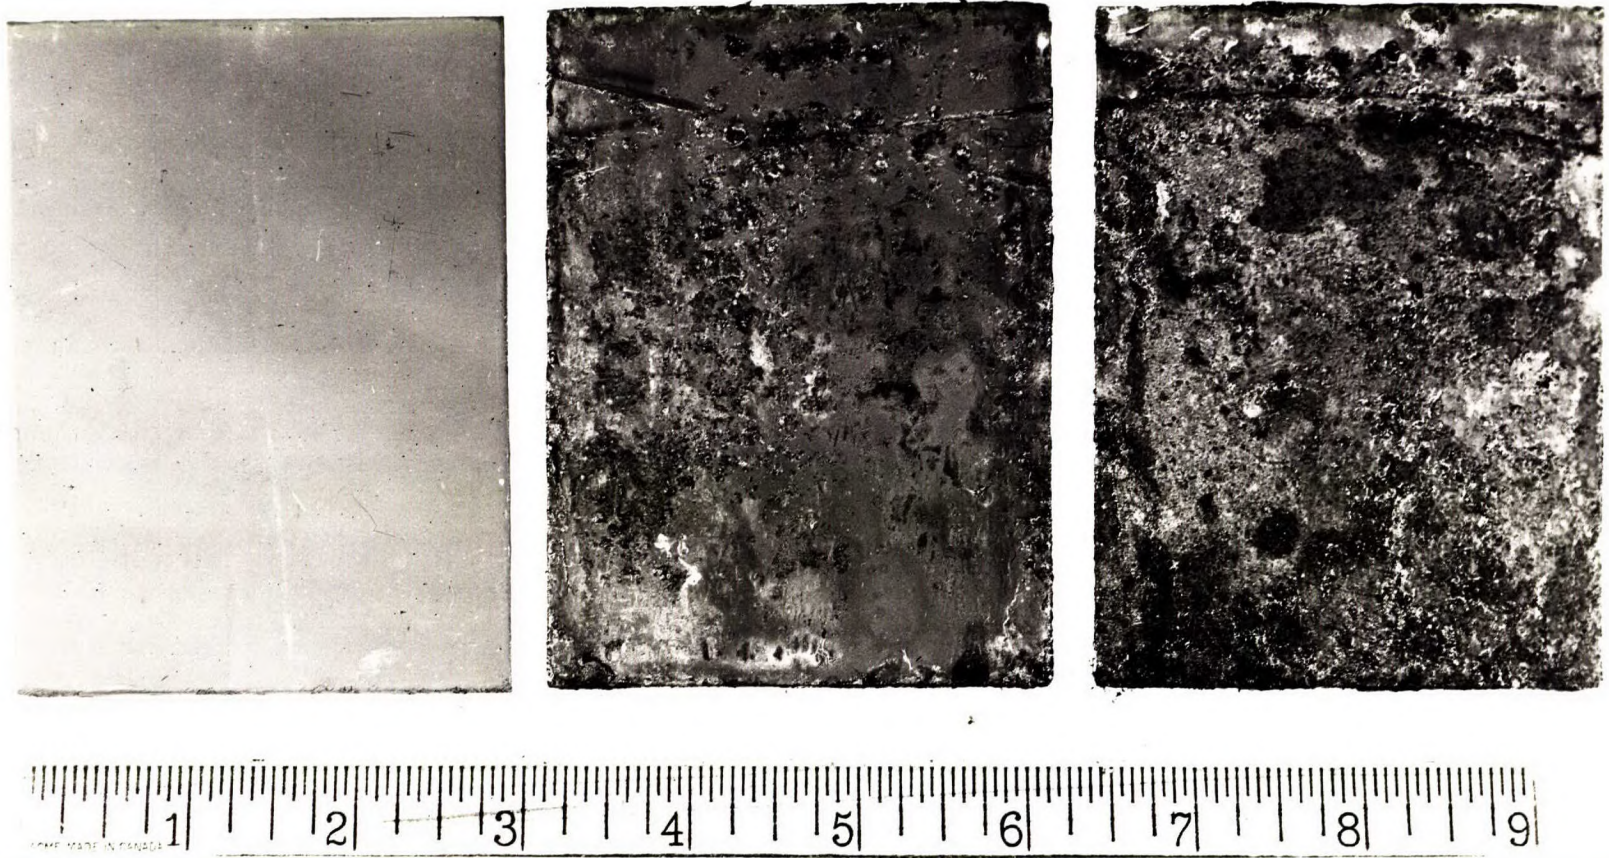
Metallic Roofing Co. Ltd. - General breakdown on one panel, and the other in very bad condition. See Figure 5.

The samples from the Metallic Roofing Co. Ltd. were separated from one another by oiled paper when they were received. Some of the oil undoubtedly came in contact with the paint and may have increased its life to a certain extent.

PAINTED STEEL PANELS FROM METALLIC ROOFING CO. LTD.

(a) Uncorroded; (b) and (c), After 64 Days in the Salt Spray Cabinet.

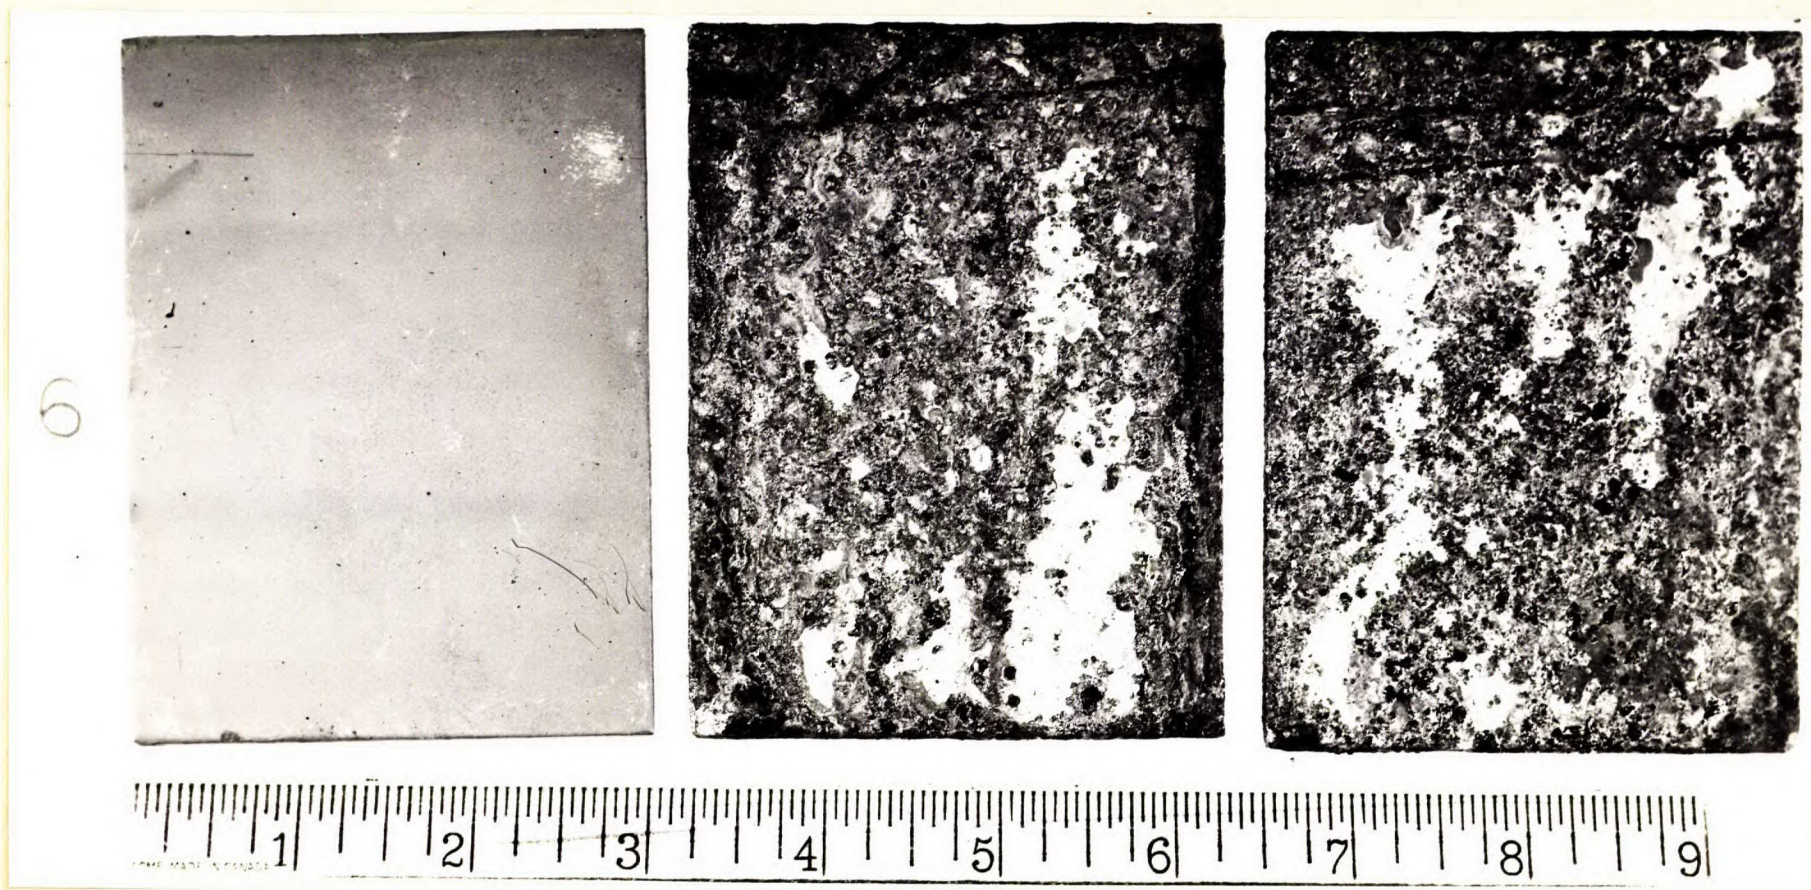
Gotfredson - General breakdown. See Figure 6.

PAINTED STEEL PANELS FROM GOTFREDSON LTD.

(a) Uncorroded; (b) and (c), After 64 Days in the Salt Spray Cabinet.

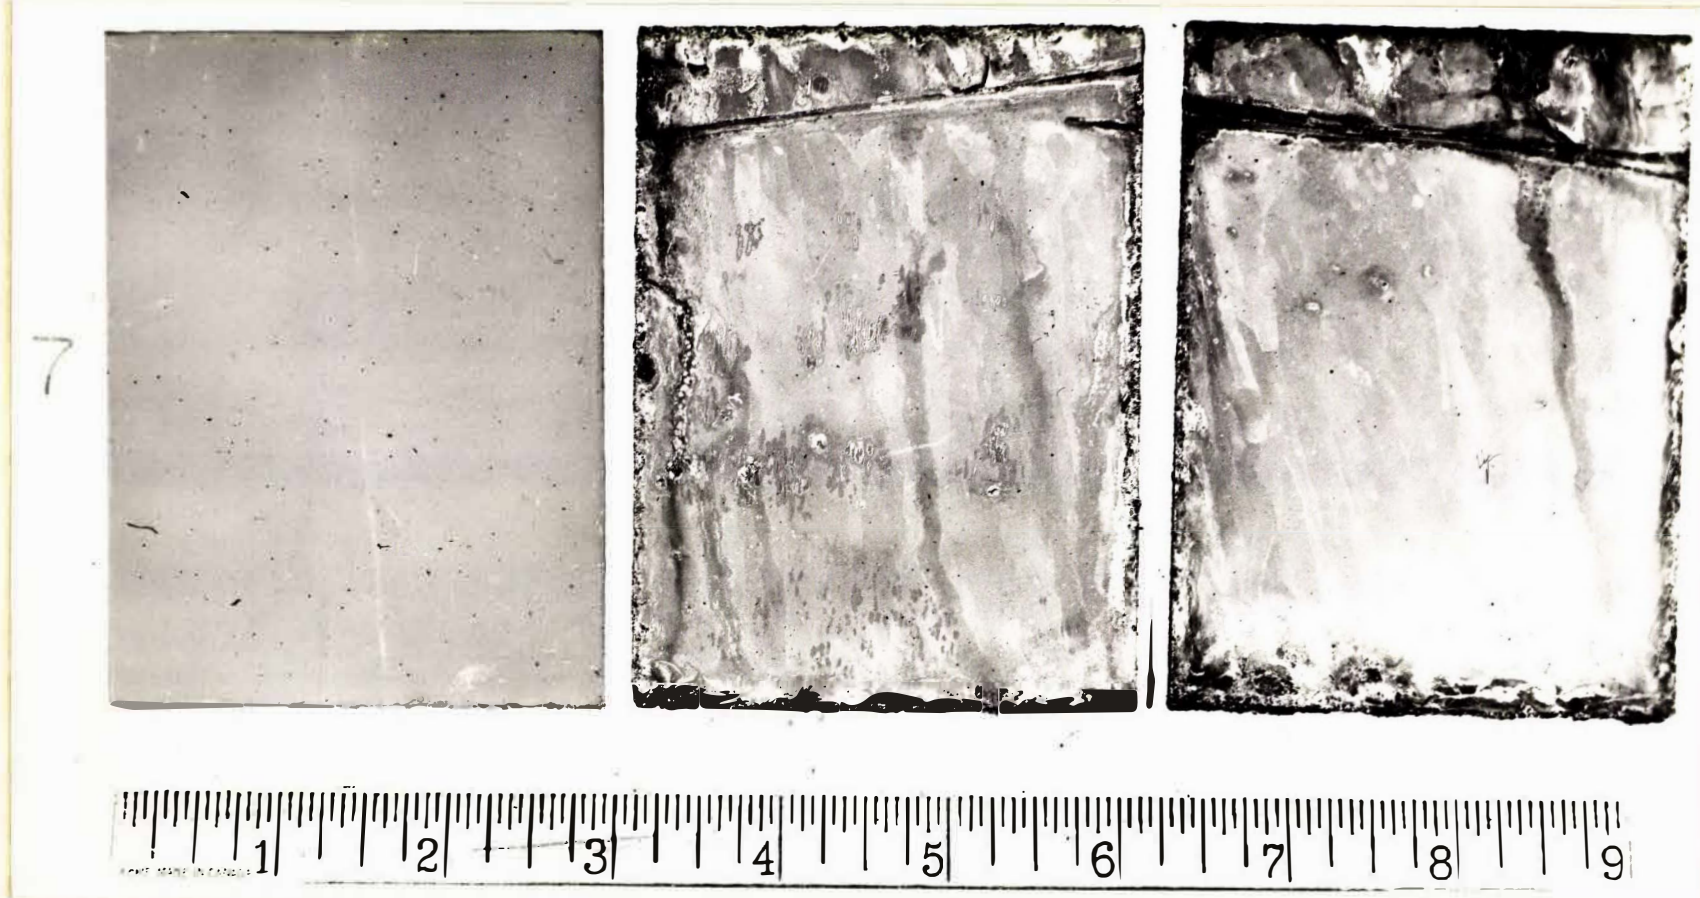
Sunshine Waterloo Co. - A number of fairly small, isolated spots where corrosion has taken place in addition to corrosion around the edges. See Figure 7.

PAINTED STEEL PANELS FROM SUNSHINE WATERLOG CO.

(a) Uncorroded; (b) and (c), After 64 Days in the Salt Spray Cabinet.

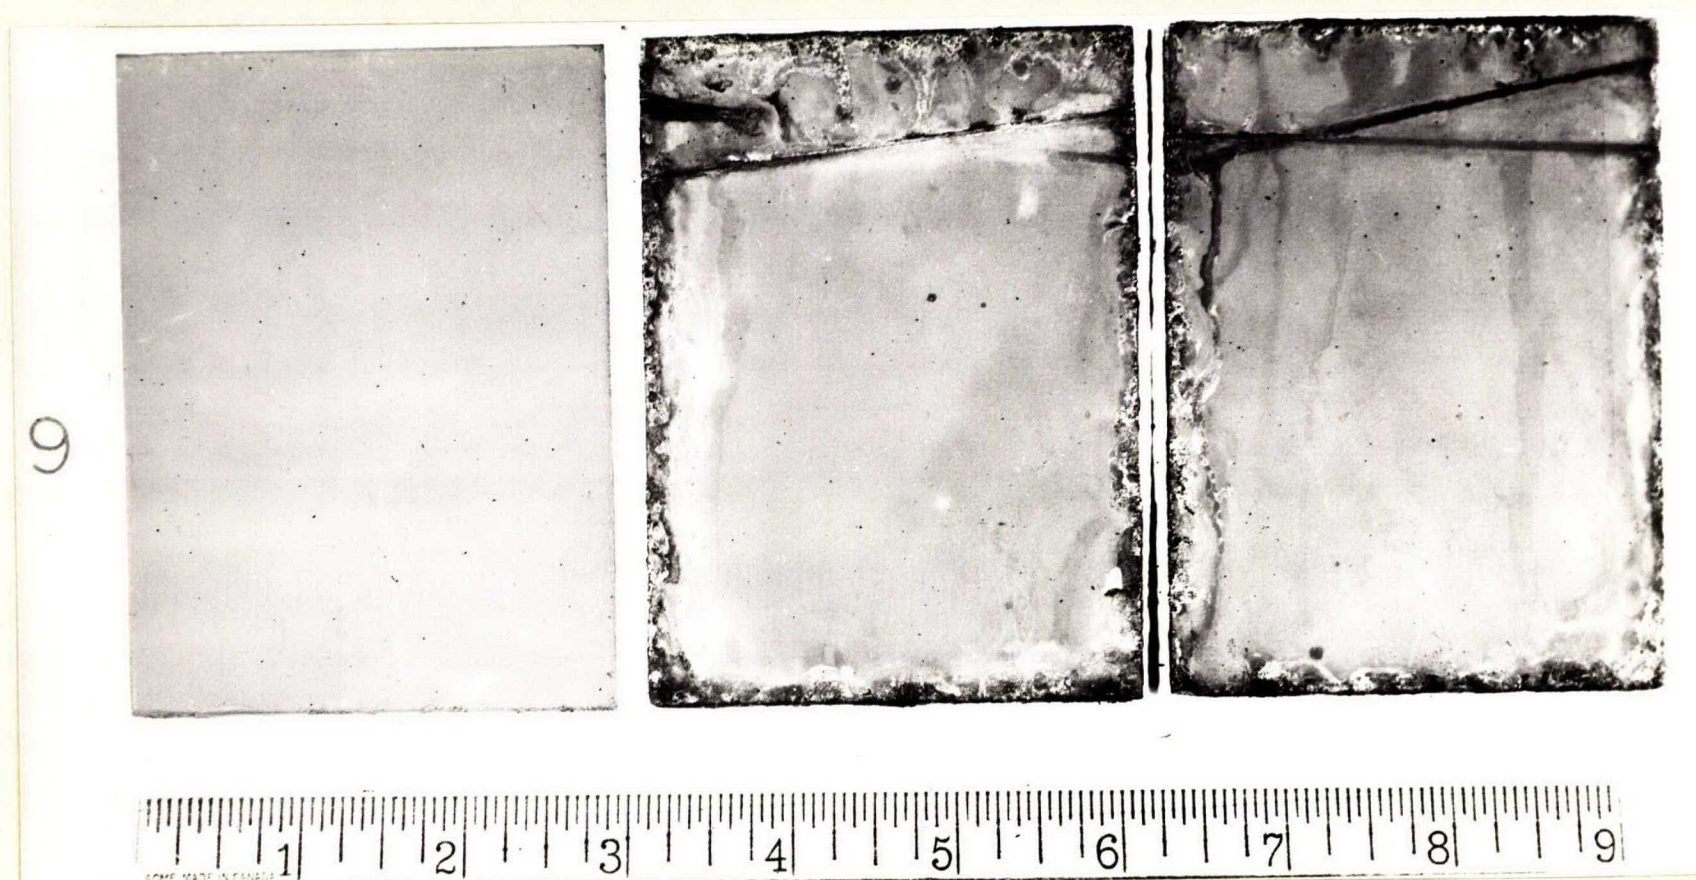
Truscon Steel Co. - Corrosion around the edges. Considerable number of small blisters just beginning to form. See Figure 9.

PAINTED STEEL PANELS FROM TRUSCON STEEL CO.

(a) Uncorroded; (b) and (c), After 64 Days in the Salt Spray Cabinet.
