August 29, 1945.

ORE DRESSING AND METALLURGICAL LABORATORIES.

Investigation No. 1926.

Corrosion Resistance of Metal Name Plates
For Export Packing Cases.

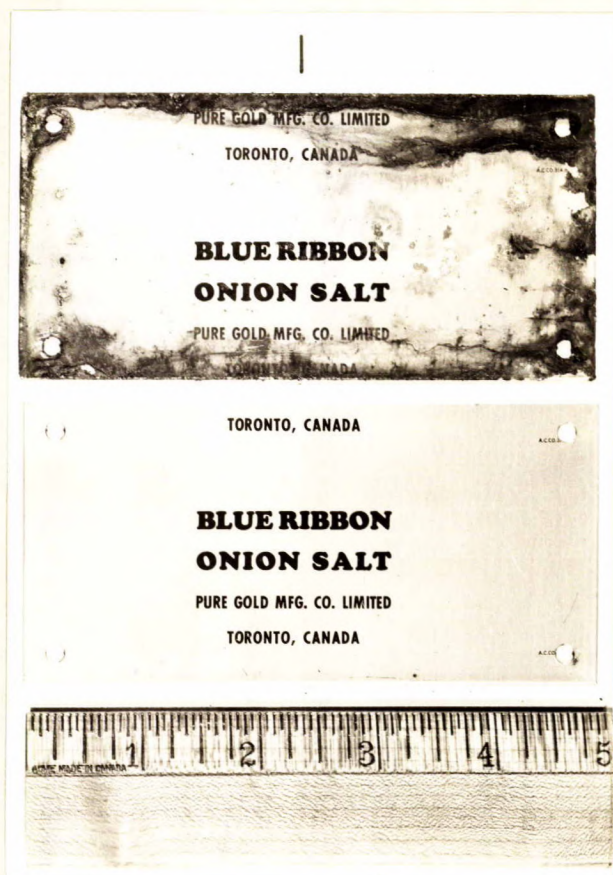
Figure 1.

After 40 days the plates were removed from the Salt Spray Cabinet and one of them was photographed (see Figures 1 and 2). Considerable rusting had occurred around and near the edges, covering up some of the printing.

1. The most serious deterioration due to corrosion took place under salt water conditions, especially in the salt spray. Even in this case, the damage was not serious. The corrosion product was readily removed.

UPPER PLATE - AFTER 40 DAYS OF SALT
SPRAY CORROSION.

LOWER PLATE - UNCORRODED.

Note: It was found that the rust could be removed by swabbing the plate with dilute acid. This made the printing quite readable.

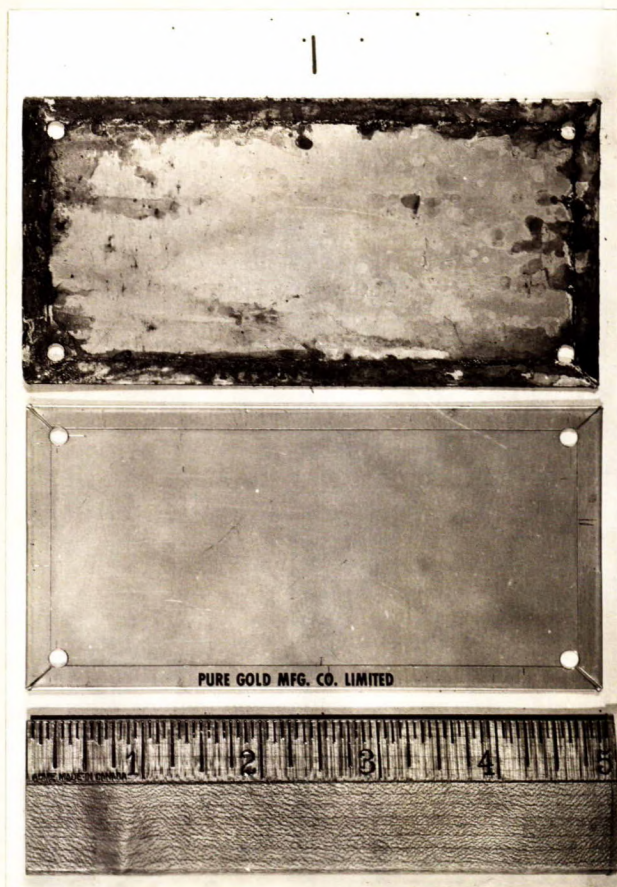
Figure 2.

REVERSE OF PLATES SHOWN IN FIGURE 1.

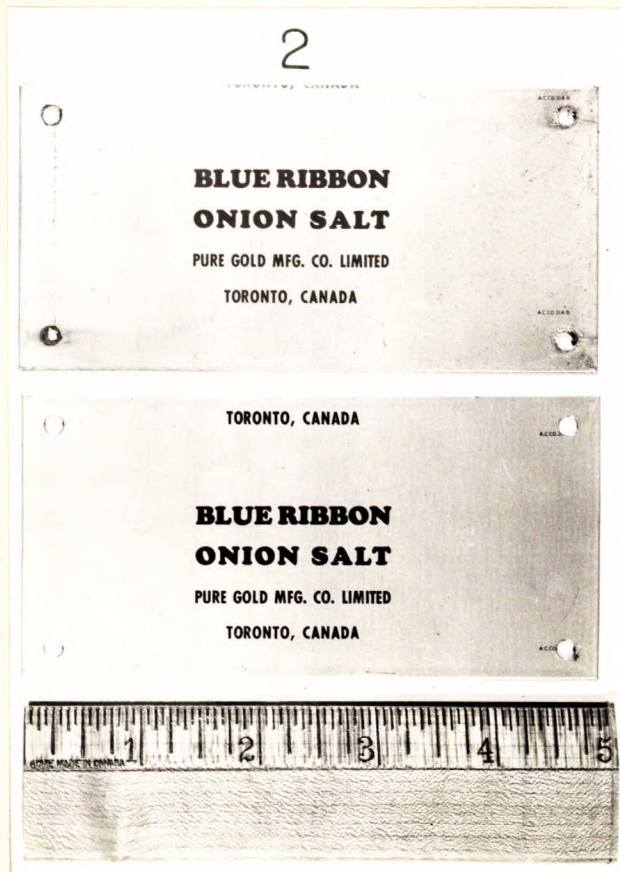
Figure 3.

After 40 days the plates were removed from the Intermittent Immersion Corrosion Machine and one of them was photographed (see Figures 3 and 4). The fronts of the plates were covered with a thin film of brown rust. The printing still could be read very easily. This film of rust could be removed by rubbing with a dry cloth.

UPPER PLATE - AFTER 40 DAYS OF INTER-MITTENT IMMERSION CORROSION.

LOWER PLATE - UNCORRODED.

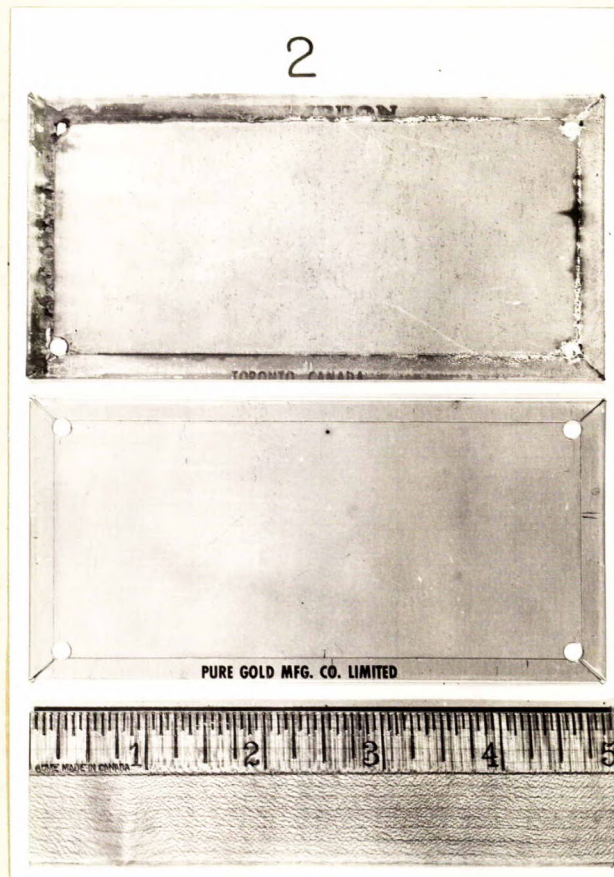
Figure 4.

REVERSE OF PLATES SHOWN IN FIGURE 3.

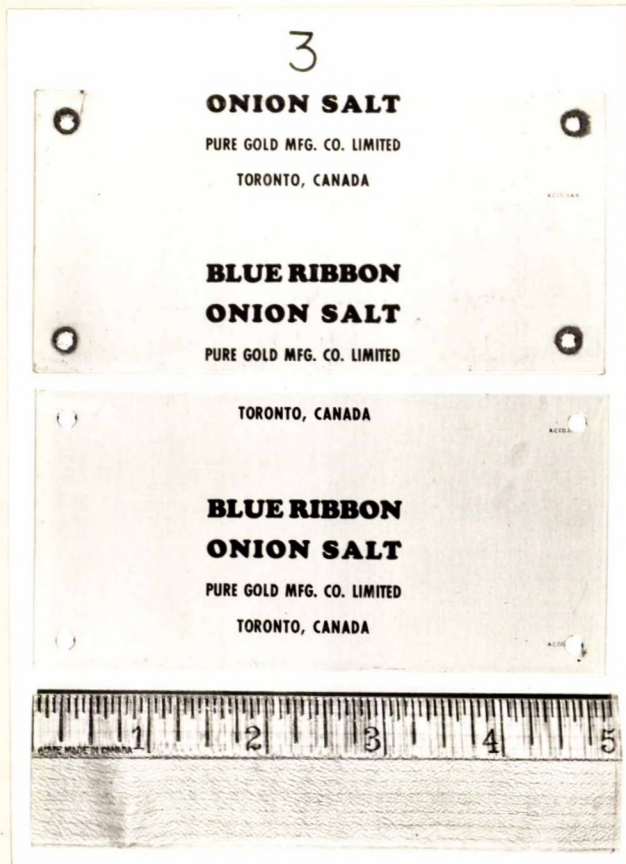
Figure 5.

After 40 days the plates were removed from the salt solution and one of them was photographed (see Figures 5 and 6). Considerable rust was observed at the four holes on the front of each plate and near the edge on the back of each plate.

UPPER PLATE - AFTER 40 DAYS OF TOTAL
IMMERSION CORROSION.

LOWER PLATE - UNCORRODED.

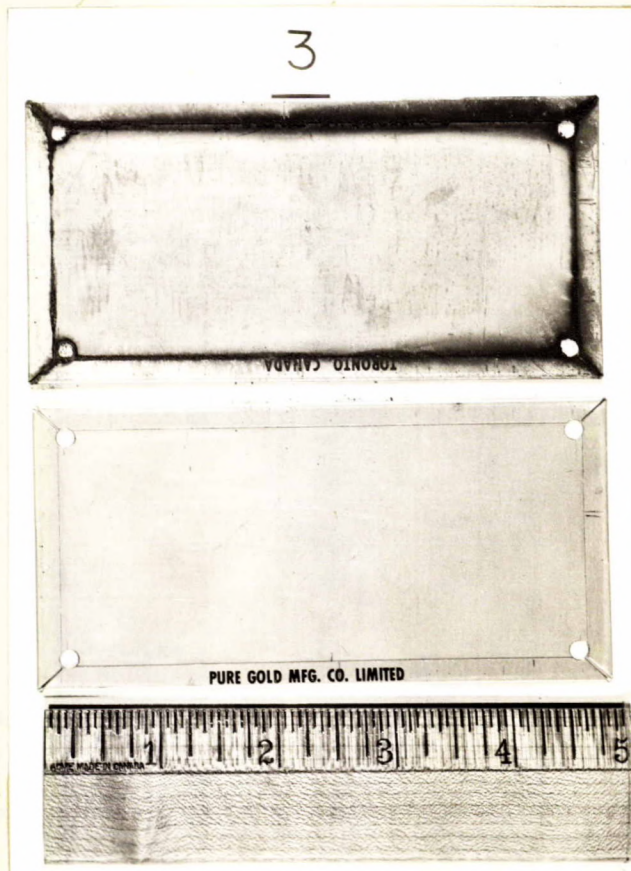
Figure 6.

REVERSE OF PLATES SHOWN IN FIGURE 5.

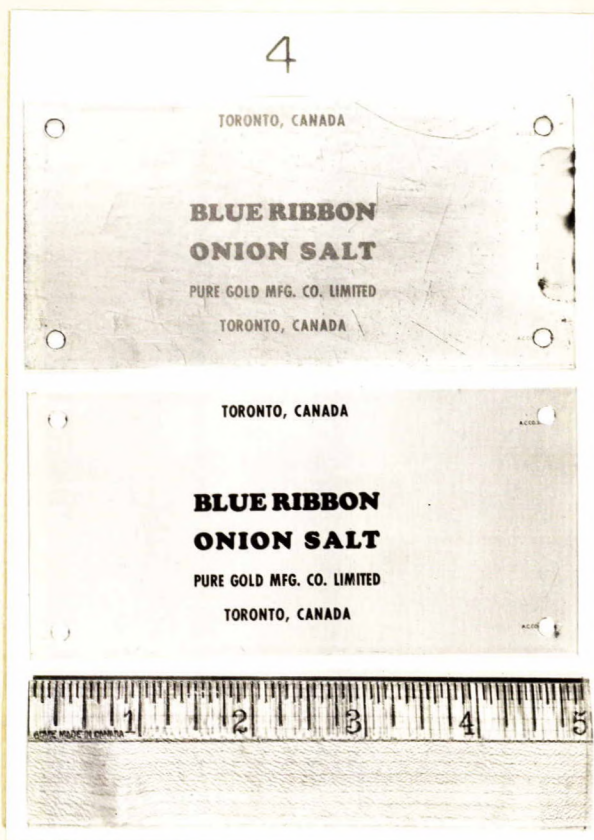
Figure 7.

After 40 days the plates were removed from the Weather-Ometer and one of them photographed (see Figure 7). The surface had become a duller, darker grey and printing had faded considerably. However, it still could be easily read.

2. The printing faded considerably in the Weather-Ometer. This probably was due to the effect of the bright light.

UPPER PLATE - AFTER 40 DAYS IN THE WEATHER-OMETER.

LOWER PLATE - UNCORRODED.

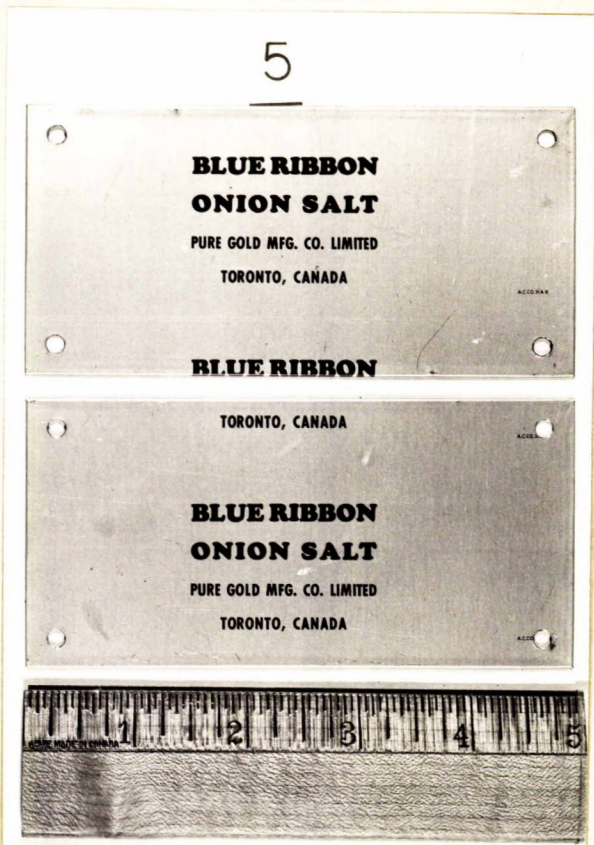
Figure 8.

After 40 days the plate was removed from the Humidity Cabinet and photographed (see Figure 8). The plate showed little or no deterioration.

UPPER PLATE - AFTER 40 DAYS IN THE HUMIDITY CABINET.

LOWER PLATE - UNCORRODED.

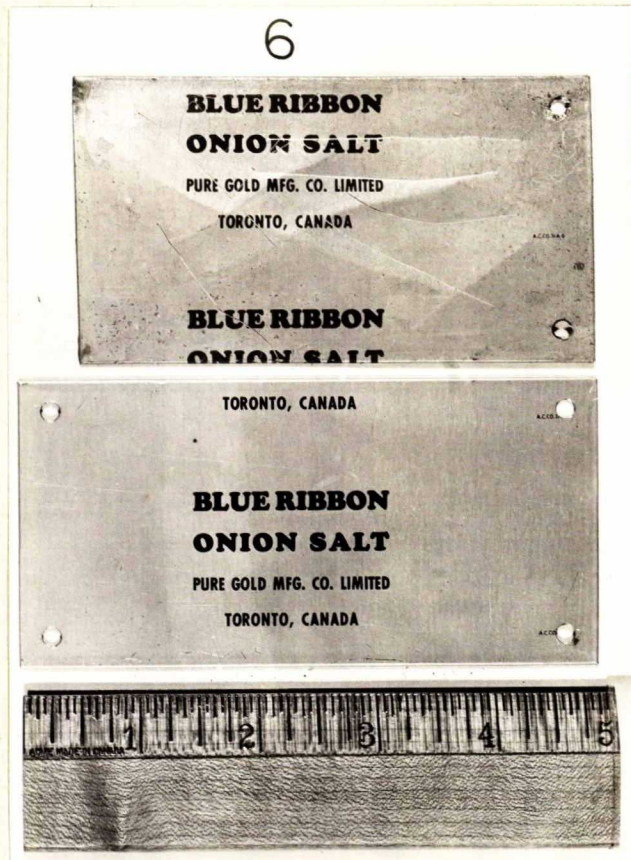
Figure 9.

After 40 days in the Intermittent Immersion Corrosion Machine, the scratched and cut plate was removed and photographed (see Figures 9 and 10). Little or no increase in corrosion was noted at the scratches and at the cut edge.

UPPER PLATE (DAMAGED) - AFTER 40 DAYS IN THE
INTERMITTENT IMMERSION
CORROSION MACHINE.

LOWER PLATE - UNCORRODED.

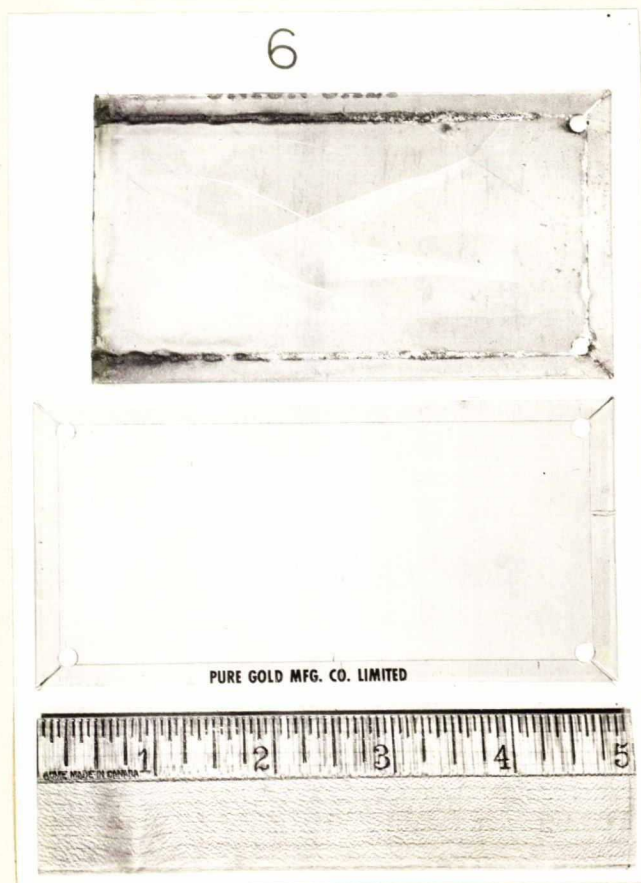
Figure 10.

REVERSE OF PLATES SHOWN IN FIGURE 9.
