September 24, 1945.

ORE DRESSING AND METALLURGICAL LABORATORIES.

Investigation No. 1938.

Investigation of Defects in Aluminium Sand Castings.

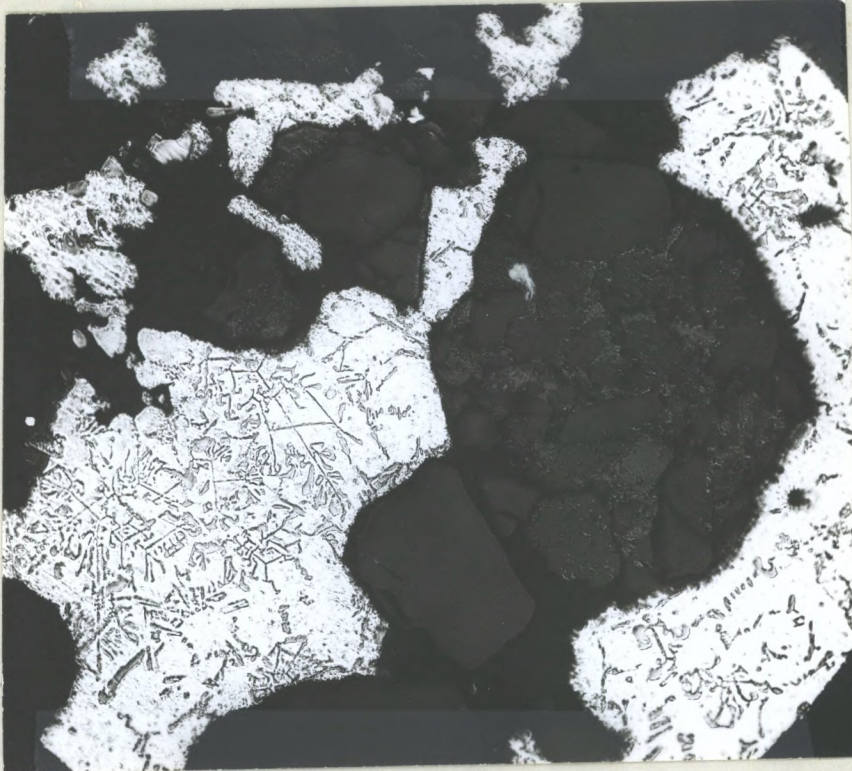
Figure 1.

A sample containing an inclusion was polished and photographed (see Figure 1). The micrograph shows that the inclusion did not originate in the melt. The massive appearance and dissociated habit would indicate that the inclusion had been picked up during the melting operation but had not been wetted by the melt. Under polarized light the inclusion appeared to be of an alumina-silica type.

INCLUSIONS IN ALUMINIUM-SILICON CASTING.

The results of this examination would suggest that the inclusions were due to the pick-up of some non-metallic material, possibly pieces of the furnace lining.

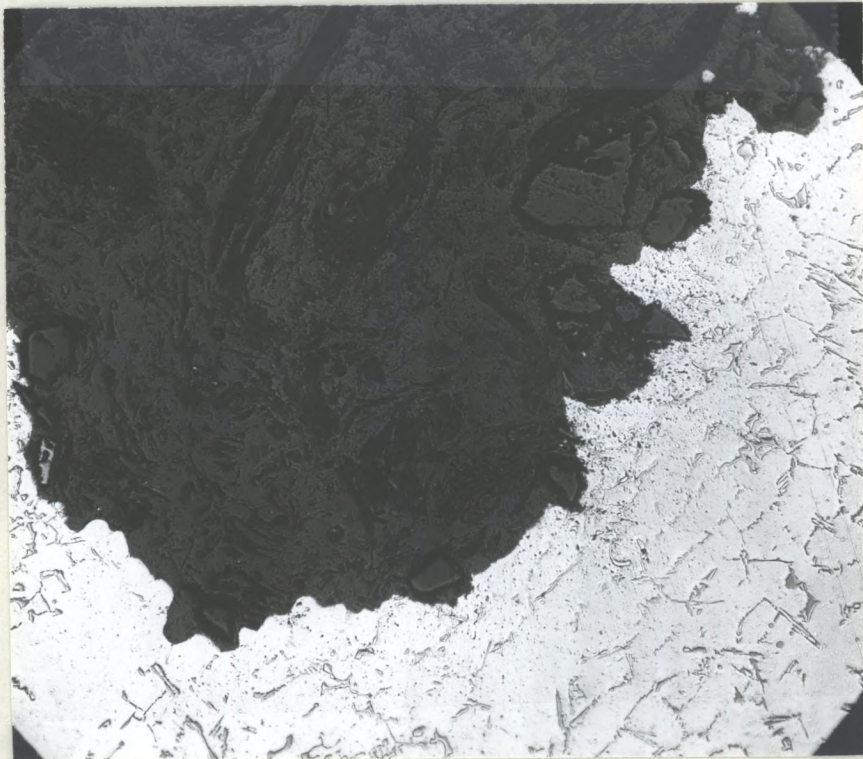
The surface defect is shown in Figure 2. Some sand grains are visible adhering to the surface of the casting. These were more apparent during the earlier stages of polishing.

SURFACE DEFECT IN ALUMINIUM-SILICON CASTING.

The adherence of sand grains and the irregular shape of the cavity would support the explanation of Mr. Wm. Bond, Manager, Foundry Division, Ottawa Car and Aircraft Ltd., Ottawa, Ontario, that the surface defects were due to minute clay explosions at the surface of the mould.
