October 22, 1945.

### ORE DRESSING AND METALLURGICAL LABORATORIES.

Investigation No. 1946.

Metallurgical Investigation of Rock Drill  
Bits for Lake Shore Mines Limited.

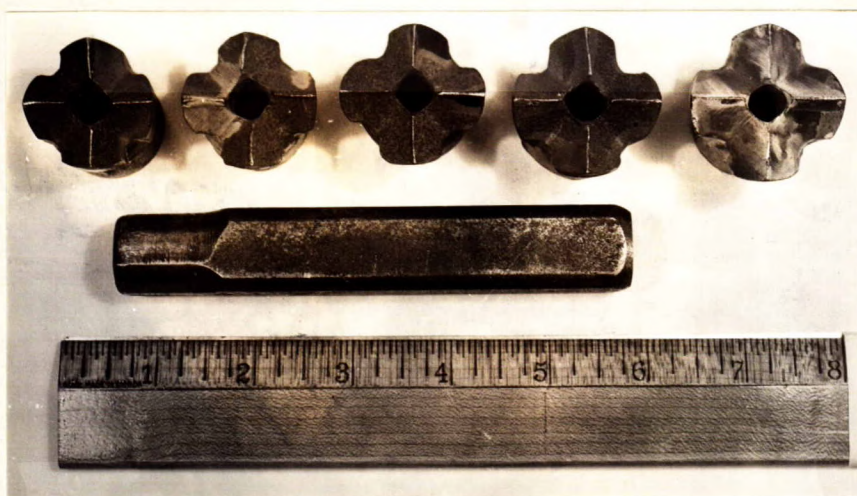
Figure 1.

BITS AND SHANK AS RECEIVED.

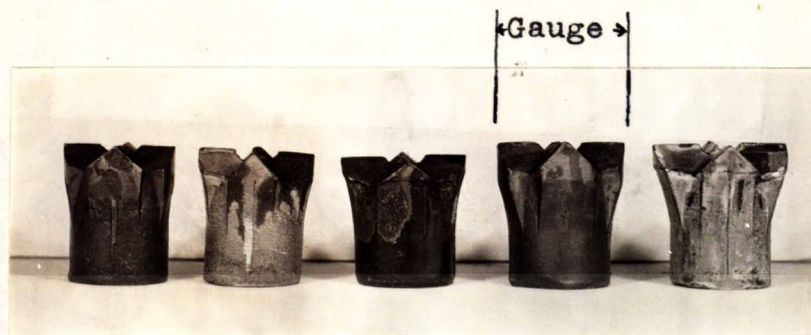
Figure 2.

BITS AS RECEIVED.

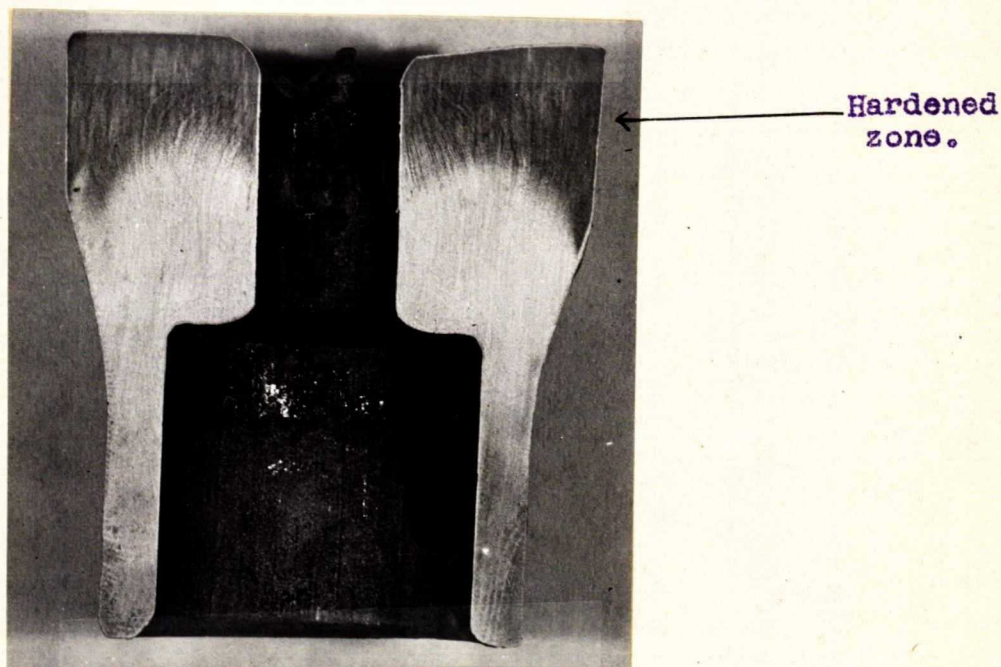
Figure 3.

MACRO-ETCH OF A SPLIT BIT.

The depth of hardening shown in Figure 3 is indicated by the dark area on the teeth and is usual for this type of work.

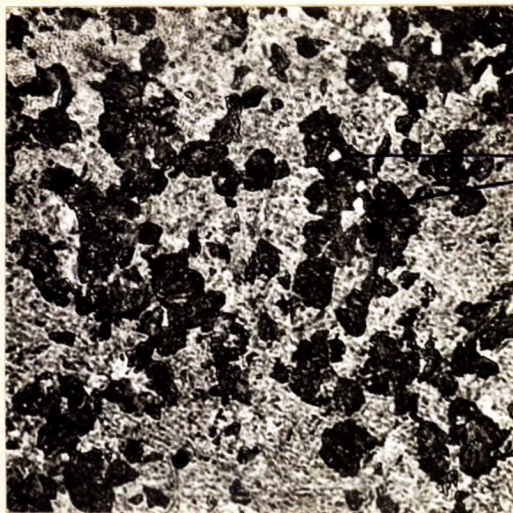
Figure 4 shows the structure of the hardened tooth of the green bit as revealed by a 2 per cent nital etch.

Undissolved  
carbides.

STRUCTURE OF "AS RECEIVED" BIT.

The hard martensite (needle-like constituent) in Figure 4 contains areas of softer troostite (dark). The undissolved carbides in the troostitic areas would, if soaked longer, have dissolved to form a richer austenite from which an all-martensite structure would have resulted. This desirable structure was obtained by re-hardening, as Figure 5 shows.

The finishing temperature in forging was correct, as shown by the fine, uniform grain size of Figure 4.

1. Check a series of soaking times in the hardening furnace microscopically and with hardness tests, to obtain the maximum amount of martensite.
2. When the conditions for obtaining an all-martensite structure are established, the effect of time and temperature of drawing should be studied on a representative number of performance tests in service.
3. It would be interesting to compare the gauge-holding properties of ordinary bits with those of bits that have been ground on the gauge surface to remove all decarburization after hardening.

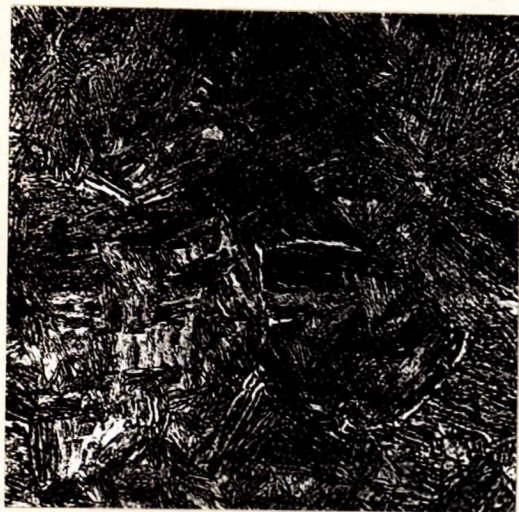
Figure 5.

Figure 5 shows the structure of the same bit after re-hardening.

STRUCTURE OF  
RE-HARDENED BIT.

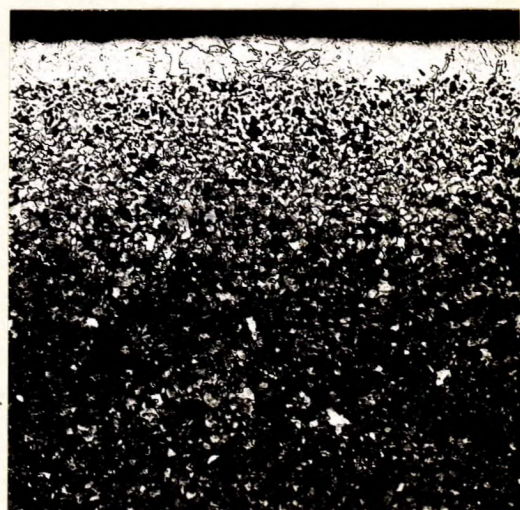
Figure 6.

Figure 6 is a transverse section through the socket, the upper edge of the picture being the outer surface.

STRUCTURE OF  
SOCKET WALL.

Decarburization, shown in Figure 6, is complete to

0.005 inch and partial to 0.015 inch. This layer will not harden to the same extent as the base material and suffers from impaired wear resistance. It is not improbable to expect 1/32 inch loss of gauge due to this decarburization.

Rapid dulling of the cutting edges is another result of decarburization.

If any considerable number of bits are breaking in use, this may be largely due to fatigue originating in the decarburized area.
