ORE DRESSING AND METALLURGICAL LABORATORIES.

Investigation No. 1949.

Metallurgical Examination of Cracked Flame-Hardened  
Rail Segments from a Revolver Gantry Crane.

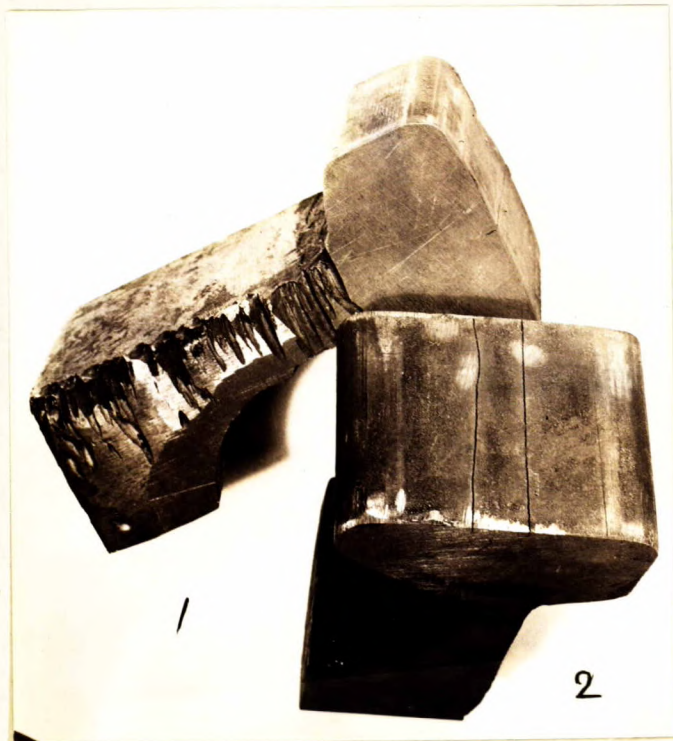
Figure 1.

This requisition, dated September 7, 1945, requested a metallurgical examination in order to determine the cause of the longitudinal cracks evident on the surface of the rail

LONGITUDINAL CRACKS IN RAIL  
SEGMENTS FROM REVOLVER GANTRY CRANE.

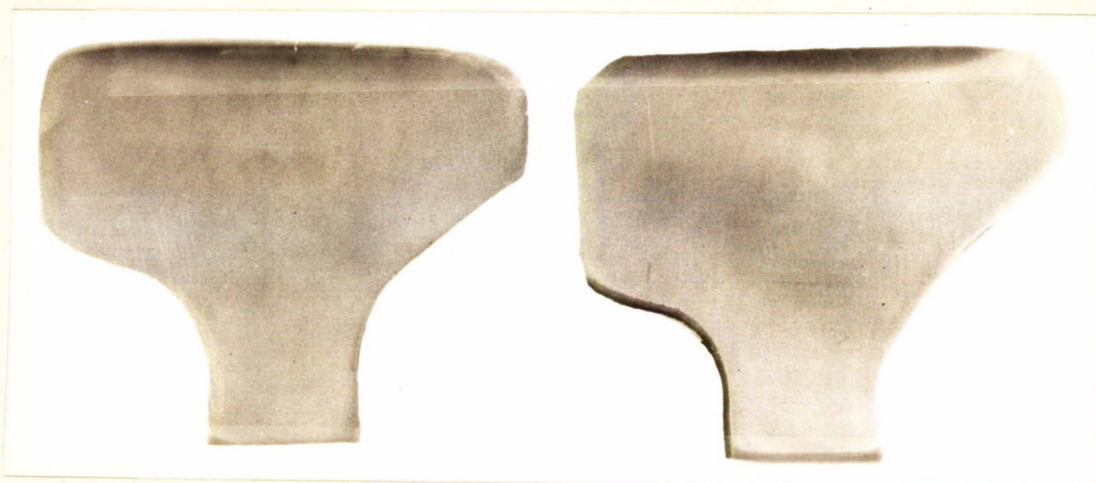
Transverse sections were cut from each of the submitted rail segments, polished, and etched in 2 per cent nital. A photograph of the etched sections is shown in Figure 2. The extent and depth of the flame-hardened zones are clearly evident.

The microstructure indicates that the rails had been cast and subsequently annealed by slow cooling in the furnace (see Figures 6, 7 and 10). The surfaces of the rails were then hardened by means of the flame-hardening operation, the depth of penetration extending approximately 3/16 inch (see Figures 2 and 8).

TRANSVERSE SECTIONS OF RAIL SEGMENTS, REVEALING  
EXTENT AND DEPTH OF FLAME-HARDENED AREAS.

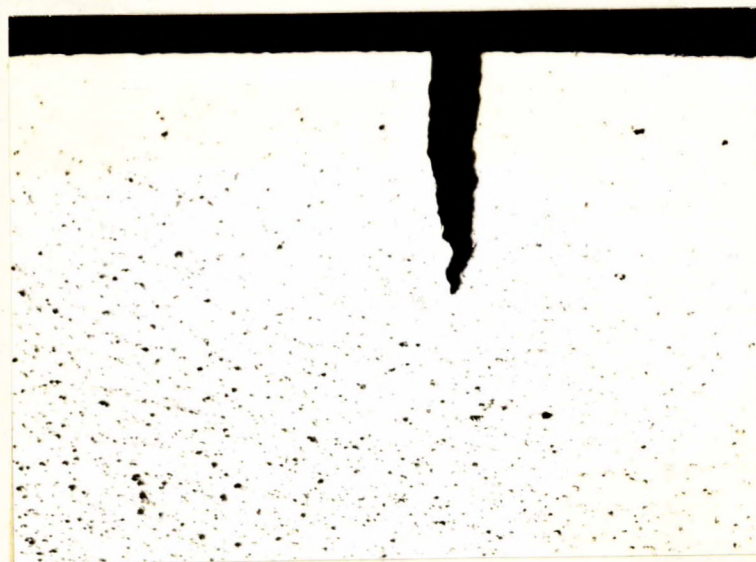
Figure 3.

Figure 3, taken at  $X11\frac{1}{2}$  magnification, shows the extent of one of the cracks in the flame-hardened zone, in Sample No. 2.

The cracks were longitudinal in character and penetrated into the flame-hardened zone to a depth of 1/8 inch (see Figure 3). No evidence of penetration beyond the hardened zone was found.

that the cracks did not occur during the heat-treating operation previous to flame hardening. It is thought that small cracks had been initiated during flame hardening and had subsequently opened up in service.

SHOWING DEPTH OF CRACK IN FLAME-HARDENED ZONE.

Sample No. 2.

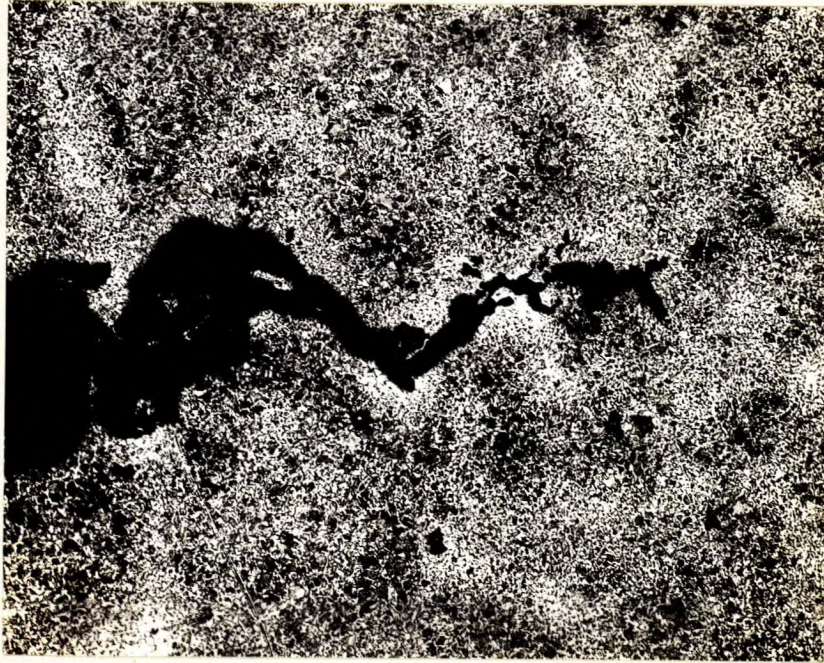
Figure 4.

Figure 4, taken at X100 magnification, shows the base of one of the cracks found in Sample No. 1. The segregation of the hardened metal is clearly visible.

The microstructure indicated a very considerable segregation in the steels (see Figure 10). During the casting operation, ferrite was precipitated about the manganese sulphide inclusions. Evidence of this segregation was noted in the hardened areas (see Figure 4).

Another factor which may have contributed to the cracking is the marked segregation in the steel. This segregation would result in areas of high carbon adjacent to areas of low carbon, each having a different hardenability. A possible remedy for this would be a thorough soaking of the rail, by means of the torch, previous to quenching.

SHOWING BASE OF CRACK IN HARDENED  
AREA OF SAMPLE NO. 1.

Note segregation.

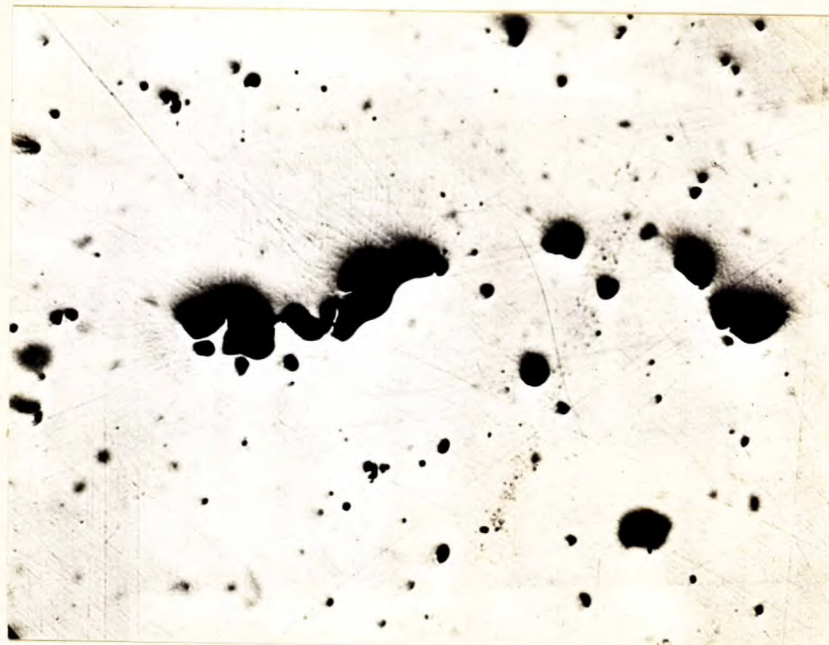
Figure 5.

Figure 5 illustrates the magnitude of some of the porosity noted in the steel. The photograph was taken at X100 magnification.

Porosity in the metal, caused by improper casting procedure, was noted (see Figure 5). While the porosity observed is not considered abnormal for a cast steel, nevertheless this condition should be kept to a minimum for proper flame hardening.

SHOWING POROSITY IN STEEL, CAUSED BY  
FAULTY CASTING PROCEDURE.

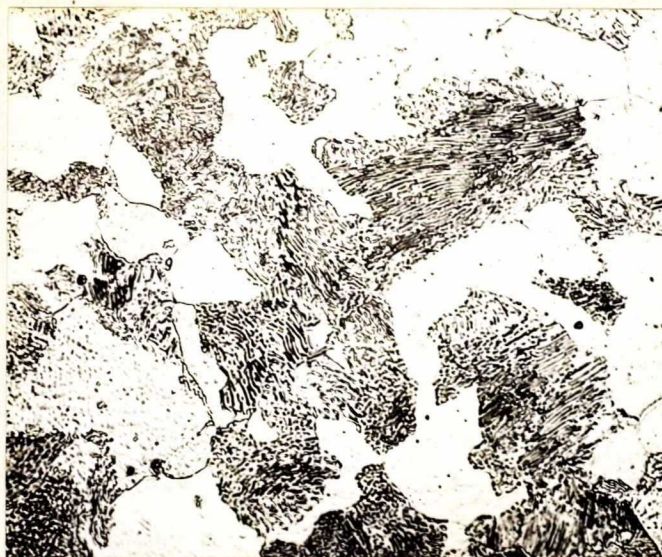
Figure 6.

Figures 6 and 7, taken at X500 magnification, show the annealed structure of Samples Nos. 1 and 2 respectively in the areas unaffected by the flame hardening.

Sample No. 1.

MICROSTRUCTURE OF RAIL SEGMENTS IN AREAS  
UNAFECTED BY THE FLAME HARDENING.

Well laminated pearlite indicates slow cooling  
in furnace.

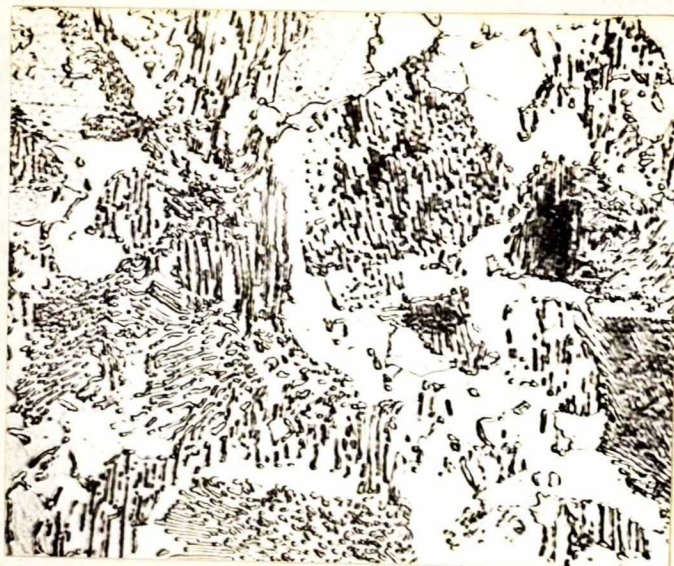
Figure 7.

Sample No. 2.

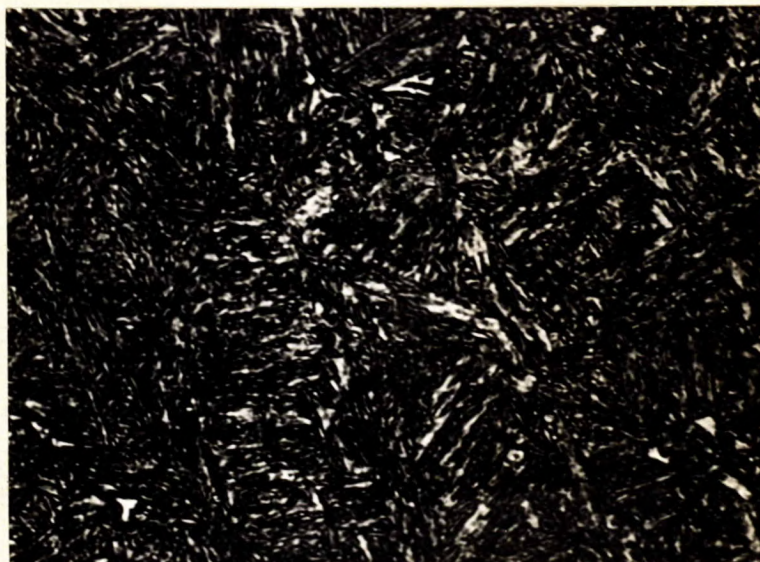
Figure 8.

Figure 8 (at X1000 magnification) shows the martensitic structure of the rail, resulting from the flame-hardening operation.

X1000, nital etch.  
FLAME-HARDENED AREA, SHOWING  
MARTENSITIC STRUCTURE.

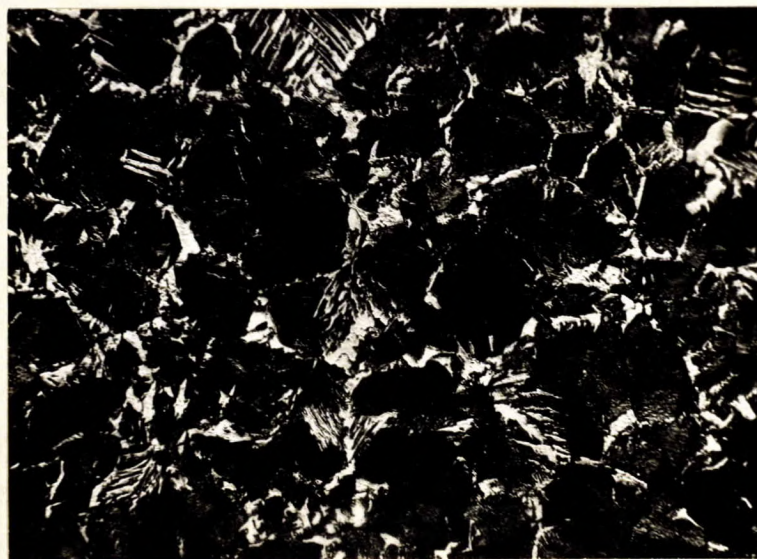
Figure 9.

Figure 9, taken at X500 magnification, shows a portion of the rail improperly hardened, as evidenced by the free ferrite present.

It should be noted that by far the most common reason for cracking in flame-hardened steels is improper flame-hardening technique. Overheating followed by severe quenching will invariably result in cracking. The presence of free ferrite in the hardened zone (see Figure 9) is an indication of non-uniformity in the quenching operation.

X500, nital etch.  
FLAME-HARDENED AREA, SHOWING PROEUTEC-  
TOID FERRITE (WHITE) CAUSED BY  
IMPROPER COOLING RATE.

If similar failures are current it is recommended that a thorough investigation be made into the flame-hardening technique, with special emphasis placed on the following:

- (a) Distance between burner and rail surface.
- (b) Uniformity of heating.
- (c) Severity and uniformity of quench. (Correct water pressure).
- (d) Proper surface conditions.
- (e) Stress relief.

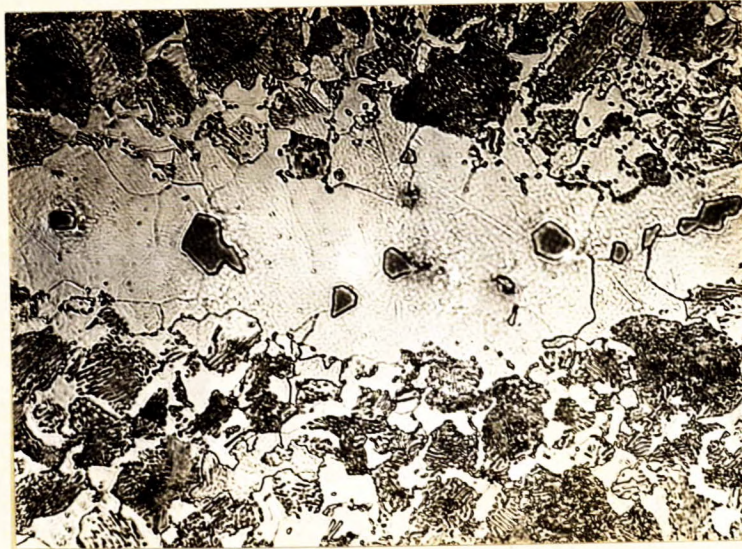
Figure 10.

Figure 10 (at X500 magnification) shows segregation resulting during the cooling from the molten state, and unaltered by the subsequent annealing operation.

AREA UNAFFECTED BY THE  
FLAME-HARDENING OPERATION.

Sample No. 2.

Note segregation caused by precipitation of  
ferrite around MnS inclusions during the  
casting period. Subsequent annealing  
operation leaves the segregation unaltered.
