ORE DRESSING AND METALLURGICAL LABORATORIES.

Investigation No. 1952.

Investigation of the Cause of Leaking
in a Boiler Casting.

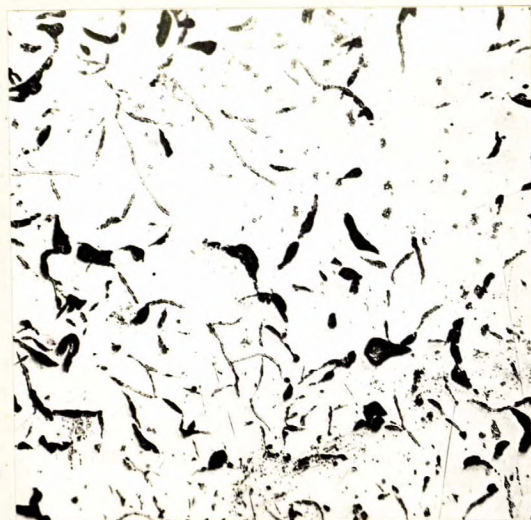
Figure 1.

X100, unetched.

GOOD CASTING.

The graphite flake size and distribution are practically the same in both castings. The structures revealed by etching are also similar.

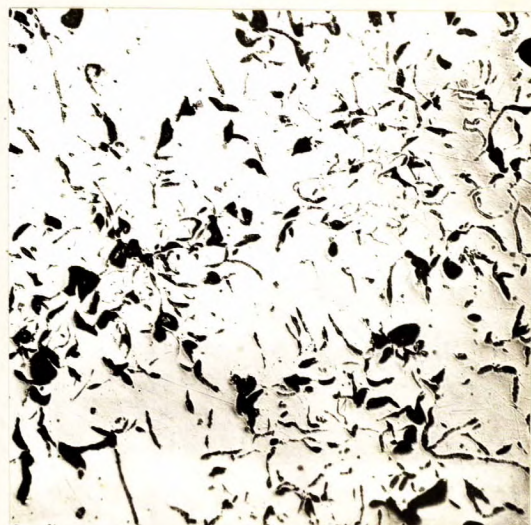
Figure 2.

X100, unetched.

LEAKY CASTING.

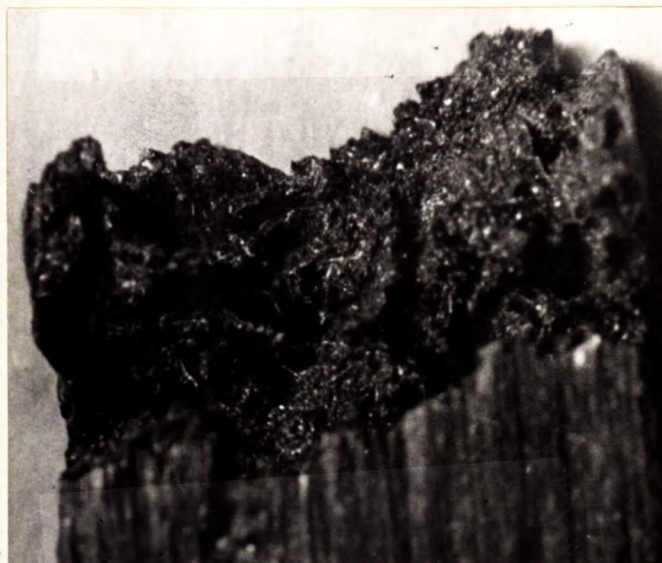
LEAKY AREA IN CASTING.
(Magnified 10 diameters).

Figure 3 shows a dendritic pattern in the leaky area of the casting. This means that metal was drained away from this area when the iron was partly solidified.

1. The quality of metal is practically the same in both of the castings examined.
2. The formation of the leaky area was as follows; First the mould was filled with metal. Solidification started with the usual 'pine-tree' crystals growing from the outside of the casting surface towards the centre. When the crystals were partly formed, the remaining fluid metal was drained away from the "leaky" area. The pine-tree crystals can be seen in Figure 3.

3. In view of the limited evidence at hand it is tentatively concluded that the cause of the shrinkage cavity may be either
 - (a) inherent physical design of the casting, or

- (b) Break-through of metal into the parting line of the mould or elsewhere, allowing metal to leak out of that particular part of the mould after it is poured.

4. If the cause is due to 3(b), there will be fins on the casting, or some part of it will be oversize.
5. If leaks cannot be traced to 3(b), it may be

assumed that the physical design has features that are undesirable from the foundry view-point. If this is the case, some change of section size at the leaky area may be necessary.
