ORE DRESSING AND METALLURGICAL LABORATORIES.

Investigation No. 1953.

Metallurgical Examination of Enameled Cast Iron
Stove Plate Containing Pinhole Defects.

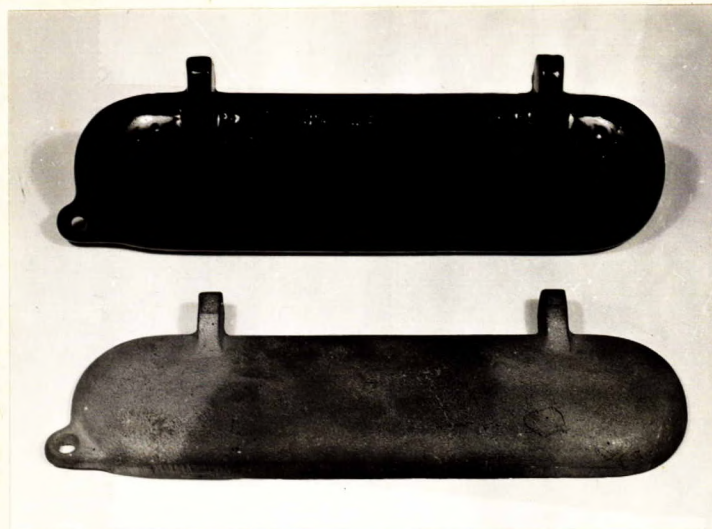
Figure 1.

CAST IRON STOVE PLATE CONTAINING
PINHOLE DEFECTS.

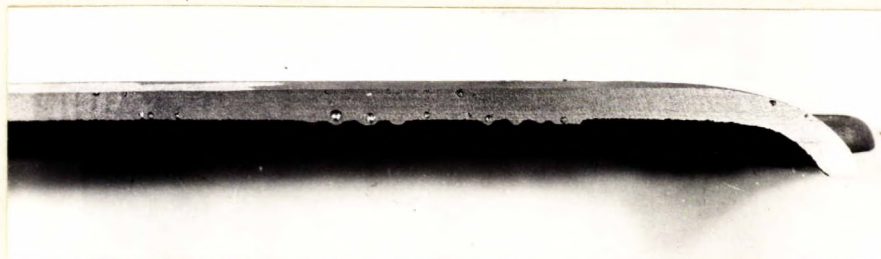
Figure 2.

A section was cut longitudinally from the "as cast" sample (see Figure 2). Visual examination revealed that the holes were located at or near the surfaces of the casting.

LONGITUDINAL SECTION OF "AS CAST" SAMPLE,
REVEALING LOCATION OF HOLES AT OR
NEAR SURFACE OF CASTING.

1. Figure 2 shows that the metal bulges outward from the surface where blowholes occur. This would lead to the conclusion that gas was generated in the metal as it cooled. This gas caused holes in the casting and was the direct cause of the enameling defect.

observed in Figure 2 may be:

(a) Wet sand or green ladles generate steam which is broken up into hydrogen and oxygen. The hydrogen is absorbed by the hot metal. As the metal cools the gas is given off again.

(b) Excessively rusty material in the charge will cause hydrogen to be dissolved in the hot metal. As the metal cools, this hydrogen is liberated.

(c) Oxidizing conditions at the melting zone of the cupola will cause iron oxide in the metal. Iron oxide is reduced by carbon as follows:

The CO (carbon monoxide) gas is liberated as the metal cools.

If the defect observed in Figure 2 is to be prevented, precautions must be taken to avoid the three conditions mentioned above. Therefore, the following is recommended:

1. The pouring ladles should be thoroughly dried.
2. The moulding sand permeability should be increased and the moisture content watched carefully.
3. Excessively rusty scrap should be used only sparingly in the cupola charge. Thin rusty sheet metal is undesirable.
4. The cupola blast should be regulated so as to avoid extremely oxidizing conditions. The colour of the fumes from the cupola will indicate whether oxidizing conditions exist.

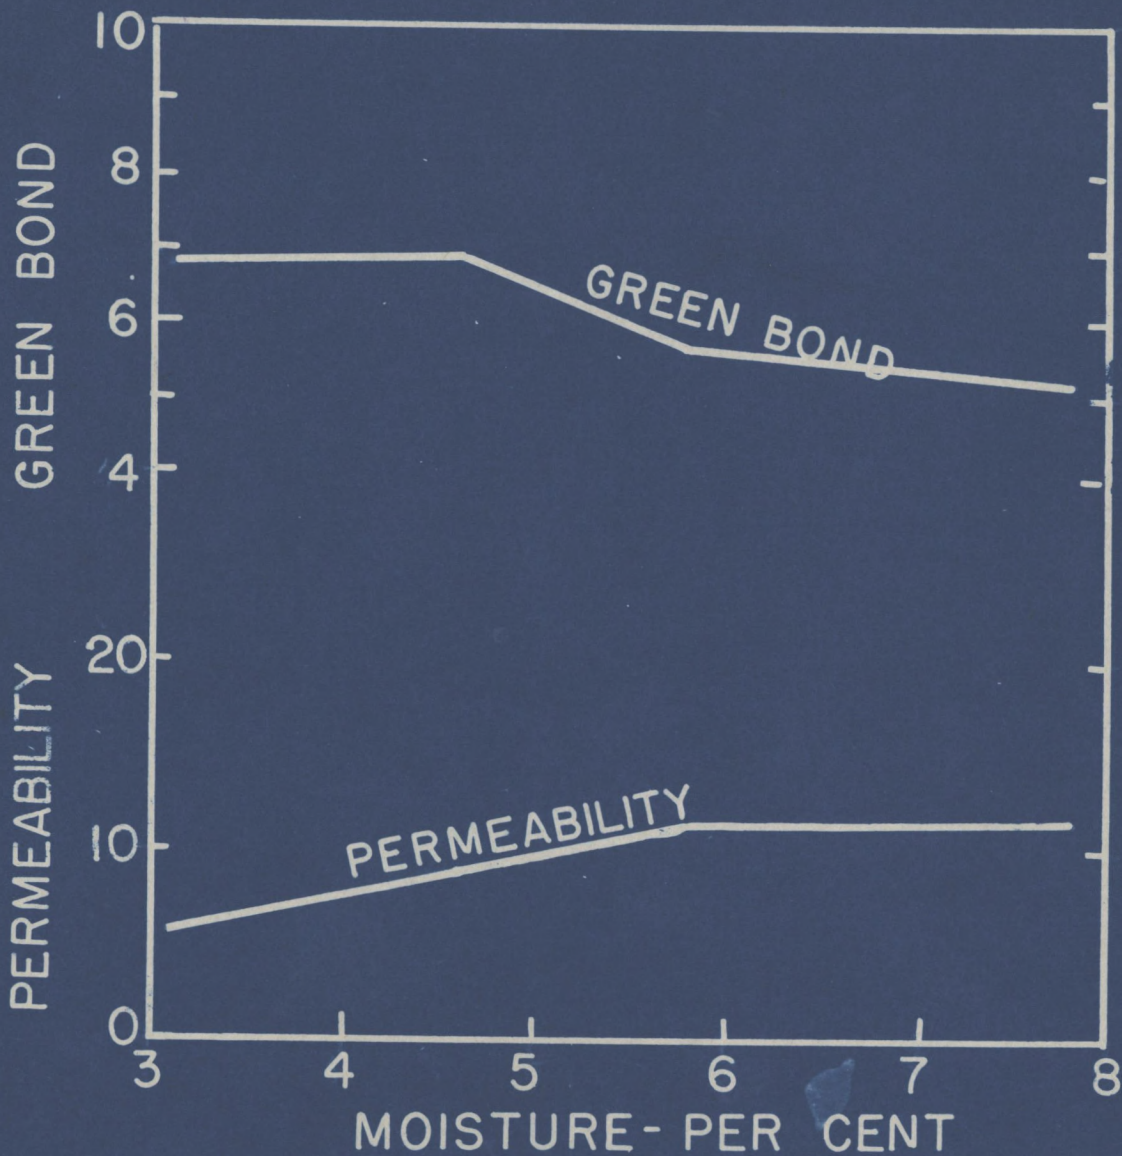
Figure 3.

Typical test values (see Figures 3, 4 and 5) obtained on the moulding sand submitted by Findlay's Limited were:

Screen analysis shows 4 to 7 per cent on each of the screens from 70 mesh to 270 mesh. There is too much fine silt in this sand. The removal of the excess fines from this sand is considered advisable.
