R E P O R T  
of the  
ORE DRESSING AND METALLURGICAL LABORATORIES.

Investigation No. 1976.

Investigation of Defective Grey Iron Casting.

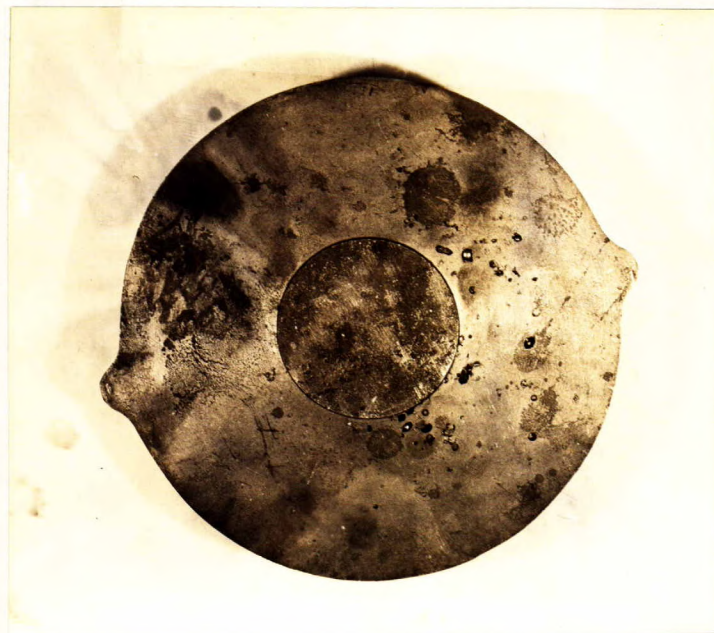
Figure 1.

Figure 1 illustrates the porous nature of the casting.

CASTING AS RECEIVED.

The results of the examination indicate that the porosity occurring in this casting was caused by a condition of the metal known as "oxidized iron".

To correct this condition it is suggested that proper attention be given to the operation of the cupola, and, especially, that all charges of metal be of the same weight.

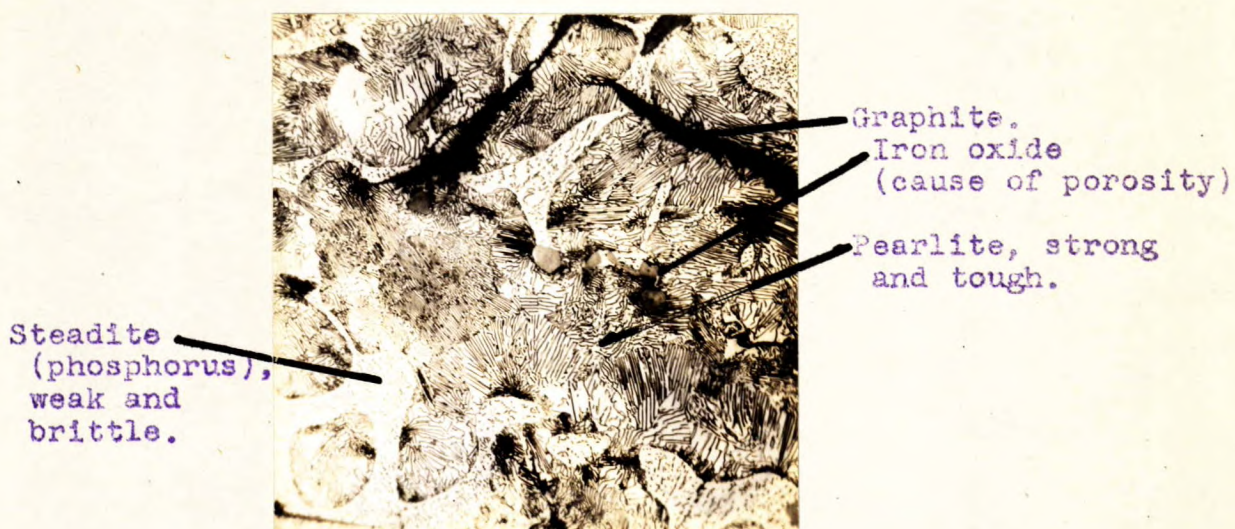
Figure 2.

Results of microscopic examination are shown in Figures 2, 3 and 4. Except for a great number of oxide inclusions (see Figure 3), the microstructure was typical for a normal stove-plate iron.

(a) Iron oxide in large amounts was observed during the microscopic examination (see Figure 2). The gas holes are made when iron oxide reacts with carbon, forming CO gas.

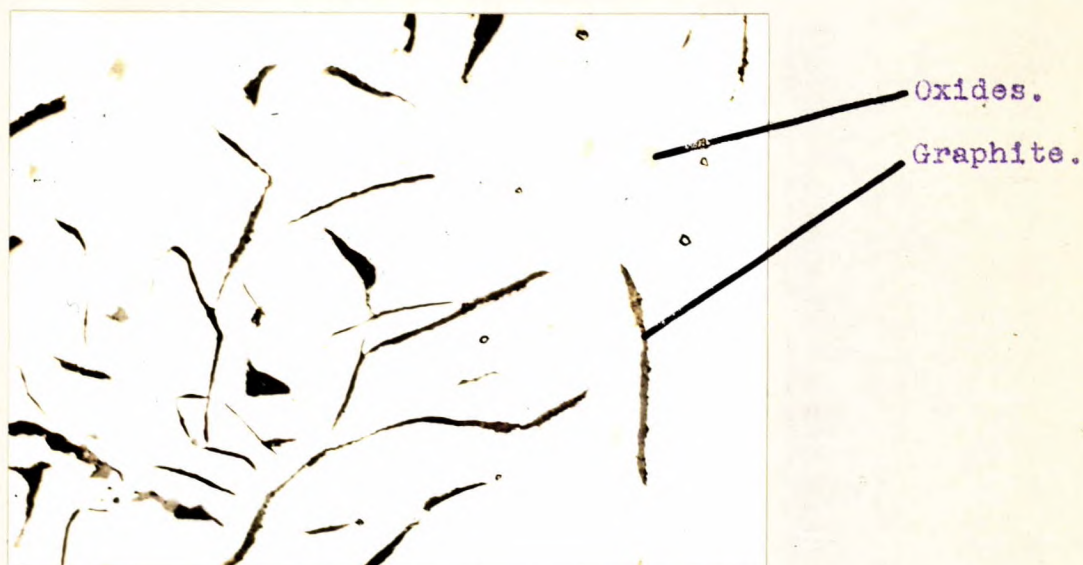
Figure 3.

X500, unetched.
