January 8, 1946.

ORE DRESSING AND METALLURGICAL LABORATORIES.

Investigation No. 1985.

Investigation of Cracked Manganese Steel Casting.

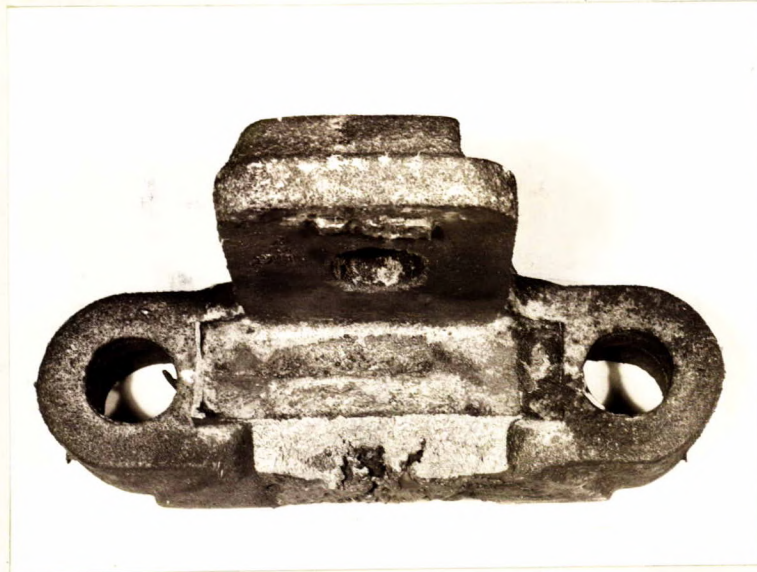
Figure 1.

CRACKED MANGANESE STEEL CASTING.

The casting as shown consists of a fairly heavy base with two lugs. One lug has broken off, showing a shrinkage cavity in the fractured surface. It was noted that a connecting bar had joined the two lugs together. This bar was cut off when the casting was cleaned.

4. In Figure 1, a view of the fractured surface shows that the fracture is not oxidized, indicating that the crack occurred when the casting was cold. A shrinkage area also appears in the fracture.

6. Strains are set up in the casting as it cools. These strains, when imposed on a high carbon metal, result in the cracking observed.

5. A change in gating and risering is necessary to avoid the shrinkage in the casting.

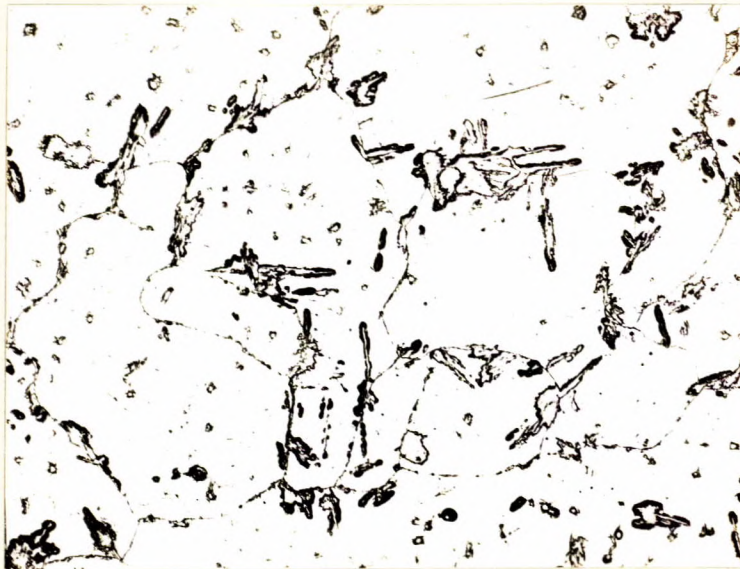
Figure 2.

AS CAST STRUCTURE.

Note the coarse grain size and grain boundary carbides.

2. The high carbon would tend to make the as-cast metal more brittle, by formation of carbides, and it would be more difficult to avoid cracking.

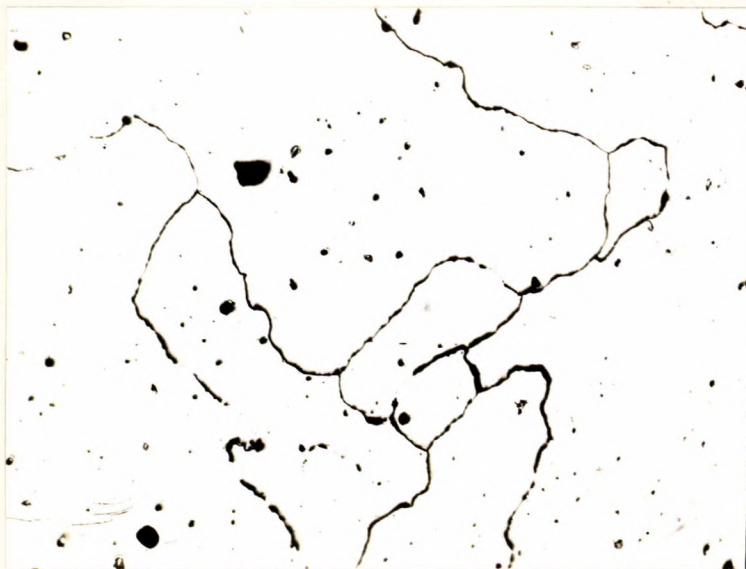
Figure 3.

HEAT-TREATED STRUCTURE.

Note the coarse grain and the cracks around grain boundaries.

(a) Excessively large grain size indicates high casting temperature. The casting may have been poured too hot.
