February 12, 1946.

ORE DRESSING AND METALLURGICAL LABORATORIES.

Investigation No. 2004.

Metallurgical Examination of Cracked Manganese
Steel Swing Hammer Casting.

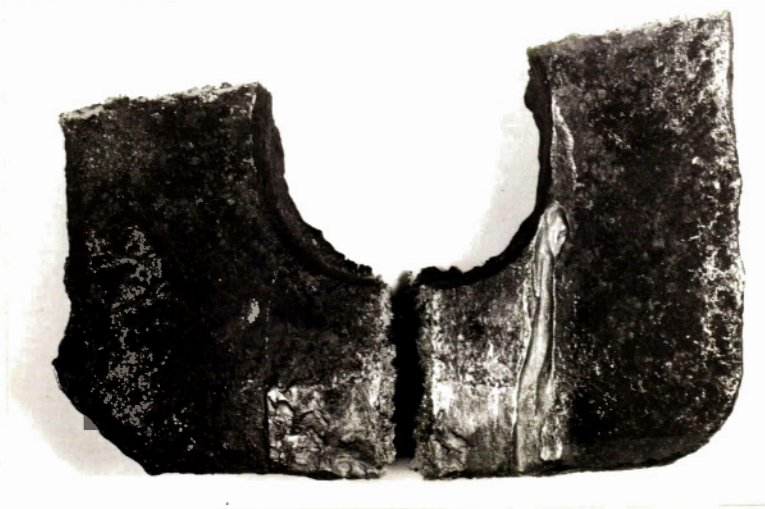
Figure 1.

MANGANESE STEEL SWING HAMMER
CRACKED IN THE MOULD.

Visual examination revealed a very coarse, crystalline fracture.

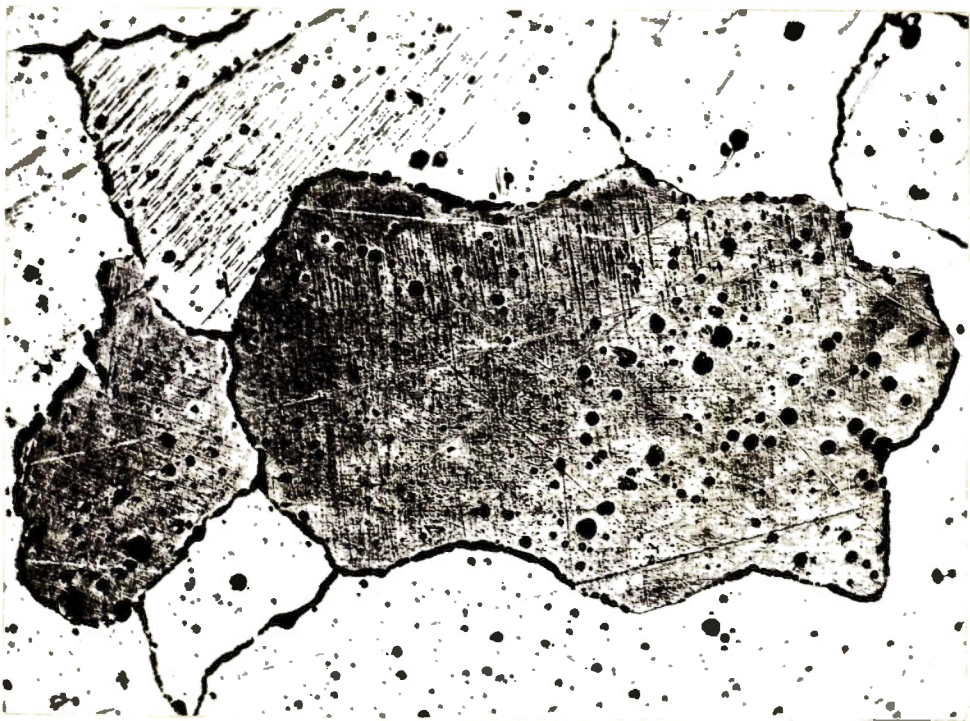
Figure 2.

Figure 2, taken at X50 magnification, shows the huge grain size of the steel, indicating high pouring temperature. Note, also, microporosity.

Note large grain size, indicating excessively high pouring temperature. Note also microporosity.

The microscopic examination shows that the steel must have been poured at a very high temperature, as is evident from the very large grain size in Figures 2 and 3.

The temperature from which manganese steel is poured has a marked effect upon the strength of the castings. A high pouring temperature produces a coarse, crystalline structure (the casting under examination is a typical example), and this structure is not refined in the subsequent heat treatment because no phase change takes place.

According to the most reliable figures, manganese steel has a melting point of 2588° F. Small castings require considerable superheat and may be poured at temperatures up to 2800° or 2850° F. Heavier castings should be poured at temperatures slightly above the solidification point, to avoid the coarse structure and to prevent hot cracks and tears in the casting.

In order to prevent a recurrence of this type of failure, it is recommended that the pouring temperature and heat treatment procedure be more carefully controlled.

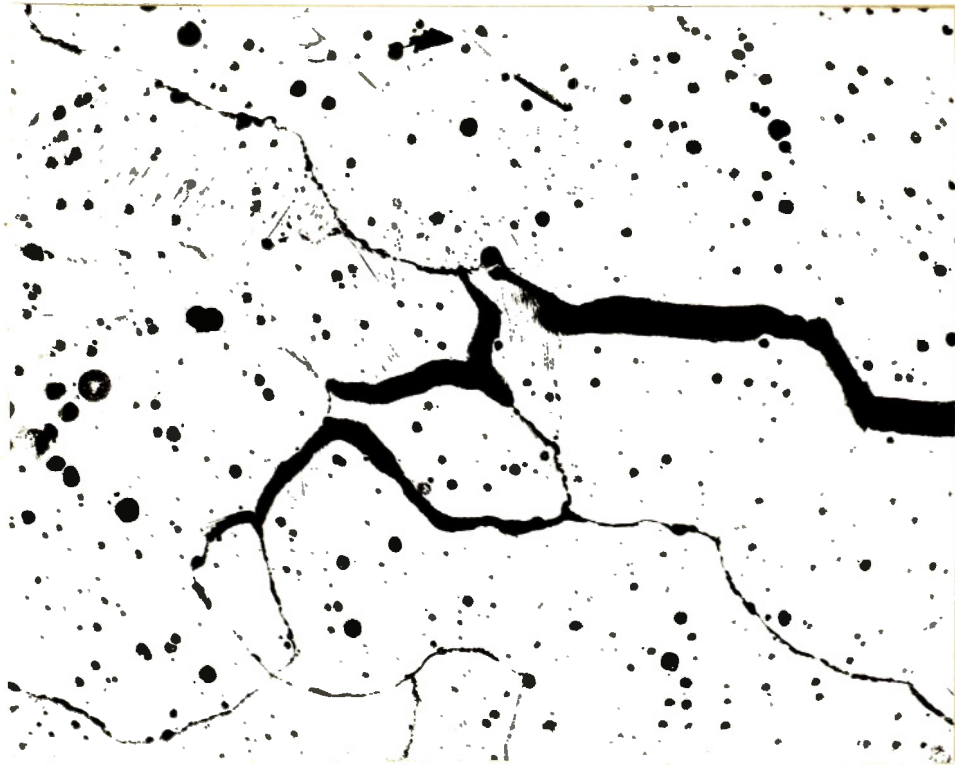
Figure 3, taken at X50 magnification, shows the intergranular nature of the cracks.

Note intergranular cracking.

Because of the huge grain size, and because cracking was observed to have taken place in the mould, it may be safely concluded that cracking had resulted from the excessively high pouring temperature employed. The intergranular nature of the cracks is clearly shown in Figure 3.

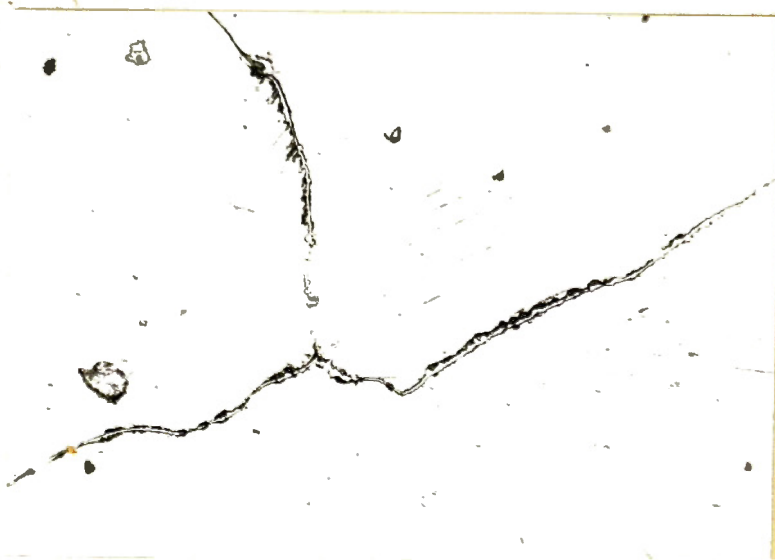
Figure 4.

Figure 4, at X500 magnification, shows the presence of some carbides at the grain boundaries.

Note presence of continuous carbides at the grain boundaries.

grain boundaries (see Figure 4) must have resulted from either of two conditions:

- (1) The quenching temperature was not high enough to permit complete solution of the carbides.
- (2) The quenching rate was not fast enough to retain the carbides in solution.

Whatever the reason, their presence would result in an embrittled steel and may have been a contributing cause of failure. This condition may be minimized by reducing the carbon content.
