ORE DRESSING AND METALLURGICAL LABORATORIES.

Investigation No. 2011.

Examination of Welded C.P.R. Locomotive Tube Steel.

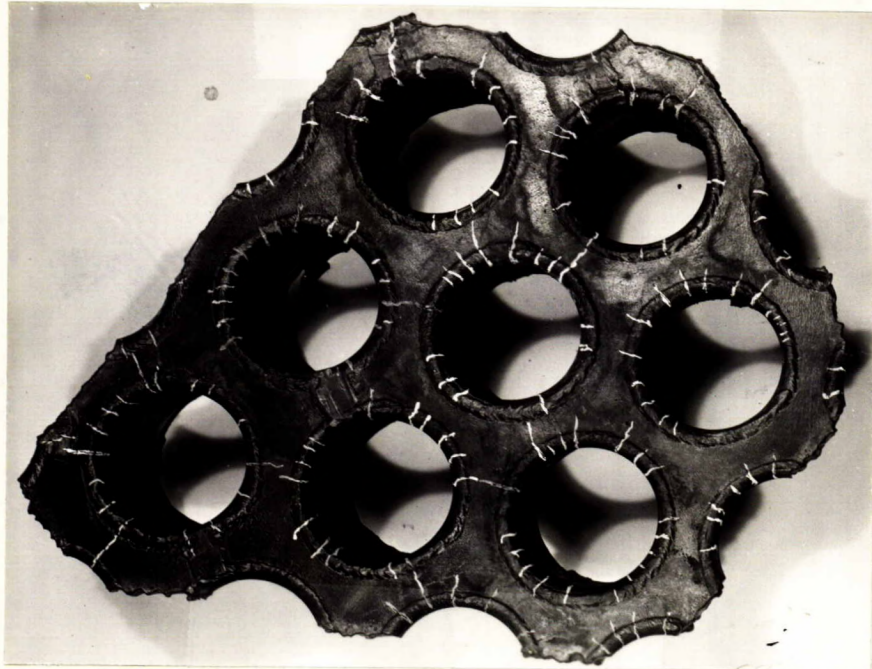
Figure 1.

A visual examination of the material "as received" reveals numerous weld cracks distributed uniformly around the complete periphery of the weld. In some cases these cracks had propagated from one weld through the tube sheet to an adjacent tube hole. Several machined welds were noted between tube sheet holes. These were apparently areas in which cracks were repaired by welding during the service life of the boiler. In at least one case, a second crack had propagated through the repaired area. It is important to note that there is no preferred direction of cracking and that the area of initiation of cracks is apparently the weld metal.

PHOTOGRAPH OF MATERIAL "AS RECEIVED".

(Cracks outlined in white ink)

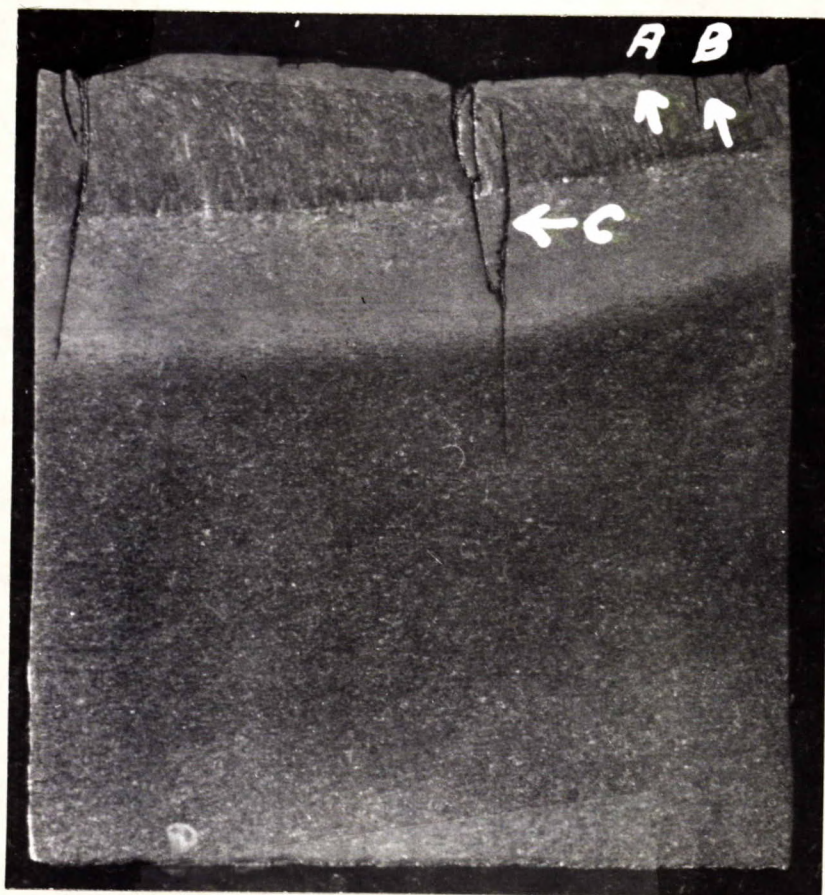
(4) Transverse weld samples showing characteristic cracks were machined from the material, mounted, polished and etched. One sample, showing numerous cracks of various lengths is shown in Figure 2. The samples were then examined under the microscope. Figures 3 to 7 show respectively the structures of

MACROPHOTOGRAPH OF CRACKED AREA IN WELD.

Note development of cracks:

- A - incipient stage.
- B - slight development.
- C - deep penetration.

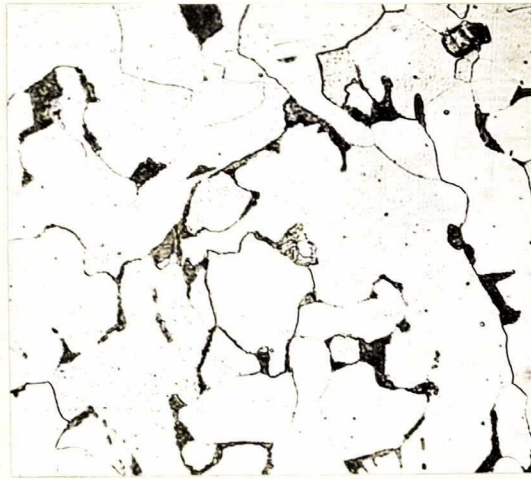
Figure 3.

NORMAL STRUCTURE OF BOILER TUBE MATERIAL.

Pearlite and ferrite matrix.

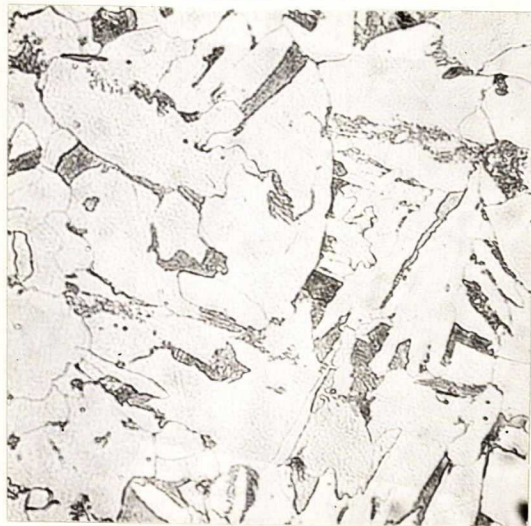
Figure 4.

NORMAL STRUCTURE OF TUBE SHEET MATERIAL.

Pearlite in a matrix of ferrite.

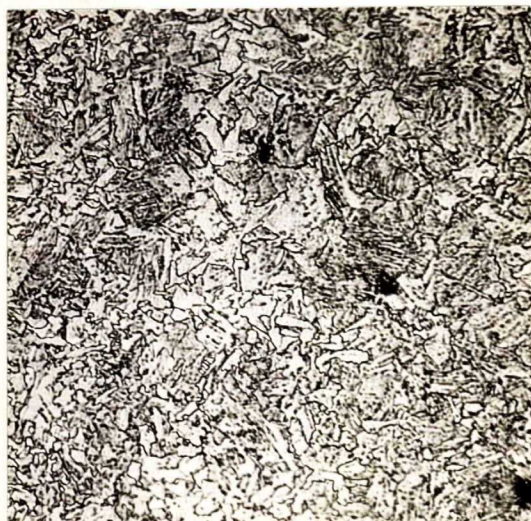
Figure 5.

TYPICAL STRUCTURE HEAT AFFECTED ZONE.

Low carbon martensite and ferrite.

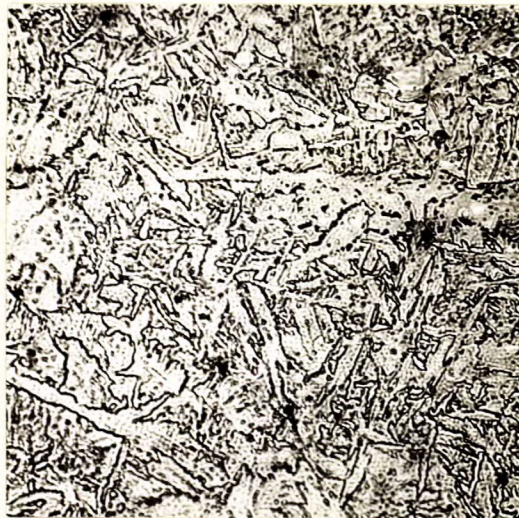
Figure 6.

TYPICAL STRUCTURE OF THE WELD METAL.
Mainly ferrite with some fine pearlite.

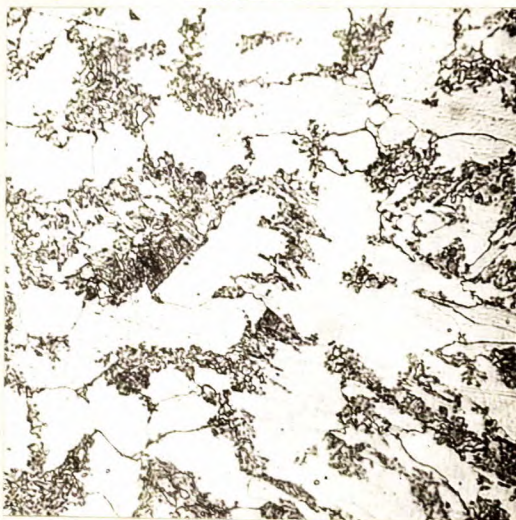
Figure 7.

TYPICAL STRUCTURE OF TRANSITION ZONE.
Partially spheroidized pearlite in ferrite matrix.

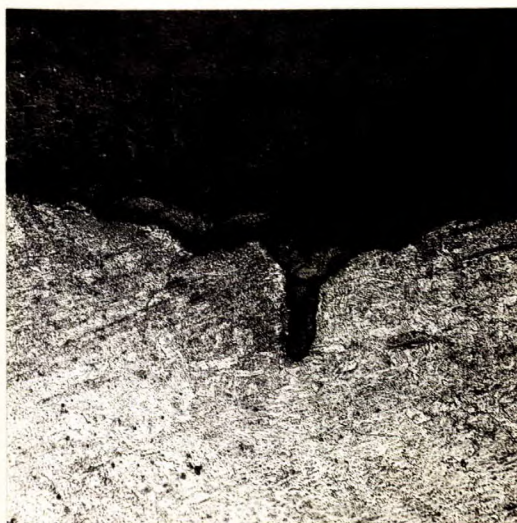
Figure 8.

the normal boiler tube material, the normal tube sheet material, the heat affected zone of the tube sheet material, the weld metal and the transition zone of the tube sheet material. Figures 8 to 10 show three stages of crack development, beginning in the weld metal and propagating deeply into the tube sheet material.

INCIPIENT CRACK IN WELD METAL.
(See Fig. 2 - crack A. Note oxide and blunt termination)

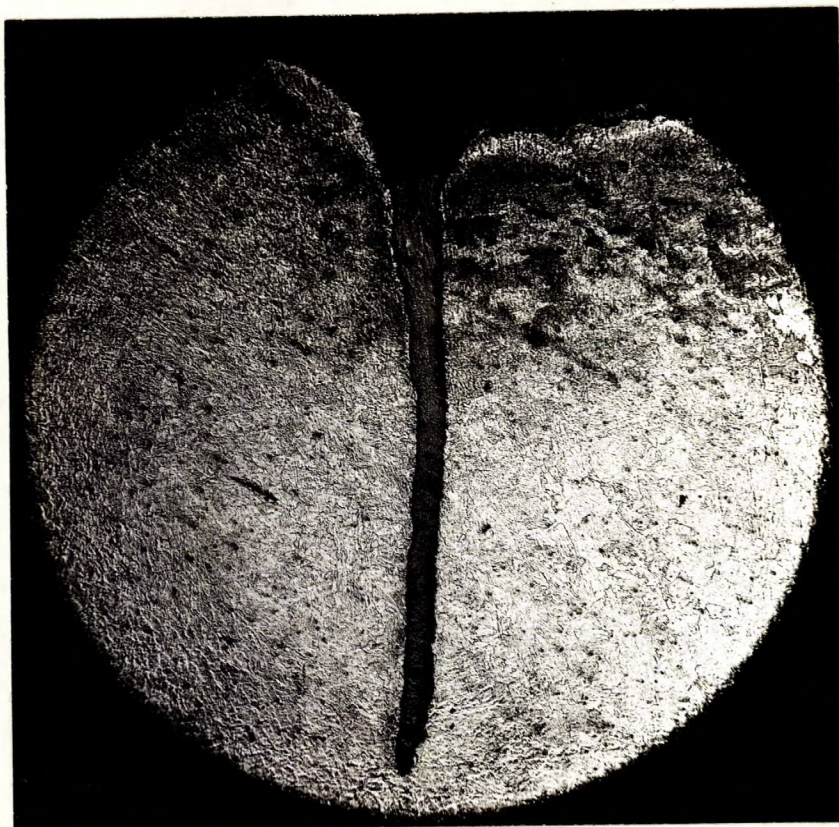
Figure 9.

CRACK IN THE PARTIALLY DEVELOPED STAGE IN WELD METAL.
(See Fig. 2 - crack B. Note oxide and blunt termination)

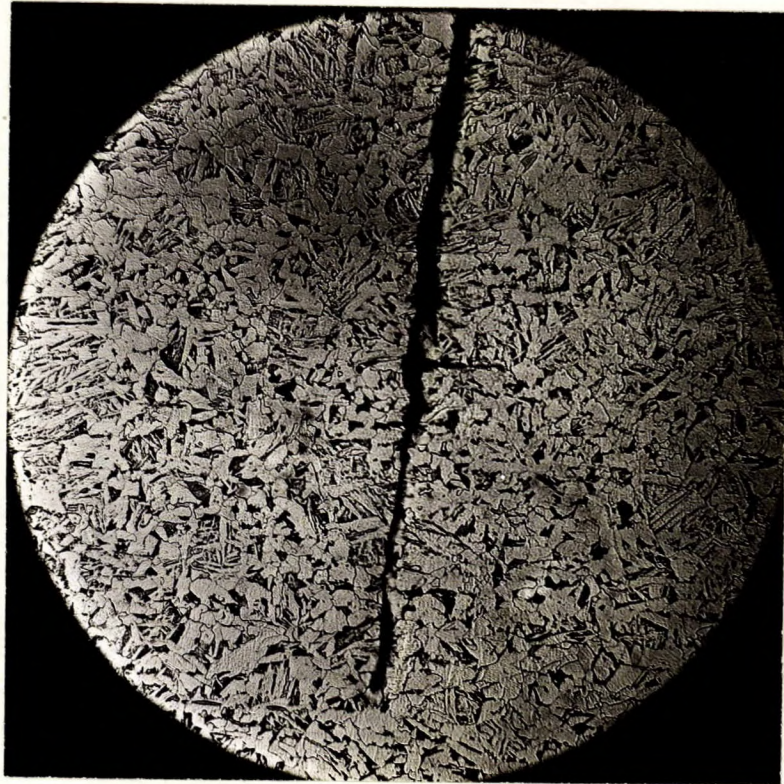
Figure 10.

in the boiler tube, tube sheet materials and weld metal. The heat affected and transition zone structures in both cases indicate a normal response to the thermal cycle of welding. A study of various cracks show that they are all transcrystalline, a condition found in cracks resulting from fatigue; and that they are all blunt ended, which is generally indicative of cracks which have been affected by corrosion.⁽¹⁾ It is difficult to assess the relative importance of the two factors of corrosion and fatigue when both are simultaneously in action. Some authorities⁽²⁾ believe that, for steel, corrosion forms relatively deep surface pits which act as stress raisers and greatly reduce the fatigue strength of the metal. Since there is some degree of correlation between notch-sensitivity of a metal and its resistance to corrosion-fatigue this property of the metal would also be playing a part in the problem. The origin of fatigue cracks in the weld metal is considered to be due to local stress concentration at the irregular weld surface, and not to any inherent weakness of the metal proper. Welds on this type of steel do not seem to show any great difference in resistance to corrosion from that of the base metal.

TERMINATION OF DEEP-SEATED CRACK IN TUBE SHEET.

(See Fig. 2 - crack C. Note transcrystalline nature of crack with blunt termination)
