R E P O R T  
of the  
ORE DRESSING AND METALLURGICAL LABORATORIES.

Investigation No. 2027.

Metallurgical Examination of Defects  
in Hot-Rolled Sections.

March 23, 1946.

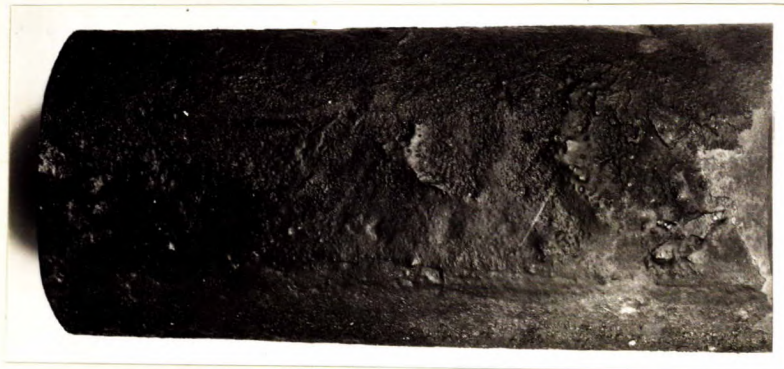
Figure 1.

INGOT SECTION SHOWING SCALING.  
(Approximately 1/3 actual size).

Visual examination of the ingot revealed considerable scale adhering to the surface.

Further visual examination of the ingot revealed considerable quantities of scale adhering to the surface. This condition, plus the evidence supplied by the microscopic examination, leads to the conclusion that the majority of the defects must have occurred during the rolling operations as a result of the rolling of improperly cleaned ingots. When the oxide scale is rolled into the metal several conditions may result:

In order to prevent such defects from recurring, standard precautions should be taken to remove scale from the ingot before rolling. The adoption of a more careful rolling procedure is also recommended, in order to prevent the formation of laps.

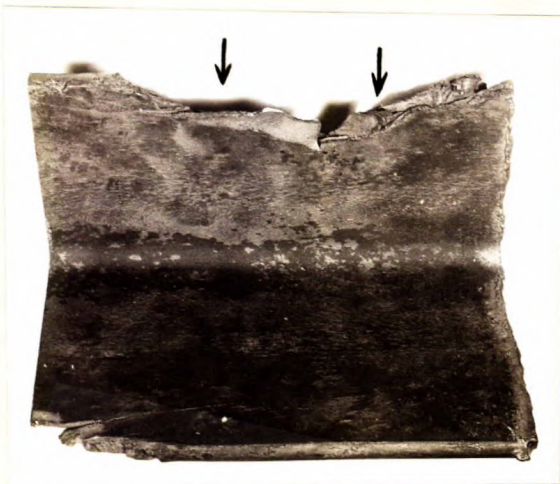
Figure 2.

ANGLE IRON (4" x 4" x 3/10").  
Showing defects encountered  
in rolling.

Visual examination of the angle iron indicated the presence of a great many laps, seams, and folded metal.

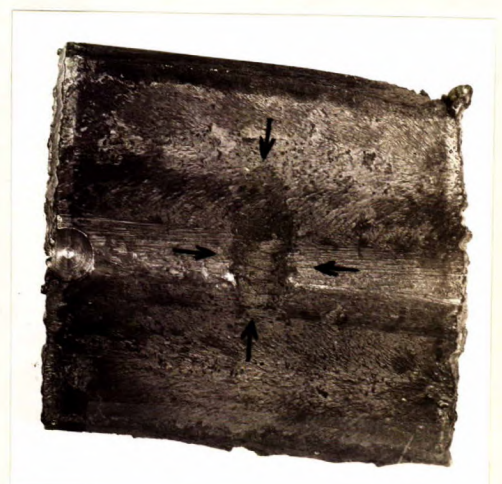
Figure 3.

ROLLED SECTION.  
Showing cavity defect  
encountered in rolling.

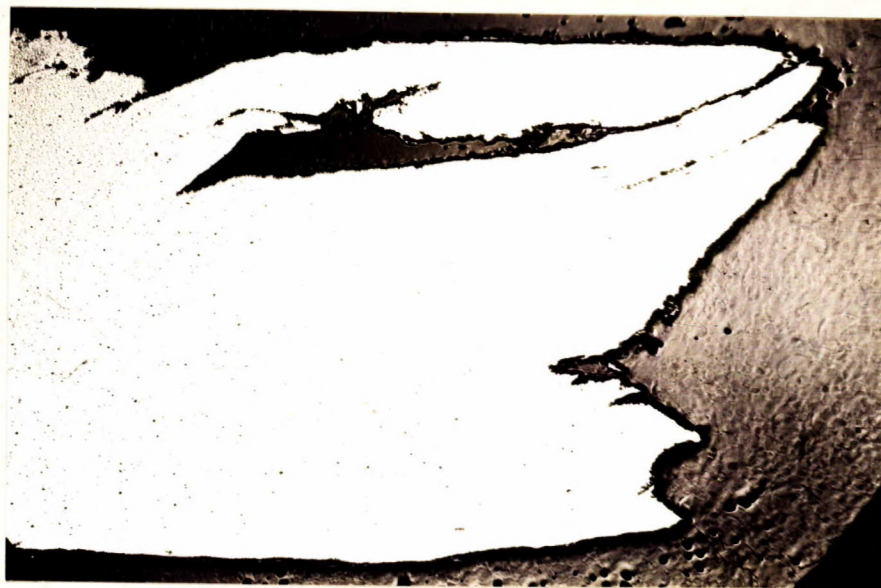
Figure 4.

Figure 4, taken at X9 magnification, is a macrophotograph of the transverse section of the angle iron at the defective area, showing the unwelded folds in the metal.

TRANSVERSE SECTION OF ANGLE IRON  
AT DEFECTIVE AREA.

Note unwelded folds resulting from rolling  
of scale into the metal.

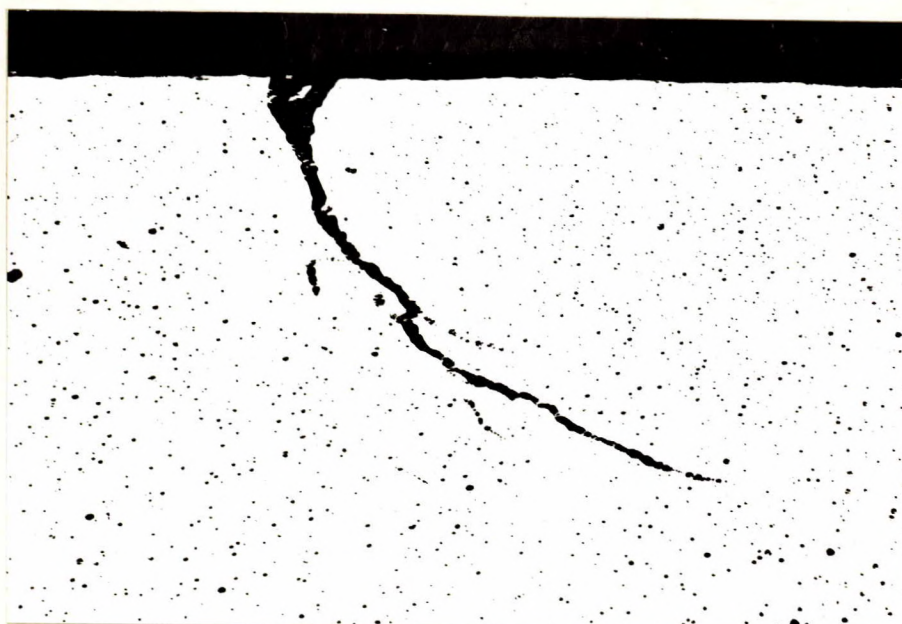
Figure 5.

Figure 5, taken at X18 magnification, is a macrophotograph made on the transverse section of the angle iron, showing a lap.

A lap is caused by the folding of one part of metal past another. This is caused by too rapid reduction or when the section is too large for the pass it is entering. A

typical lap is shown in Figures 5, 6 and 7.

TRANSVERSE SECTION OF ANGLE IRON,  
SHOWING A LAP.

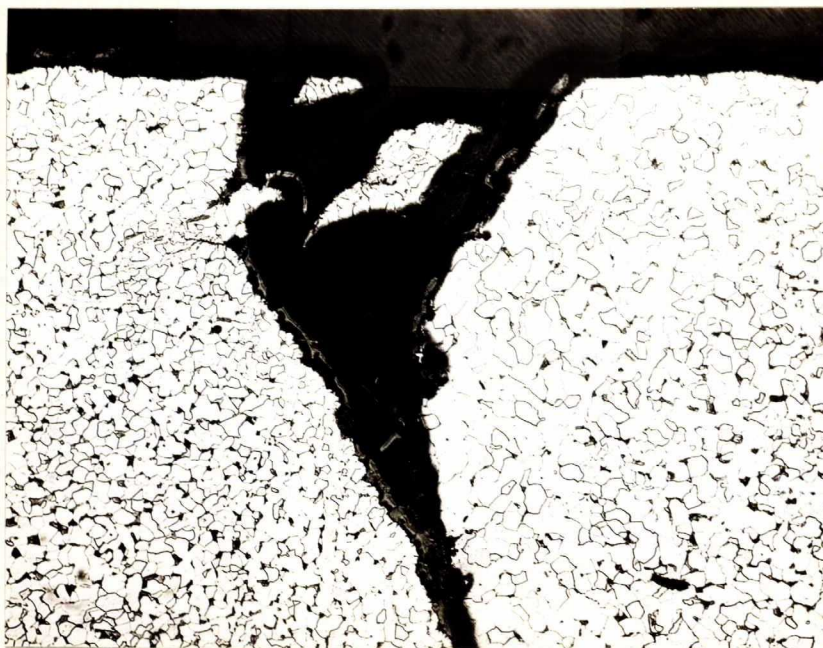
Figures 6 and 7, taken at X100 magnification, show the microstructure of the lap in the angle iron shown in Figure 5. Figure 6 reveals the microstructure of the lap at

the surface, whereas Figure 7 shows the microstructure in the centre of the metal. Note evidence of decarburization in Figure 6.

TRANSVERSE SECTION OF ANGLE IRON,  
SHOWING LAP AT SURFACE.

Note decarburization. (See Figure 5).

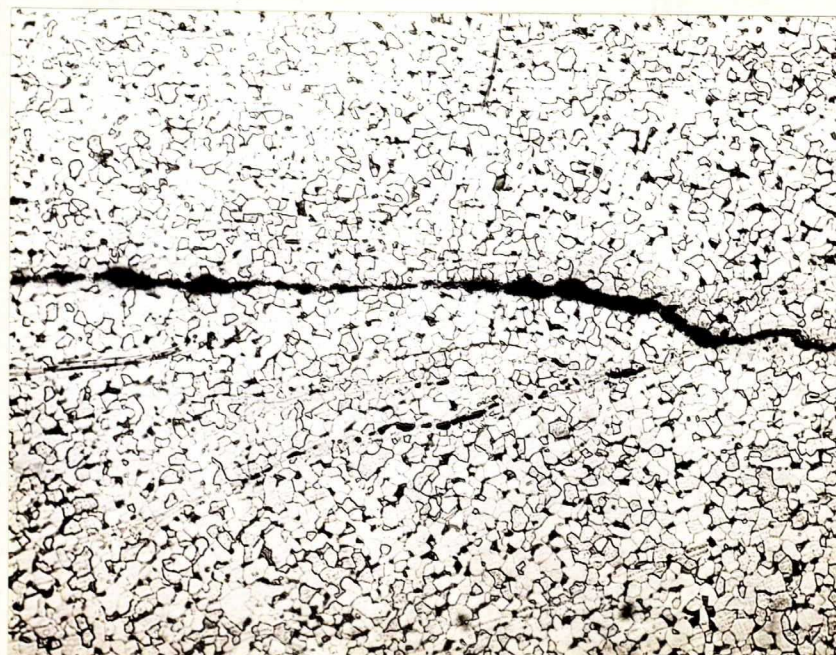
Figure 7.

TRANSVERSE SECTION OF ANGLE IRON,  
SHOWING LAP AT CENTRE OF METAL.

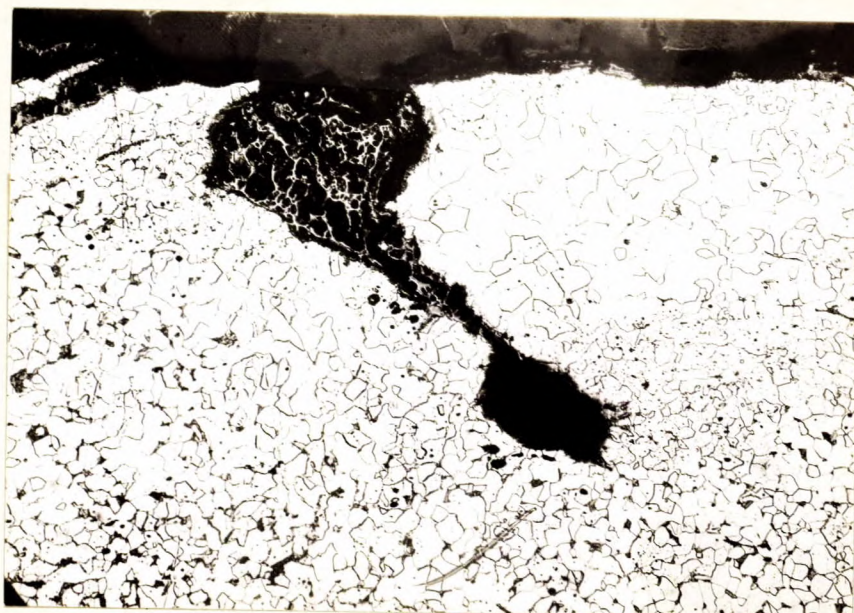
Figure 8 shows a surface defect caused by rolled-in scale. This defect secured in the angle iron. Note, also, decarburization.

- (a) Formation of folds caused by the lack of welding. (See Figure 9).
- (b) Defects as typified by Figure 8.
- (c) Decarburization of the adjacent metal. (Figures 6 and 8).
- (d) Formation of a defect in the form of unwelded oxidized metal. (See Figure 9).

TRANSVERSE SECTION OF ANGLE IRON,  
SHOWING ROLLED-IN SURFACE DEFECT.

Note decarburization.

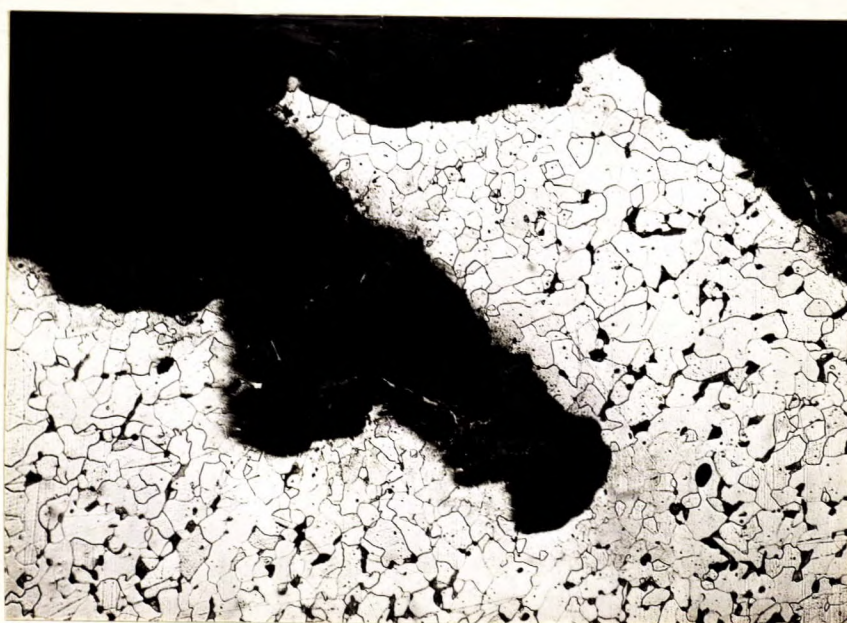
Figure 9.

Figure 9 shows the microstructure of the defective area of the rolled section. This defect is in the form of unwelded metal. Note extensive decarburization.

TRANSVERSE SECTION OF ROLLED PRODUCT  
AT DEFECTIVE AREA (UNWELDED METAL).

Note surface decarburization.

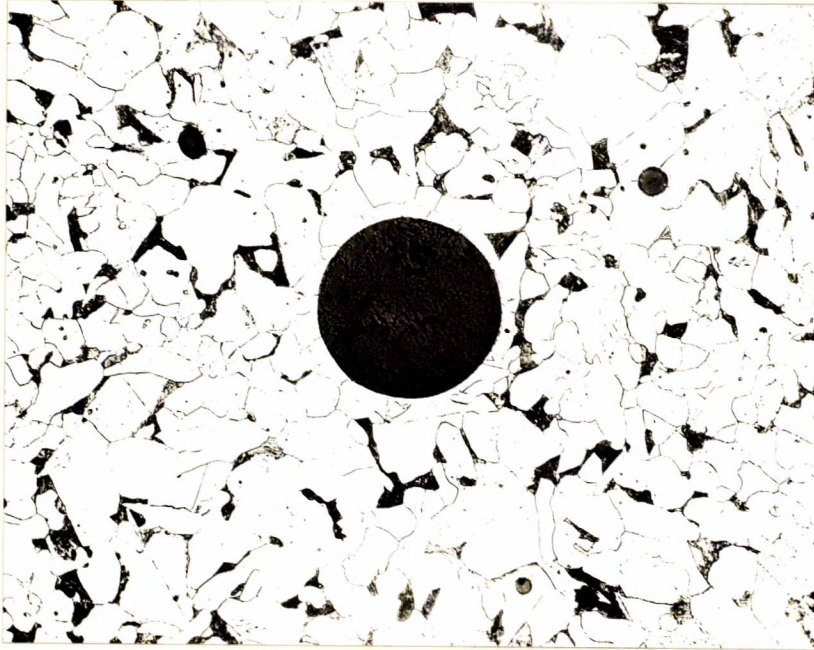
Figure 10.

Figure 10 illustrates the microstructure of the ingot at X100 magnification. Note presence of huge inclusion.

Both chemical analysis and microscopic examination of the ingot reveal normal conditions. The large inclusion shown in Figure 10 is certainly undesirable in steel. However, the average size of the inclusions are considerably smaller than the one shown and can be considered normal for a medium quality steel.

MICROSTRUCTURE OF INGOT, SHOWING  
LARGE INCLUSION.
