ORE DRESSING AND METALLURGICAL LABORATORIES.

Investigation No. 2030.

Metallurgical Examination of Trailer Spring
Suspension U-Bolts and Broken Leaf Springs
from Tractor Rear Towing Attachment.

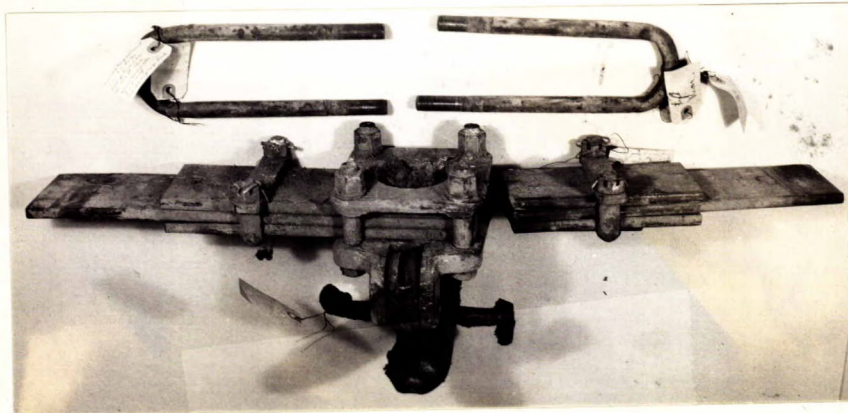
Figure 1.

U-BOLTS AND SPRING ASSEMBLY.
(Approximately 1/8 actual size).

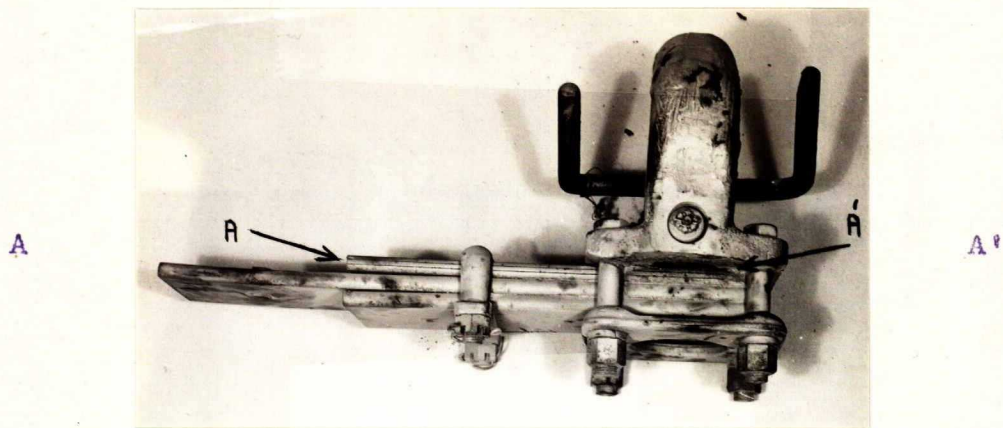
Figure 3.

Cracks were observed, on the edge of the top spring leaf, on a section removed for microscopic examination. After sandblasting, the spring assembly was magnafluxed and then examined for cracks. One crack was noted in the centre and three cracks at the edge of the top leaf. The cracks are shown in Figures 2, 3 and 4. No cracks were observed in the other two leaves.

SHOWING CRACKS IN TOP LEAF AT A, A'.
(Approximately 1/9 actual size).

- (1) The leaves should be heat treated in a protective atmosphere in order to prevent decarburization.
- (2) Shot peening of the leaves will increase their fatigue strength and is recommended.
- (3) The strength of the suspension U-bolt should be increased. Heat treating to a higher hardness is recommended.
- (4) Welding of the spring clip to the leaf is not shown on the D.N.D. drawing No. C1017, and should not be permitted.

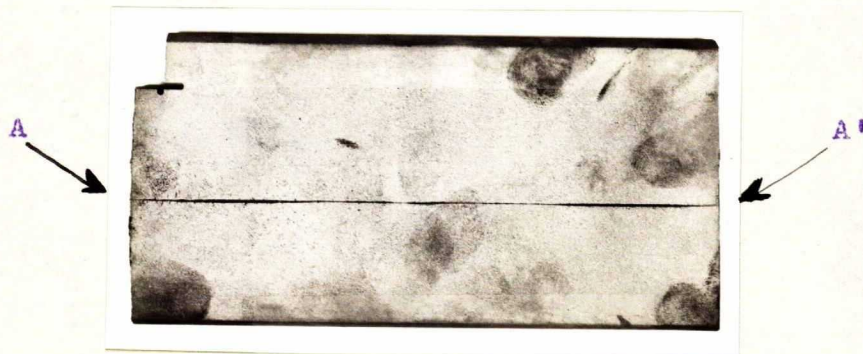
Figure 4.

SHOWING CRACK IN CENTRE OF LEAF AT A, A'.
(Approximately full size).

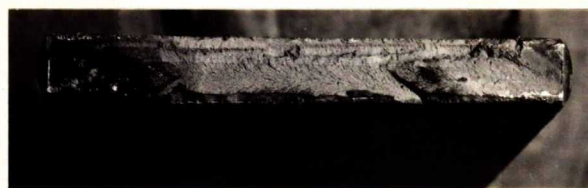
Figure 5.

SHOWING FRACTURE OF TOP LEAF.
(Approximately 7/8 size).

The compositions of the three component parts examined were within the limits specified. The macroscopic examination revealed a number of cracks in the top broken leaf. No fractures were noted in any of the other component parts. The fractures are typical of a fatigue failure. The decarburized surface and the cracks in the steel would both definitely lower the fatigue strength of the steel. The presence of a decarburized layer along the crack would indicate that these cracks were present prior to heat treatment and most probably originated in the forming operation.

From the results of this investigation, it is concluded that the spring leaves failed in fatigue. The low mechanical properties of the SAE 3125 steel U-bolt may account for its stretching in service. No defects were observed in the spring clips submitted except a crack in the weld metal

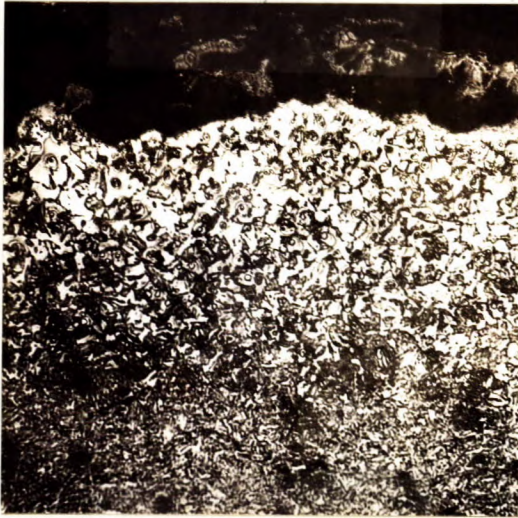
Figure 6.

X100, etched in 4 per cent picric acid.

MICROSTRUCTURE OF BROKEN LEAF SPRINGS.

The microstructure of all three leaves ~~are~~^{is} normal for that of SAE 9260 steel quenched and tempered, i.e., tempered martensite. However, in Figures 6 and 8 it will be observed that the steel is decarburized on the edge and also in the area surrounding the crack.

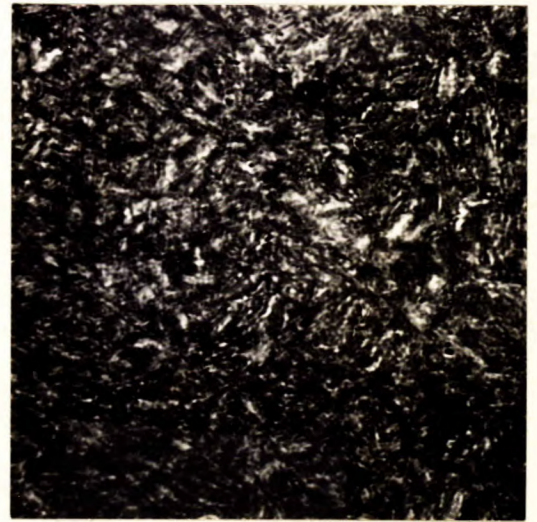
Figure 7.

X1000, etched in 4 per cent picric acid.

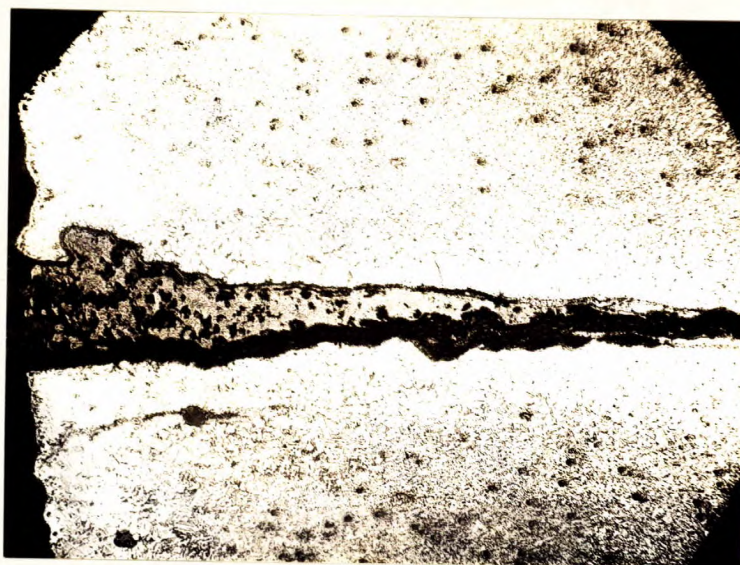
Figure 8.

X200, etched in 4 per cent
picric acid.

SHOWING CRACK AND DECARBURIZED AREA.
