ORE DRESSING AND METALLURGICAL LABORATORIES.

Investigation No. 2031.

Metallurgical Examination of Pressure-Welded  
Reinforcing Steel Bars.

April 16, 1946.

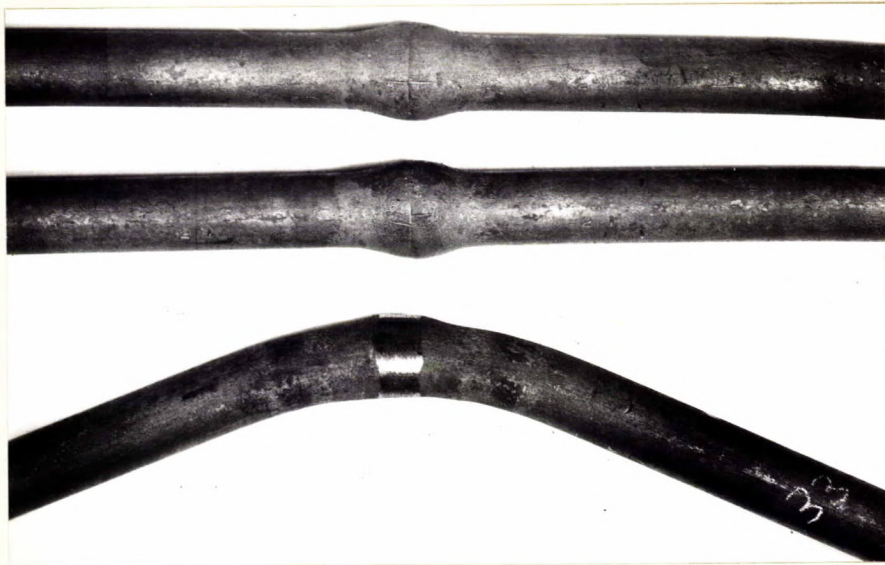
Figure 1.

AS RECEIVED SAMPLES (TOP TO BOTTOM)  
NOS. 29, 21 AND 33.

As-welded samples showing uniform upset and no rupturing. Sample No. 33 is typical of preparation for bending by light grind on upset. No. 33 is only sample exhibiting satisfactory ductility as compared with other tests.

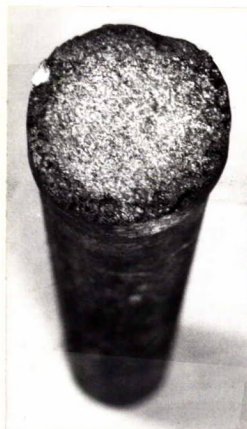
Figure 3.

tests. No evidence of burning was found other than the outer layers of the upset portion on Tests Nos. 1 and 35.

FRACTURED END OF SAMPLE NO. 35.

Note coarse grain and burning around complete periphery. This sample and No. 1 are the only ones in which burning was detected, and both samples show severely localized upsetting.

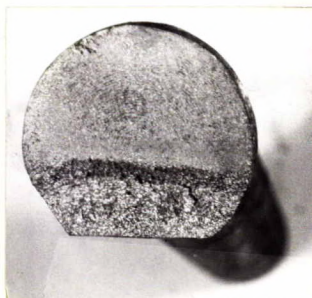
Figure 4.

11. Bend tests showing interface failures with original machining marks visible on the interface are considered to be welded at too low a temperature.

FRACTURED END OF SAMPLE NO. 15.

Fracture typical of those showing original interface machine marks.

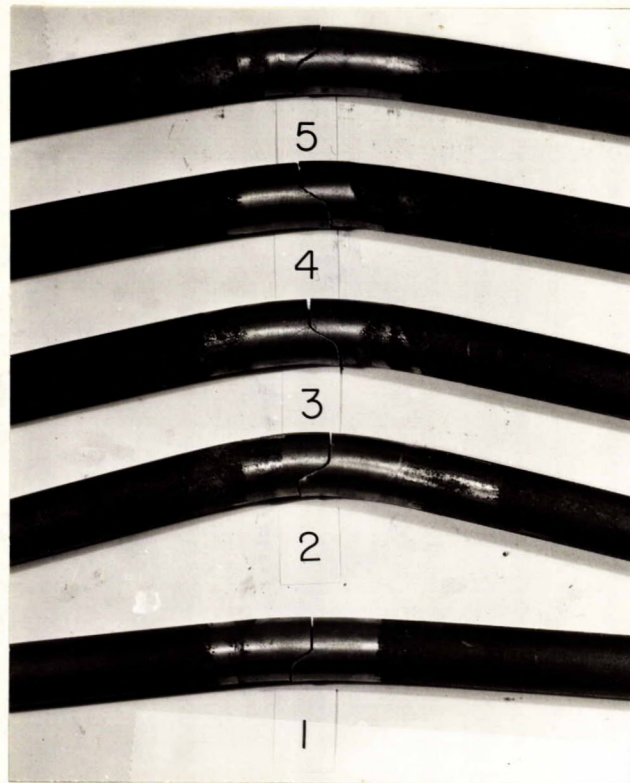
Figure 5.

BEND TESTS MADE IN THESE LABORATORIES.

In these tests the upset portion was completely removed in an effort to assess the importance of the upset as a stress raiser. Removal of upset in no way improved ductility.

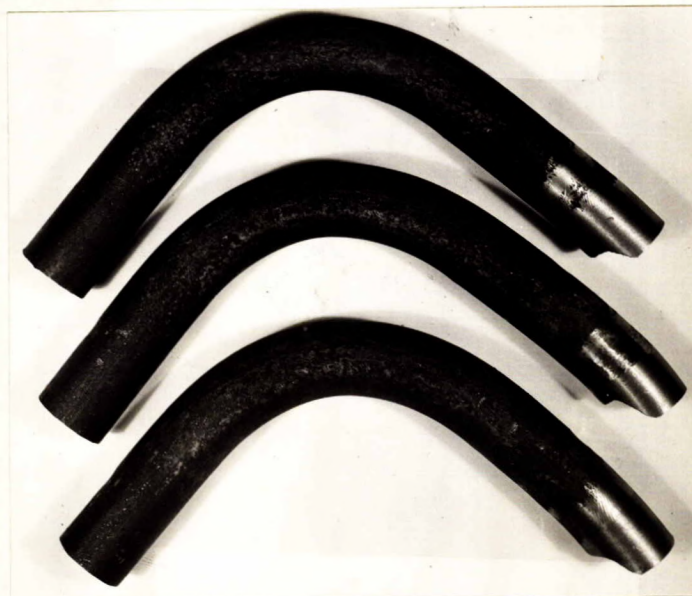
Figure 6.

(8) One end of each of three of the tests shown in Figure 5 was bent between 9-in. centres around a 4"-diam. pin. All test bars bent 90° without failure. Figure 6 shows the condition of these bars after bending. It is apparent that the ductility of the unwelded material is far superior to that of the welded material.

BEND TESTS ON UNWELDED BARS.

These tests were made on ends of bars shown in Figure 5. Unheated material has far greater ductility than welded tests.

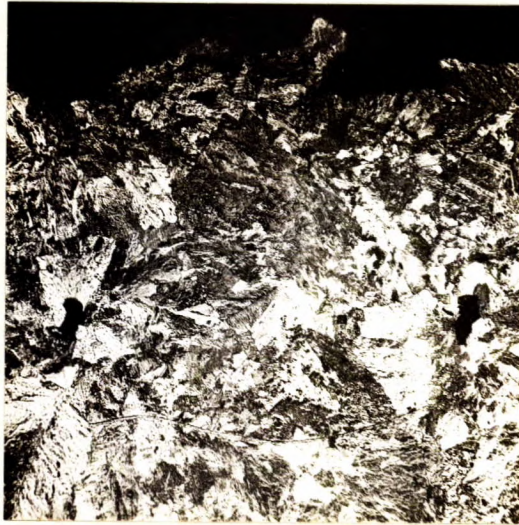
Figure 7.

X100, etched in 4  
per cent picral.

COARSE-GRAINED STRUCTURE AT FRACTURED EDGE OF  
'AS WELDED' BEND TEST.

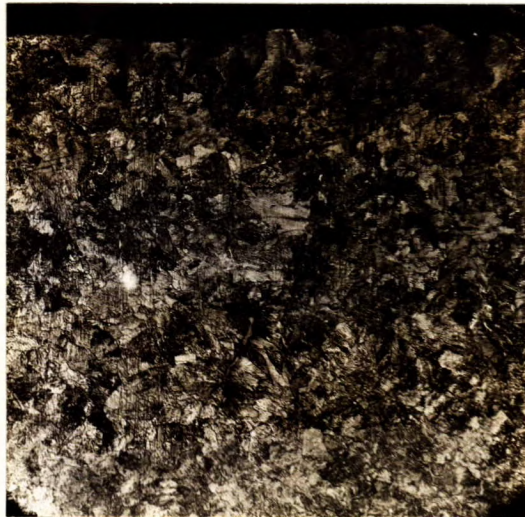
Figure 8.

X100, etched in 4  
per cent picral.

FINE-GRAINED STRUCTURE AT FRACTURED EDGE OF  
A MACHINE-NORMALIZED SAMPLE.

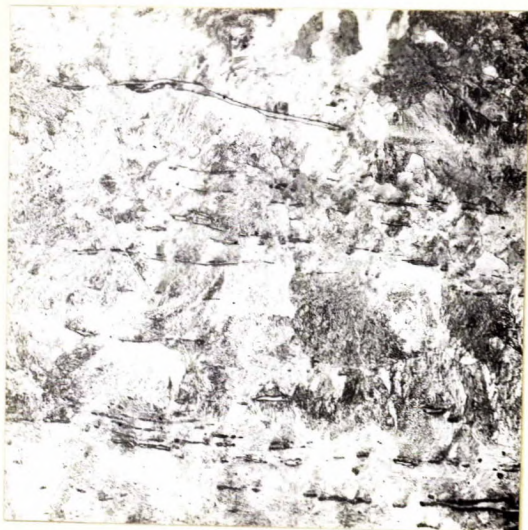
Figure 9.

X100. light 4 per  
cent picral etch.

TYPICAL AREA SHOWING NUMEROUS MANGANESE  
SULPHIDE INCLUSIONS.

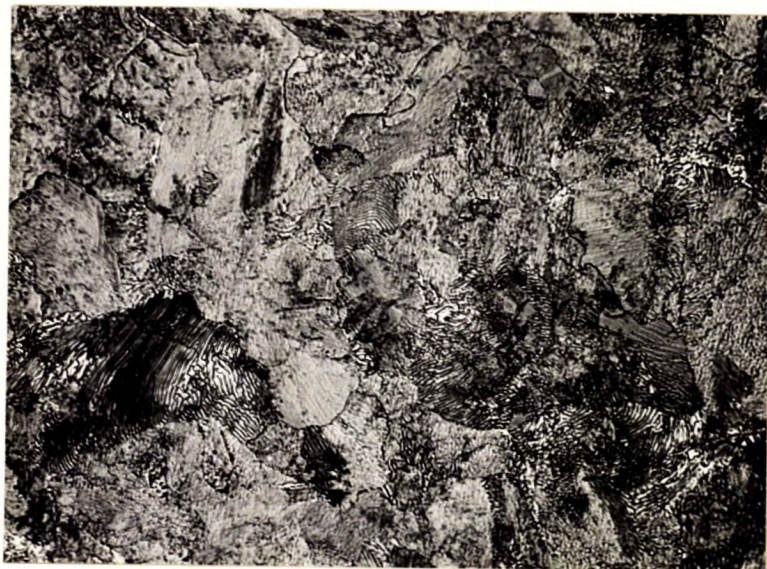
Figure 10.

X500, etched in 4  
per cent picral.

FINE AND COARSE PEARLITE STRUCTURE  
OF 'AS ROLLED' BARS.

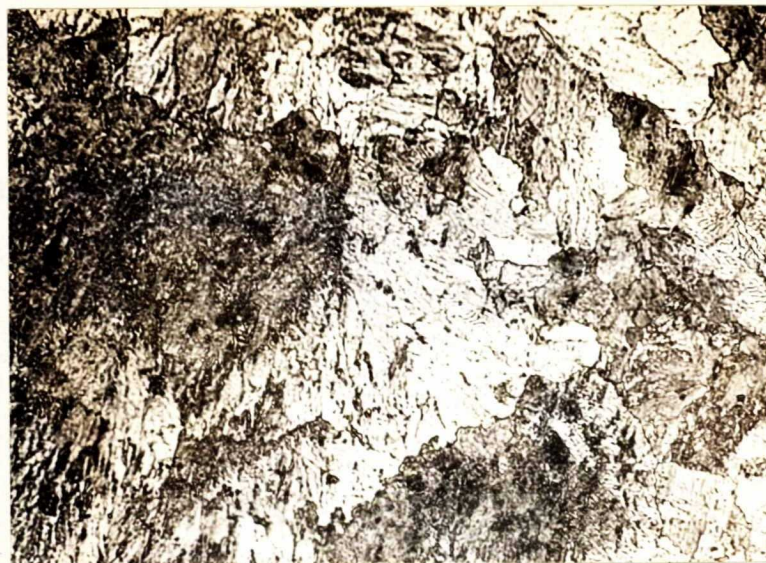
Figure 11.

X500, etched in 4  
per cent picral.

COARSE-GRAINED PEARLITIC STRUCTURE TYPICAL  
OF HEAT-AFFECTED ZONES OF 'AS WELDED' MATERIAL.

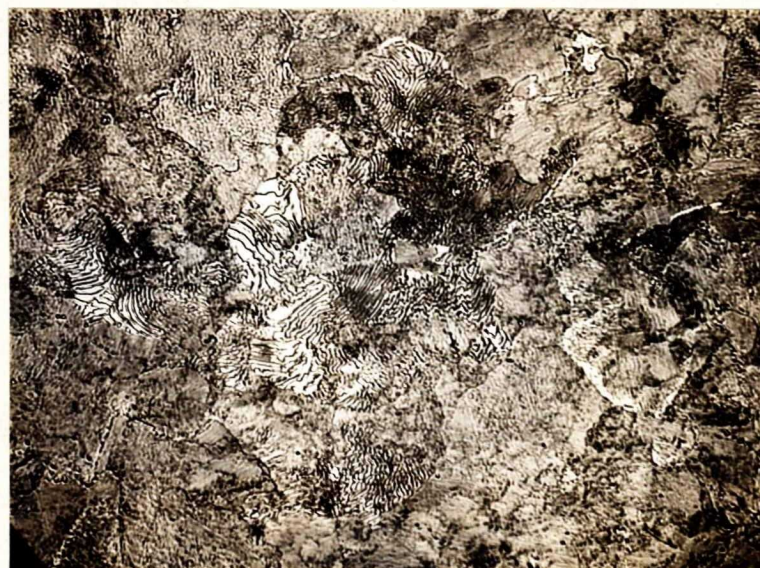
Figure 12.

X500, etched in 4  
per cent picral.

FINE-GRAINED, FINE AND COARSE PEARLITIC STRUCTURE  
TYPICAL OF HEAT-AFFECTED ZONES OF MACHINE-  
NORMALIZED WELDS.

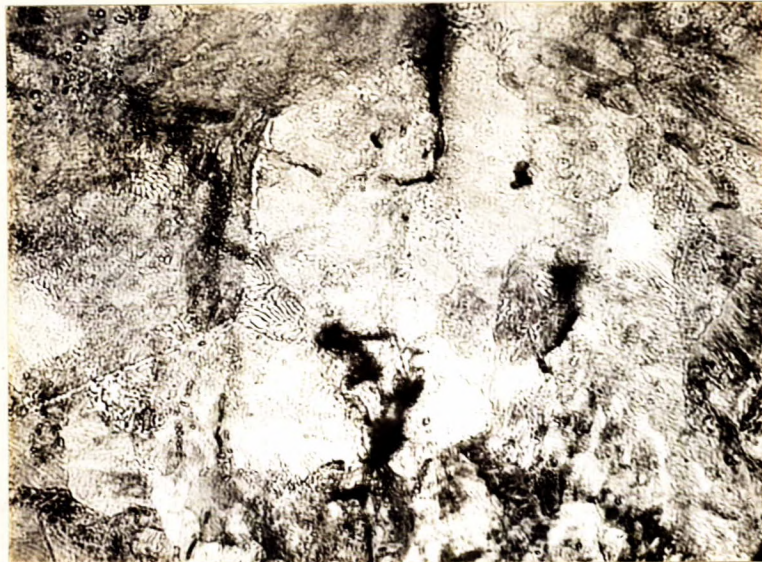
Figure 13.

8. When too localized upsetting occurs, internal rupturing results to a depth well below the original diameter of the bar.

X500, light 4 per  
cent picral etch.

INTERNAL RUPTURING FOUND IN TESTS IN WHICH THE  
UPSETTING IS TOO SEVERELY LOCALIZED.

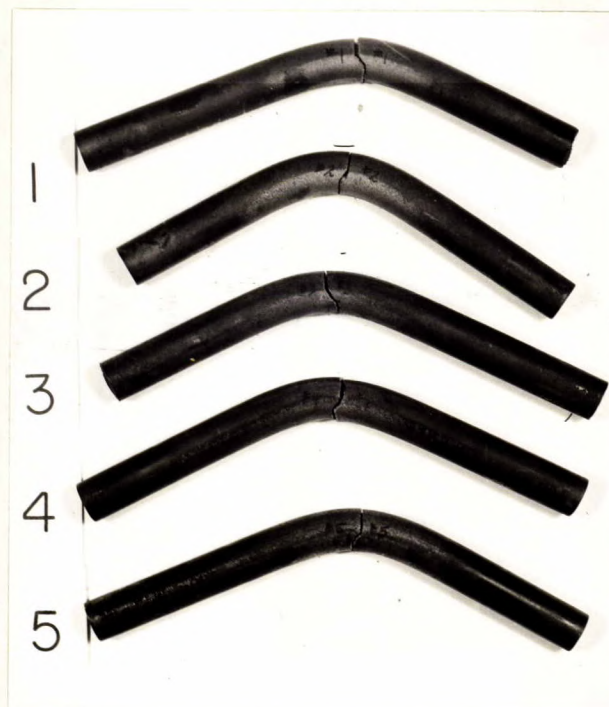
Figure 14.

HALF-INCH-DIAMETER TEST BARS,  
BENT AFTER ANNEALING.

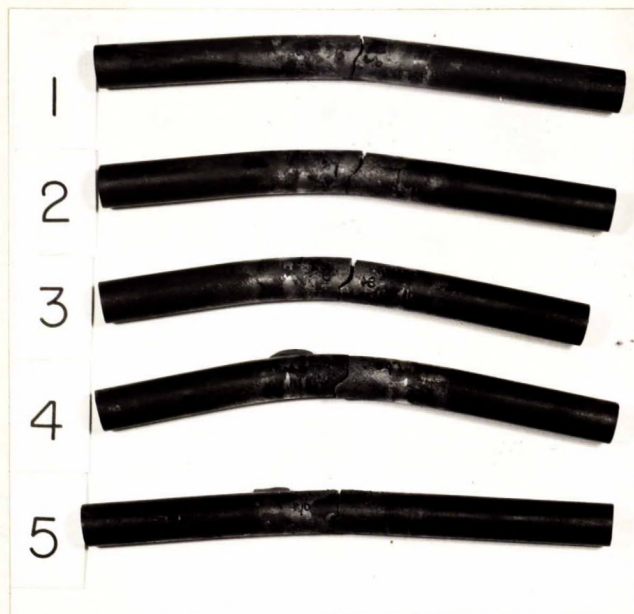
Figure 15.

HALF-INCH-DIAMETER BARS, ANNEALED, HEATED TO 2200° F. AT CENTRE WITH OXYACETYLENE TORCH, COOLED IN AIR, AND BENT.

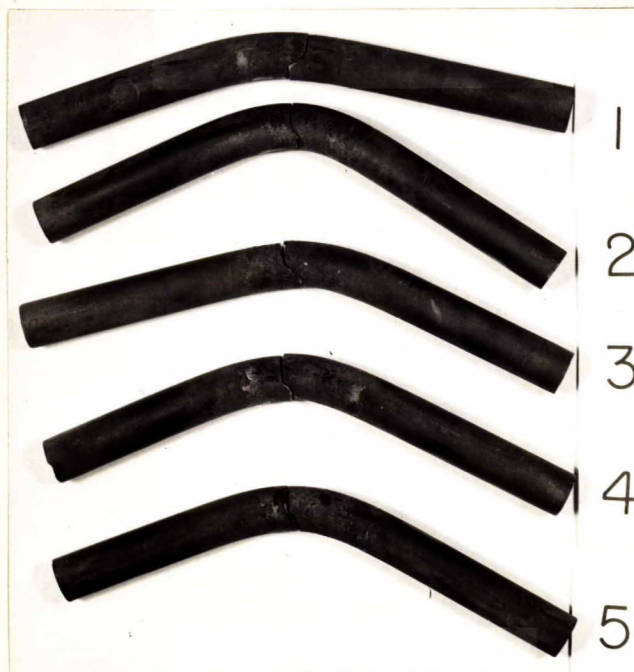
Figure 16.

HALF-INCH-DIAMETER BARS, ANNEALED, HEATED TO 2200° F. AT CENTRE WITH OXYACETYLENE TORCH, COOLED IN AIR, RE-ANNEALED, AND BENT.

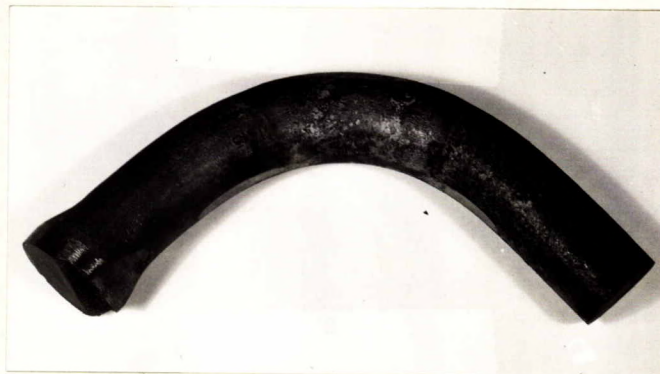
(13) One bar, unwelded 1" diam., was heated by means of an induction coil at its centre to a temperature of approximately 2000° F. Temperature attained was uncertain due to oxide film interfering with optical pyrometer reading. This bar, after cooling in still air, bent 90° without failure. See Figure 17.

ONE-INCH-DIAMETER BAR OF UNWELDED METAL,  
INDUCTION-HEATED TO APPROXIMATELY  
2000° F. AT CENTRE AND AIR-COOLED.

Bent without failure.
