#### ORE DRESSING AND METALLURGICAL LABORATORIES.

Investigation No. 2060.

Stress Analysis with Brittle Lacquer, Performed on a Cast Magnesium Piano Plate. - Part I.

In a letter (File No. D/18/2/1 - Piano Plate) dated February 22, 1946, Mr. W. Z. Jarmicki, design engineer of Dominion Magnesium Limited, 67 Yonge Street, Toronto, Ontario, requested that a stress analysis be performed upon a cast magnesium piano plate which he was submitting.

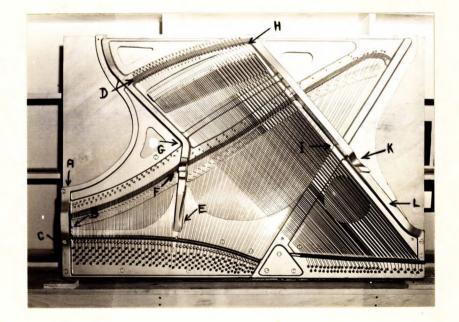
#### Figure 2.

A view of the plano plate is shown in Figure 2. The plate had been cast in a green sand mould and afterwards sandblasted. Machining and mounting on a wooden frame 3 inches thick was done by Mason & Risch, Limited, of Toronto.

The most distinct strain patterns in Test No. 2 were obtained in regions A, B, E, F, I, K and L, marked with arrows in Figure 2. The details of the stress patterns at these places are shown in Figures 5 to 13.

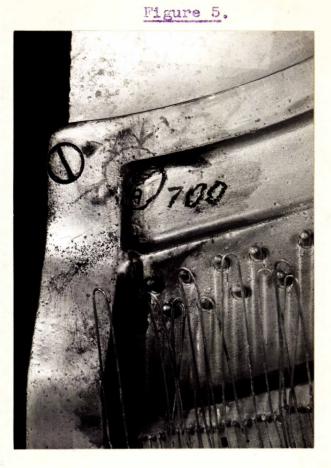
REGION "A" OF THE MAGNESIUM PLATE SHOWS CRACKS CONCENTRATED MAINLY IN RADIAL DIRECTION STARTING FROM THE CENTRE OF THE RADIUS DRAWN FROM THE CORNER.

These stress patterns show compression stresses directed perpendicularly to the radial cracks, as shown by arrows.

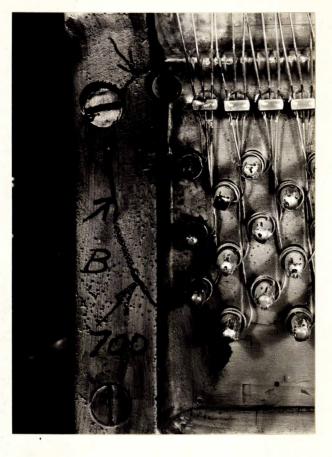
Figure 6.

REGION "B" SHOWS PARALLEL CRACKS DIRECTED PERPENDICULARLY TO THE EDGE OF THE VERTICAL BEAM A-C (see Figure 2).

The fact that the stress pattern appears only on one side of the beam proves that it is bent towards the side showing the stress pattern.

The second test (Stresscoat No. 1204) has revealed distinctly that the regions B, E and F are the places most overloaded, and that quite high concentrations of stress should be expected there.

The results of this investigation suggest that it is necessary to increase the section in regions B, E and F in order to obtain more evenly distributed stresses in the plate as a whole.

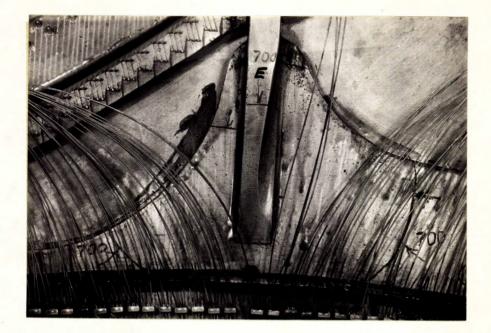
# Figure 7.

REGION "E" SHOWS CONCENTRIC GRACKS OF A SHAPE MARKED WITH PENCIL.

These stress patterns prove the presence of compression stress, with the maximum directed perpendicularly to the circular cracks.

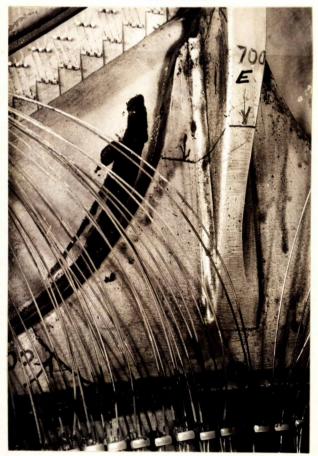
Figure 8.

The web in region "E" has a parallel stress pattern directed transversely to the length of the web, with increasing density of cracks towards the base of the web, which indicates an increase of the compression stresses in the same direction.

The web in region "E," shown in Figures 8 and 9, serves as a supporting column for the upper part of the magnesium plate and takes the main part of the compression and bending loads superimposed by all strings. The bending moment caused by inaxial loading is directed in such a way that the compression stresses are higher on the top surface and lower on the surface which is attached to the wooden box. The regions where the stress patterns were observed are marked with pencil and arrows pointing to the cracked surface.

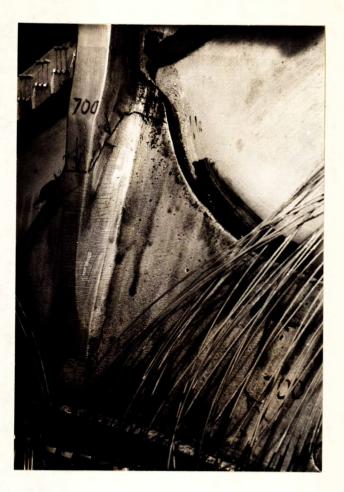
Figure 9.

PHOTOGRAPH OF THE SAME REGION ("E") AS FIGURE 8, SHOWING SIDE VIEW OF THE WEB WITH THE STRESS PATTERN ALONG IT REVEALING AN INCREASE OF COMPRESSION LOAD AS THE WEB SECTION DIMINISHES.

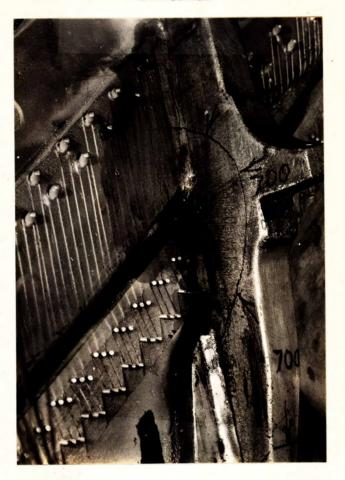
Figure 10.

THE STRESS PATTERN IN REGION "G" SHOWS COMPRESSION STRESSES ON THE INSIDE, AROUND THE CORNER BETWEEN HORIZONTAL BEAM AND VERTICAL COLUMN.

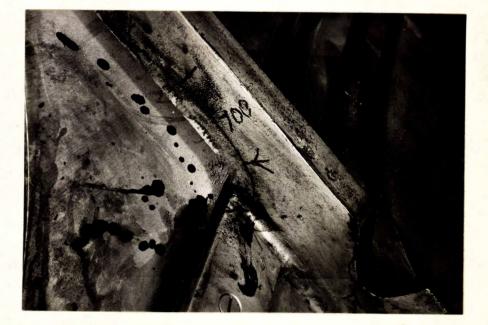
## Figure 11.

THE PATTERN IN REGION "I" IS SIMILAR TO THAT SHOWN IN FIGURE 10.

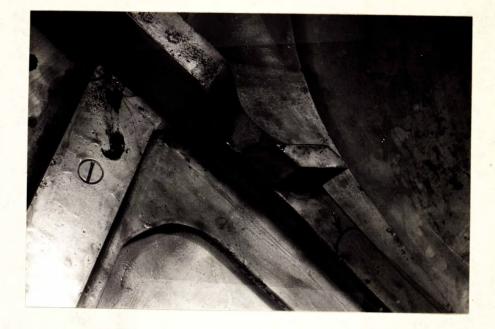
Figure 12.

SHOWING ONE OF THE MAIN COLUMNS, WITH REGION "K" COVERED WITH STRESS PATTERN IN THE SECTION WEAKENED BY A DEEP CYLINDRICAL CUT.

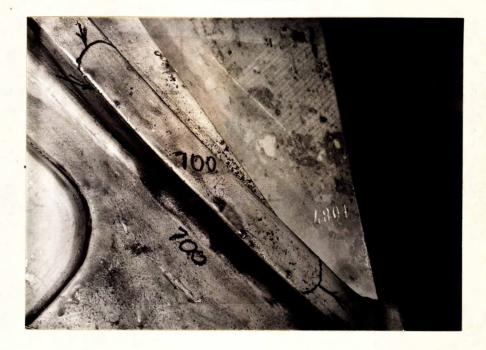
Figure 13.

THE BOTTOM PART OF A COLUMN COVERED WITH STRESS PATTERN IN REGION "L", AS MARKED WITH PENCIL.

On both sides of the column the lacquer cracked only up to 1/4 inch from the top surface.
