Investigation No. 2061.

(Subsequent to Investigation Report)  
(No. 2060, June 5, 1946.)

Stress Analysis with Brittle Lacquer,  
Performed on a Cast Magnesium Piano Plate. - Part II.

The magnesium piano plate was submitted by Dominion Magnesium Limited, Toronto, Ontario, for a stress analysis investigation in order to check the present design and obtain suggestions which should be applied in production.

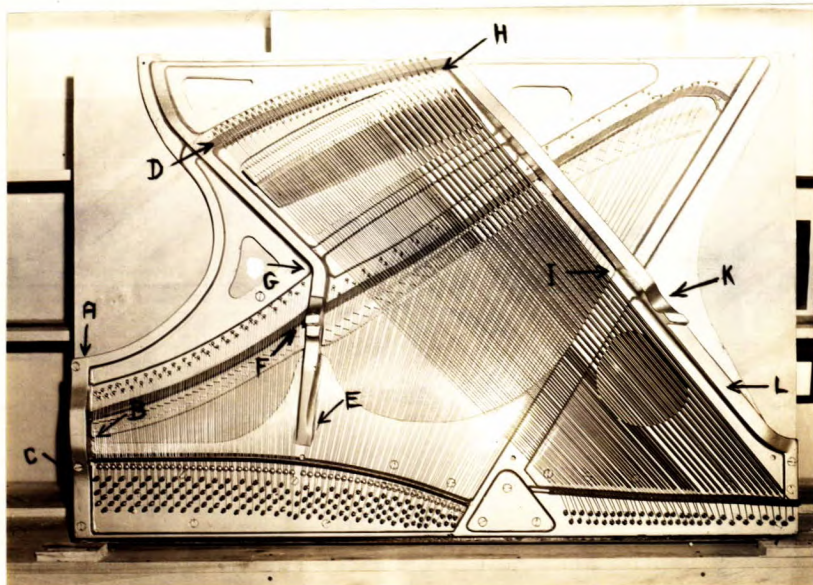
Distinctive strain patterns in this test were obtained in regions A, B, C, D, E, F, I, K and L marked in Figure 3. The details of the pattern in these places are shown in Figures 4 to 16 inclusive.

VIEW OF MAGNESIUM PIANO PLATE.

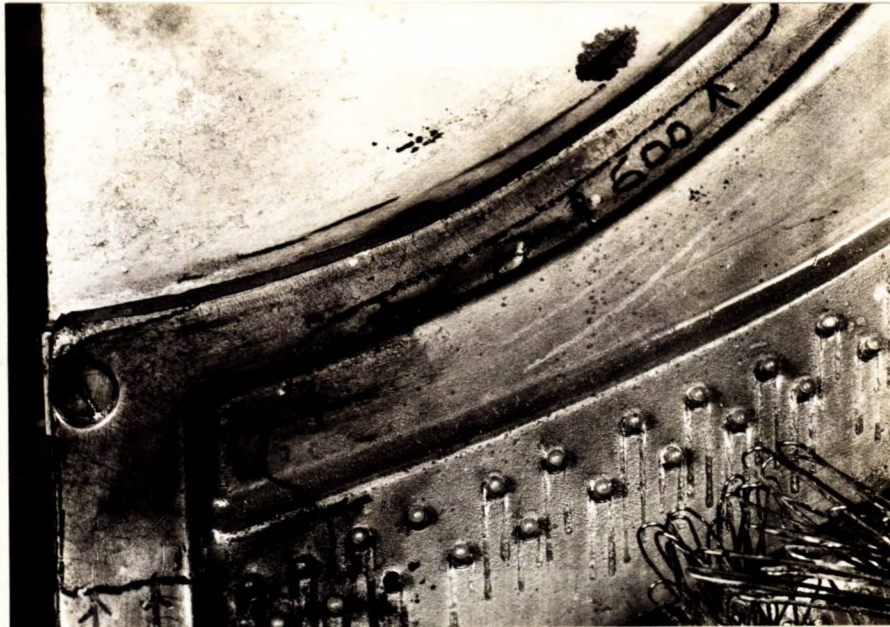
Figure 4.

Region "A" of the magnesium plate shows cracks as marked with a pencil and arrows pointing to the places where stress patterns have been noticed. The left corner of that region is under compression.

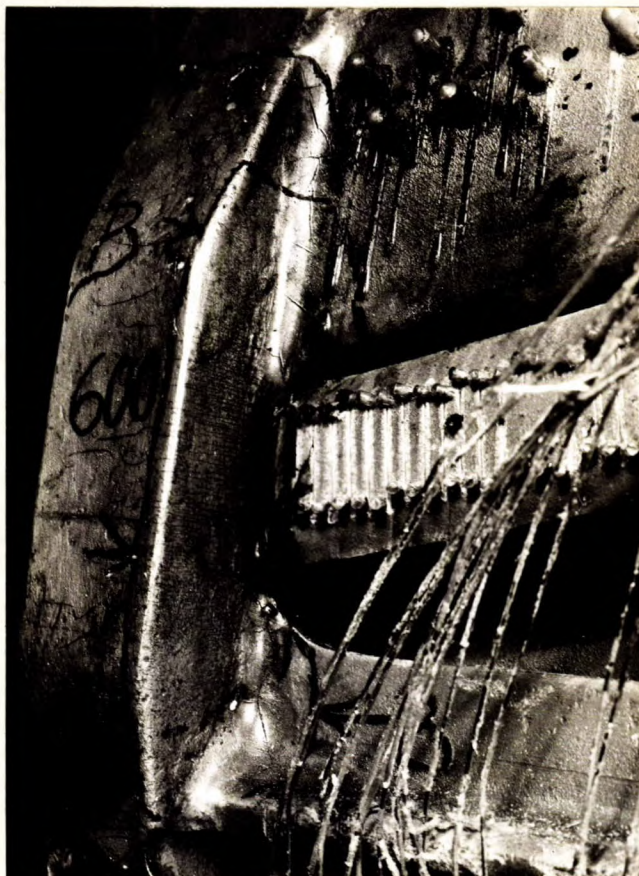
Figure 5.

Closely spaced cracks in region "B", on the vertical beam A-C, indicate that this beam is bent towards the centre portion of the piano plate.

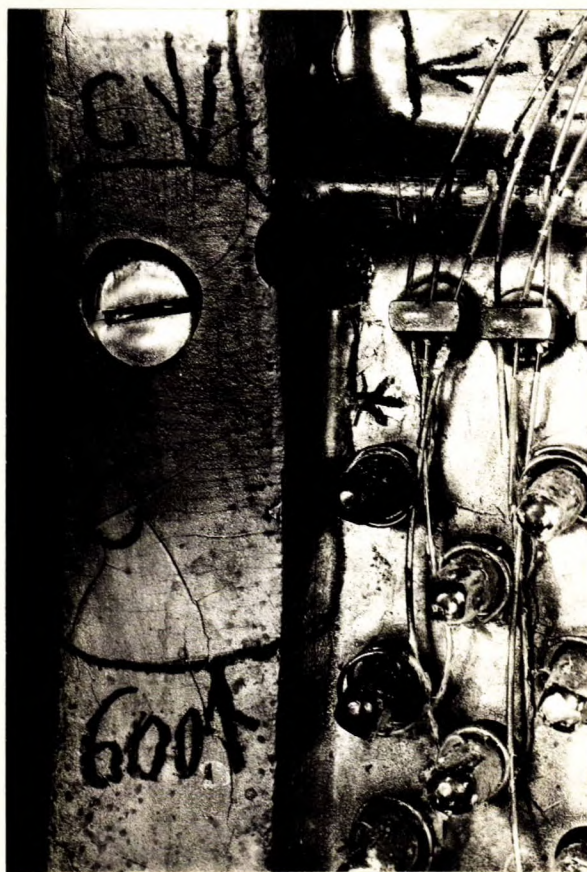
Figure 6.

The inside edge shows the existence of compression stresses in region "C". Stress patterns are directed parallel to the bottom edge of the plate.

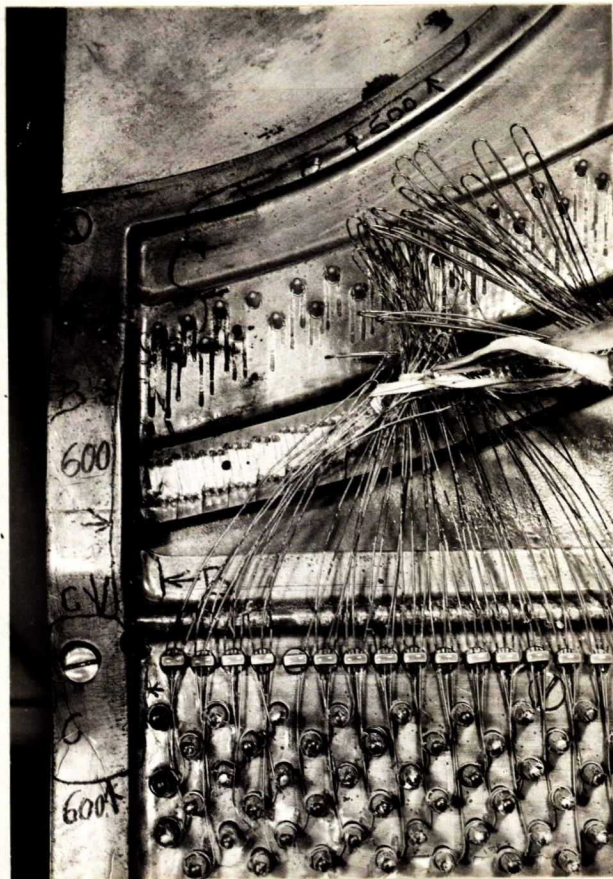
Figure 7.

The left part of the plate with regions A, B and C was shown before, separately, in Figures 4, 5 and 6. The vertical column, B-C, takes a large proportion of the pull-load superimposed by the strings. Compression and bending loading of the column are evident.

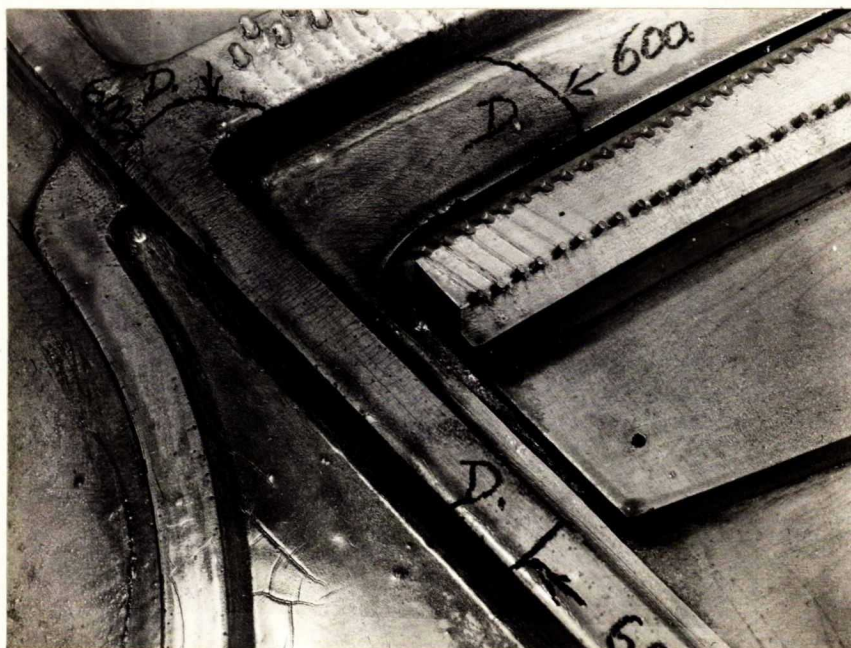
Figure 8.

The left corner of the top beam, marked as region "D", shows on the left edge a compression load with a maximum directed parallel to the edge of the rib. Also, a part of the plate on the right side of the edge is covered with stress patterns at 45 degrees to this edge.

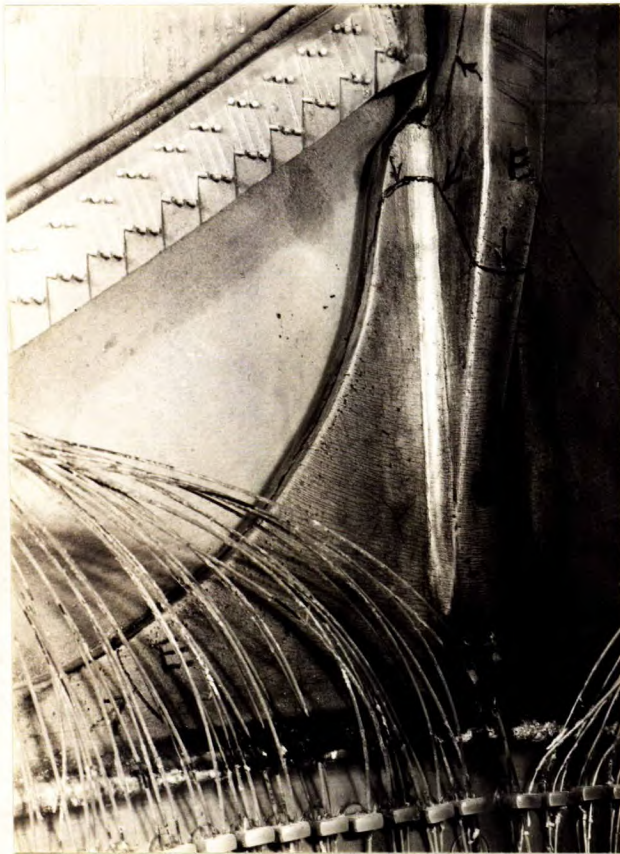
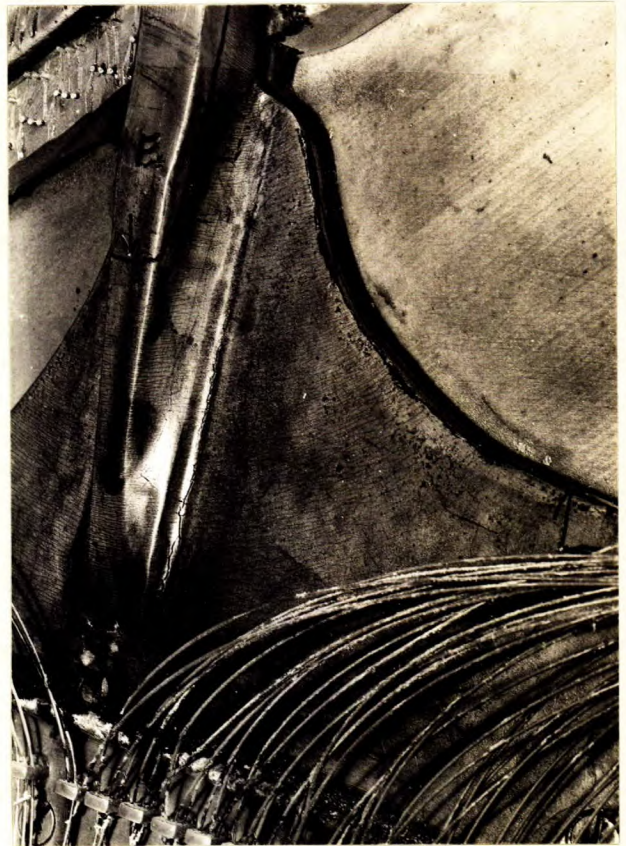
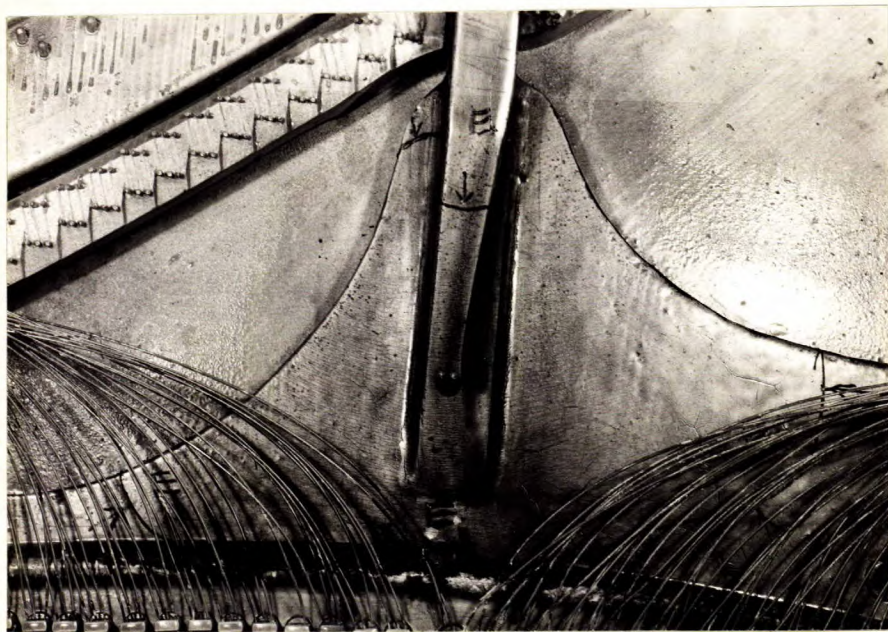
Region "E", at the end of the second vertical column, is shown in Figures 9, 10 and 11. The stress patterns in the region prove the presence of compression stresses caused by the load transmitted from the upper and lower parts of the plate.

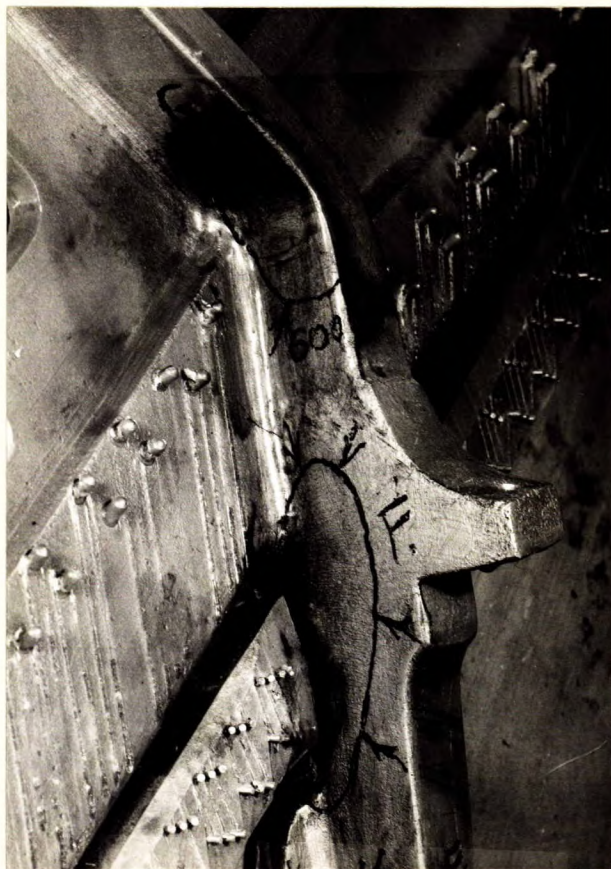
Figure 12.

In the region "G", the cracks in the stress pattern observed show compression load on the inside of the curvature. In the region "F", on the upper part of the column adjacent to the main diagonal beam, a dense stress pattern was observed. The position of this stress pattern proves the presence of a high eccentric compression load.

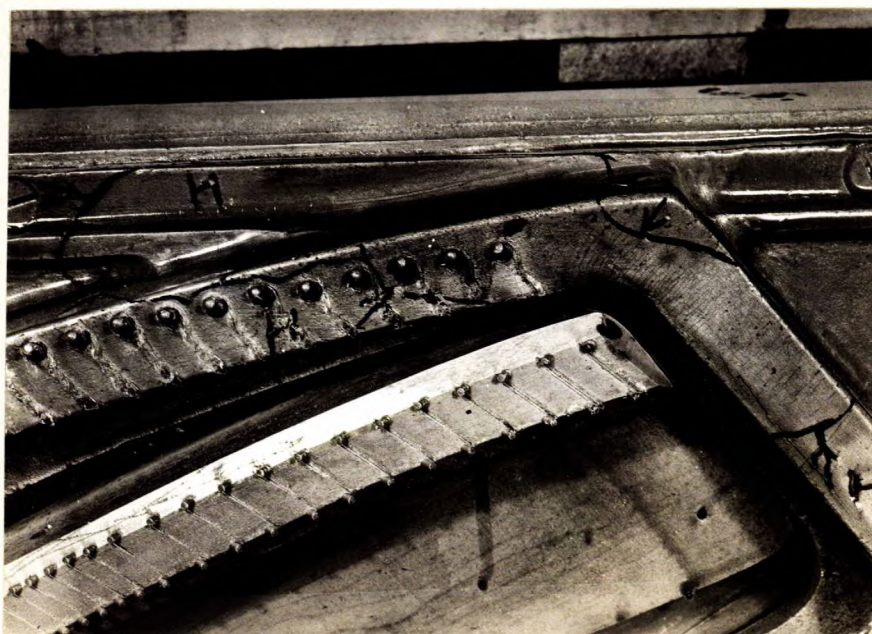
Figure 13.

The upper right-hand corner, marked as region "H", has shown stress patterns as contoured by pencil. Some concentration of compression stresses in that corner is indicated.

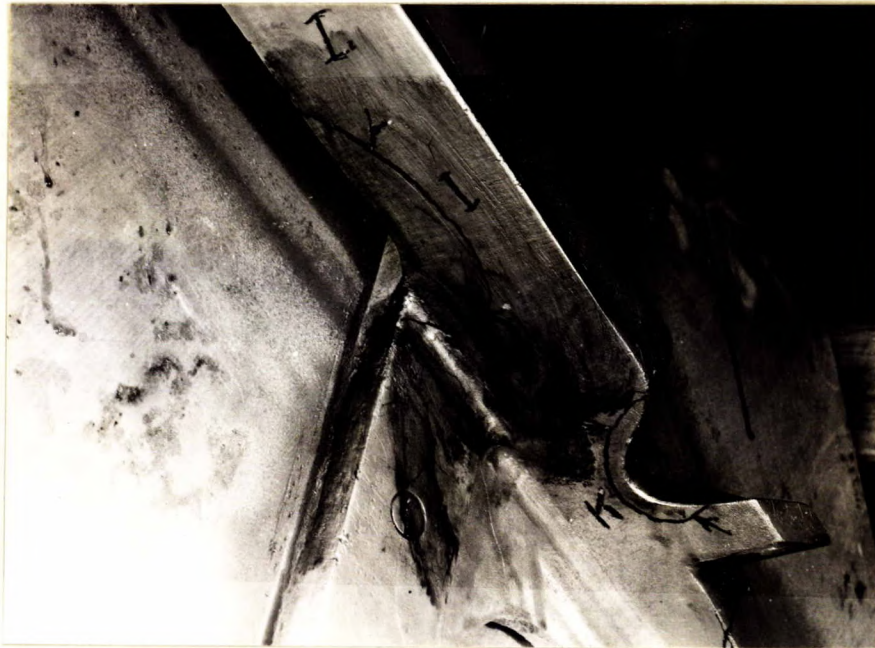
Figure 14.

The region "I" shows the lower part of the main column adjacent to the main diagonal beam; the presence of the eccentric compression load is evident.

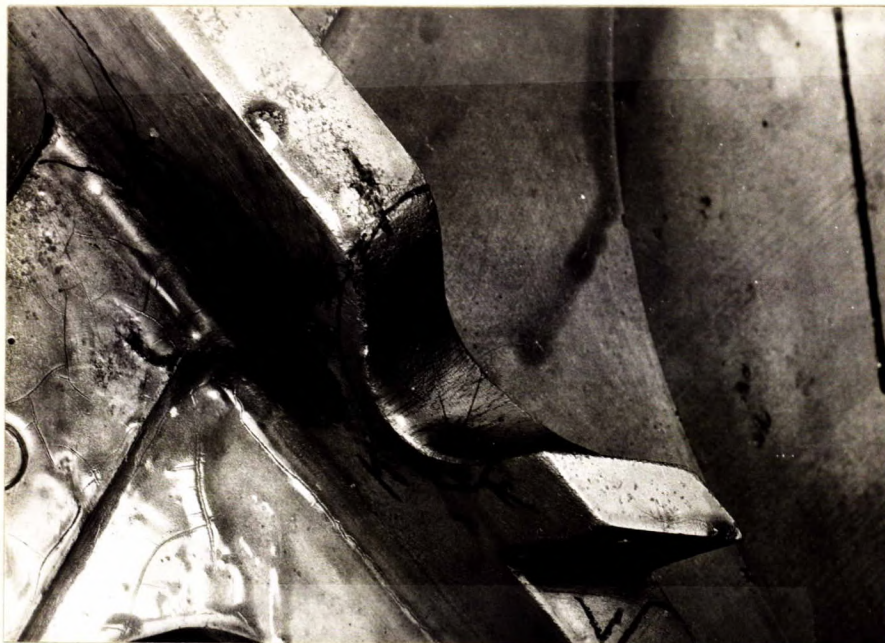
Figure 15.

The deep round cut in the main column is covered with stress patterns which show the concentration of compression stresses and also indicate the eccentric compression load in the column.

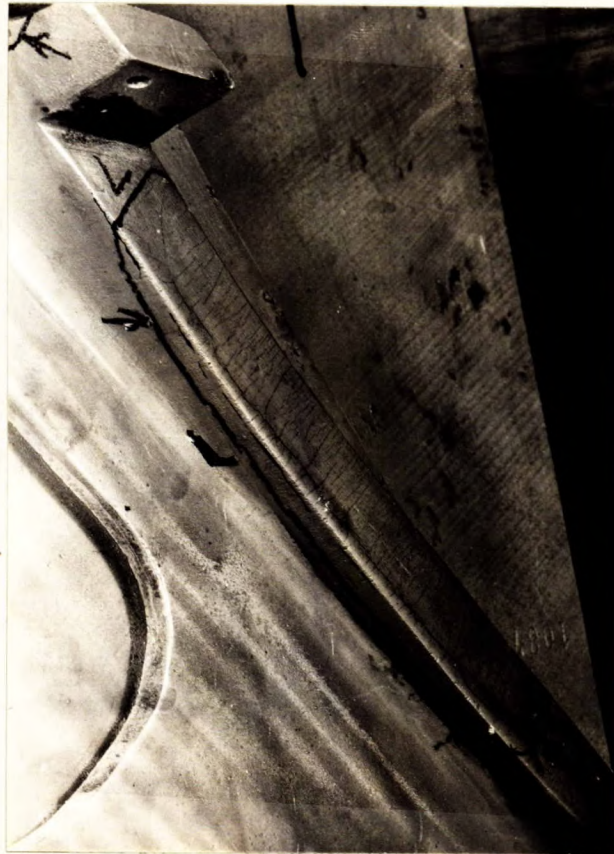
Figure 16.

The lower part of the column in region "L" is covered with stress patterns on the top surface and on the sides to nearly half the depth of the rib. This also proves the presence of eccentric compression load.

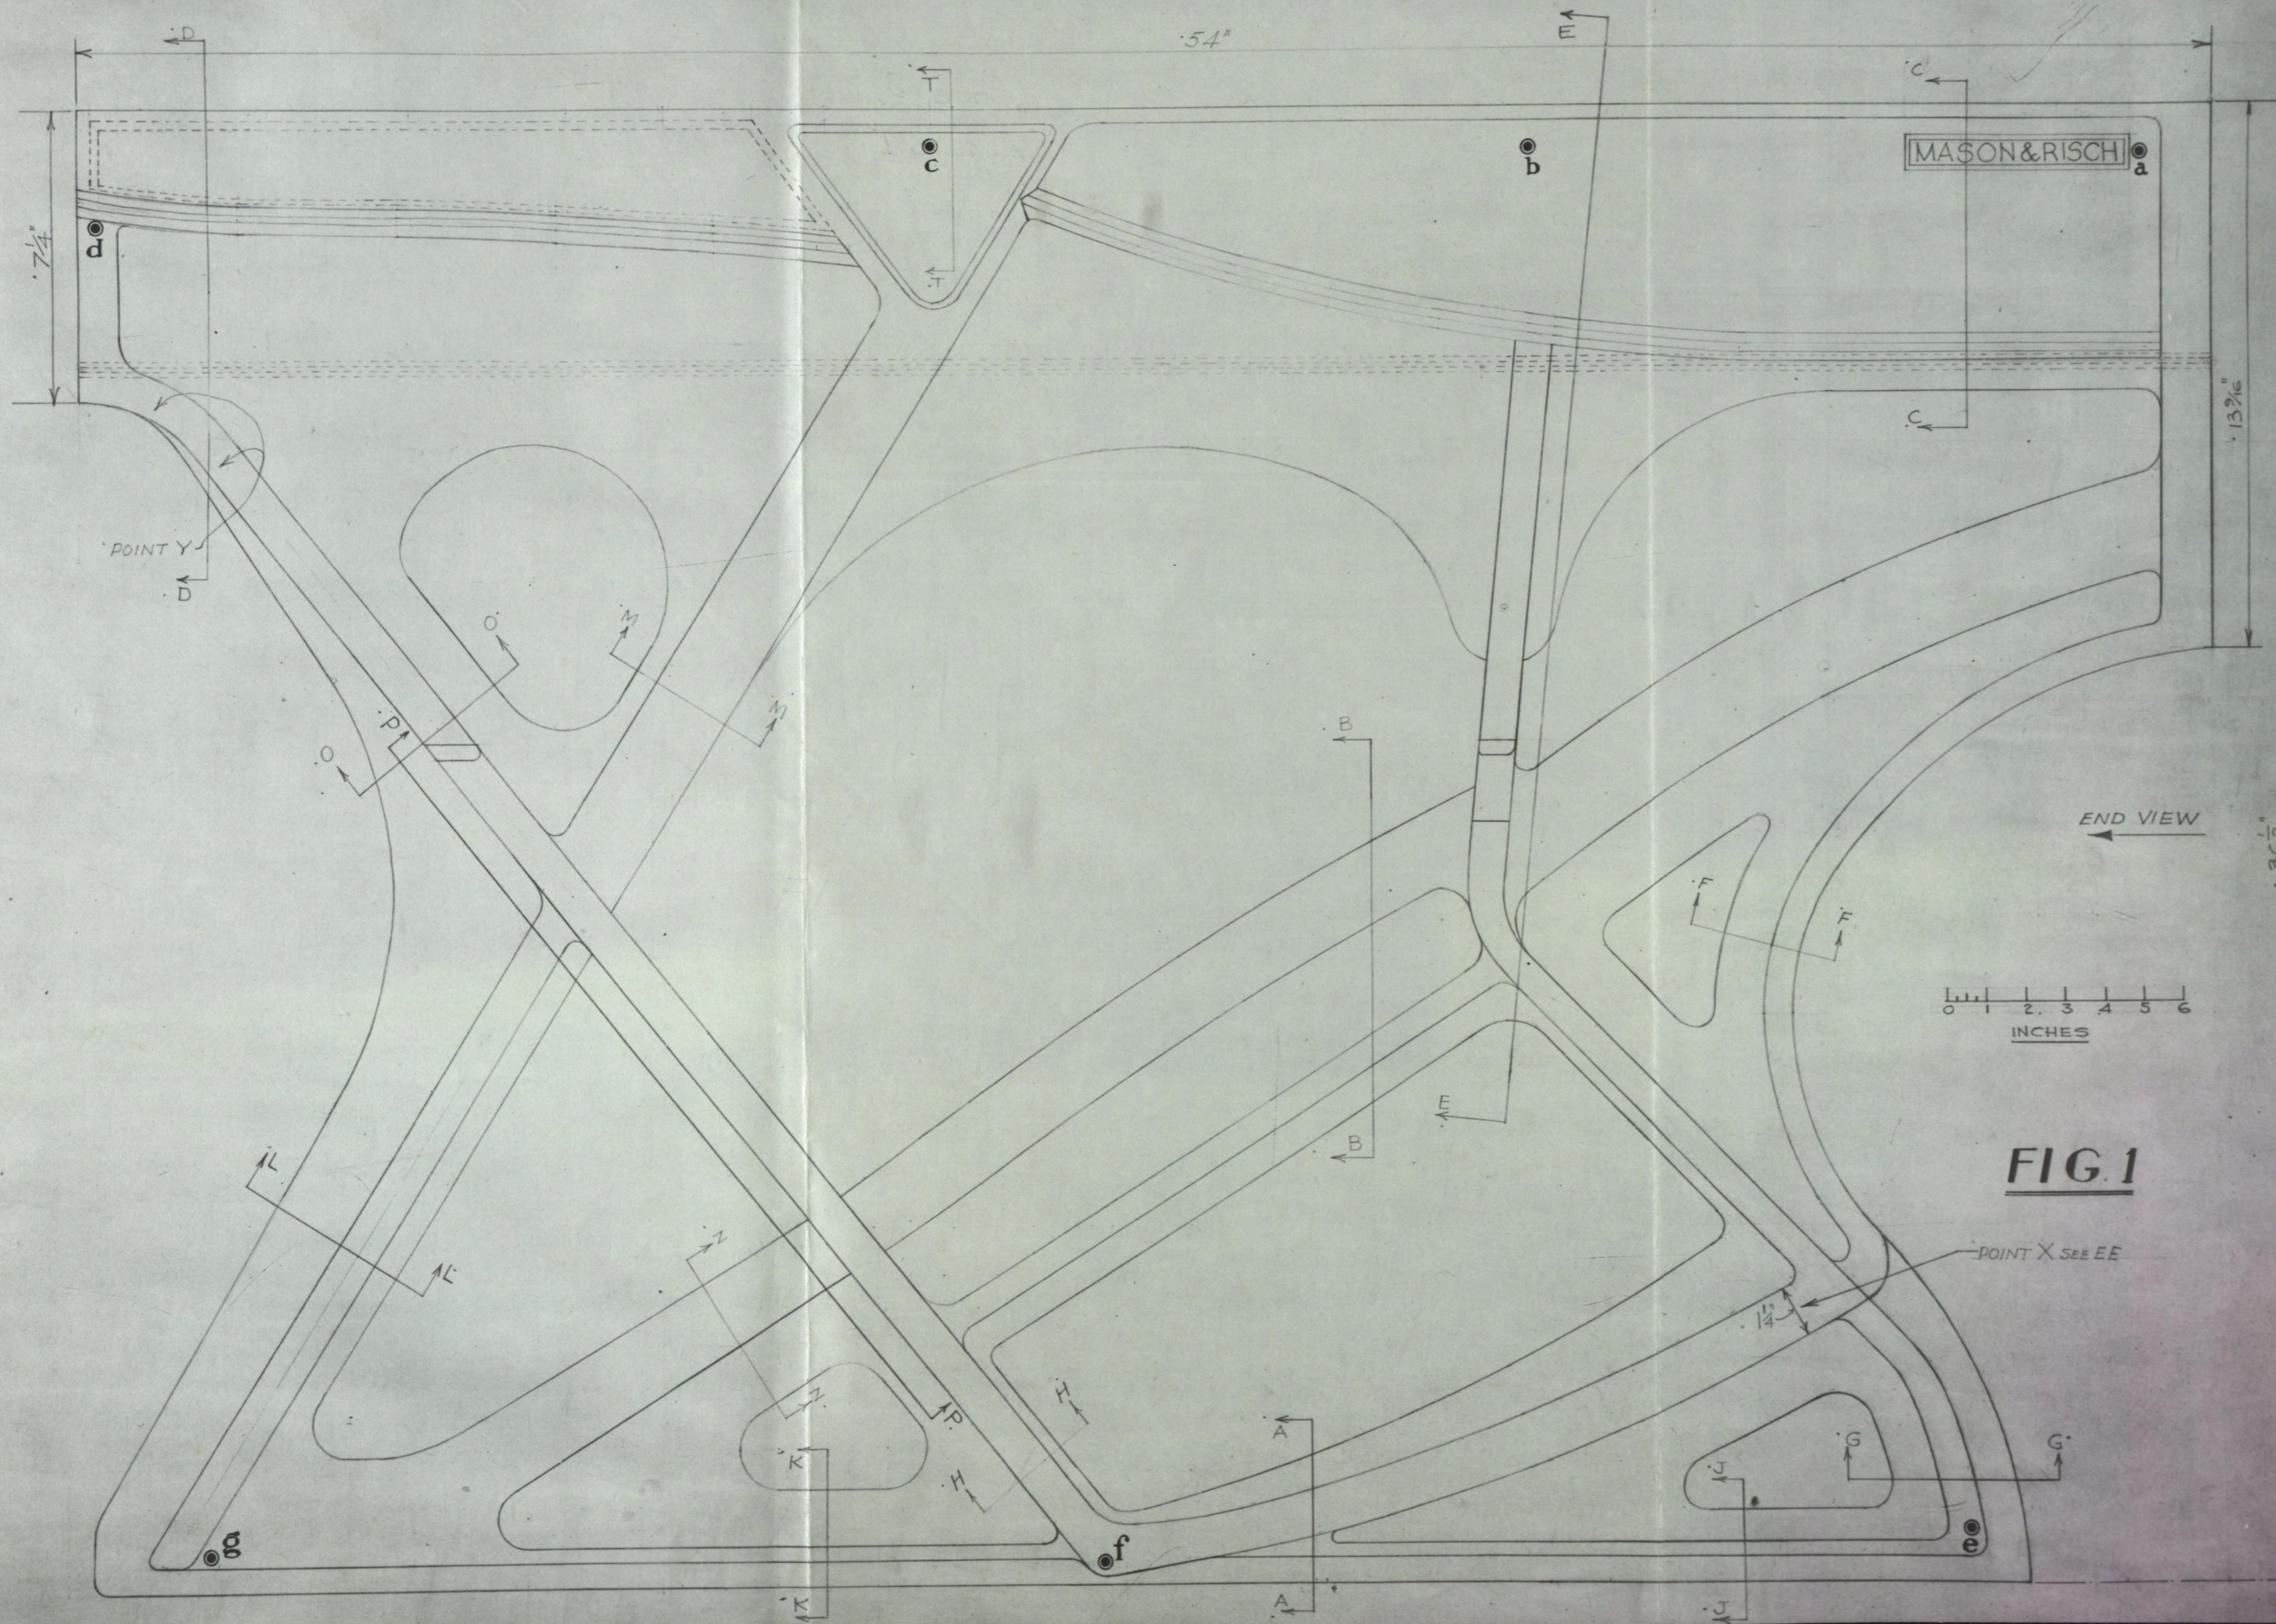
**FIG. 1**

To obtain some approximate information about the total dimensional changes, diagonal measurements were taken before and after tuning. These measurements were taken between seven points A, B, C, D, E, F, and G marked in Figure 1. The results are given in Table II.
