R E P O R T  
of the  
ORE DRESSING AND METALLURGICAL LABORATORIES.

Investigation No. 2064.

Metallurgical Examination of Manganese  
Steel Dipper Tooth Which Broke in Service

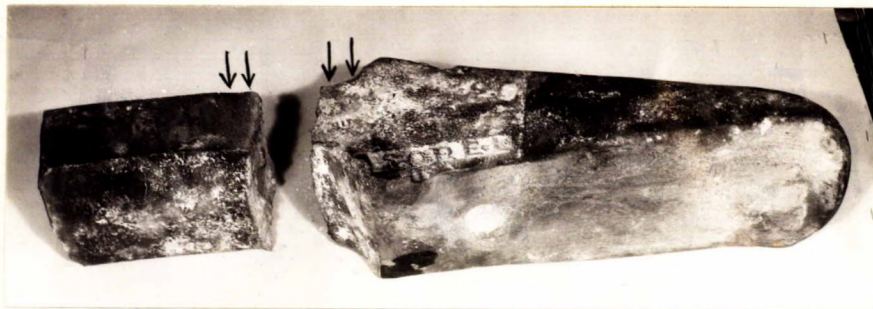
Figure 1.

BROKEN DIPPER TOOTH

Arrows point to numerous transverse cracks.

Visual examination revealed numerous transverse cracks on the upper surface of the tooth in the fillet area and running parallel with the failure.

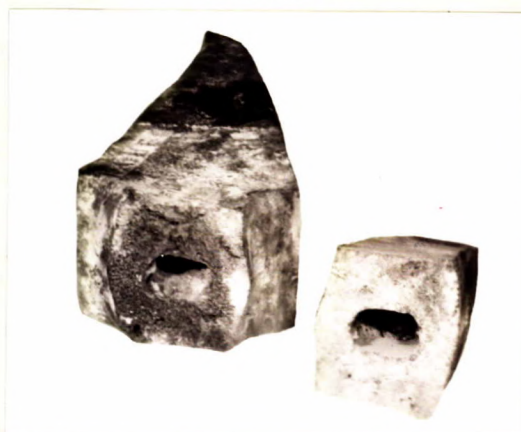
Figure 2.

BROKEN DIPPER TOOTH,

Showing Fracture.

Visual and microscopic examination revealed the presence of numerous transverse surface cracks occurring in the fillet area on the upper surface of the tooth adjacent to the fracture. It should be noted that all the cracks occur in a direction parallel to the fracture, and it appears certain that failure must have resulted from a continuation of one of these cracks. It is also significant that failure occurred at the fillet on the top surface, at an area of maximum stress. Because no cracks were found on the lower, opposite surface of the tooth, it would appear that the propagation of the cracks and subsequent failure resulted from the application in service of load conditions in excess of the yield strength of the steel.

1. Failure was most likely caused by the application in service of loads in excess of the yield and ultimate tensile strength of the metal.

1. It is recommended that consideration be given to changing the design of the tooth. There should be a greater thickness of metal in the fillet area, and the fillet radius should be made as great as possible.

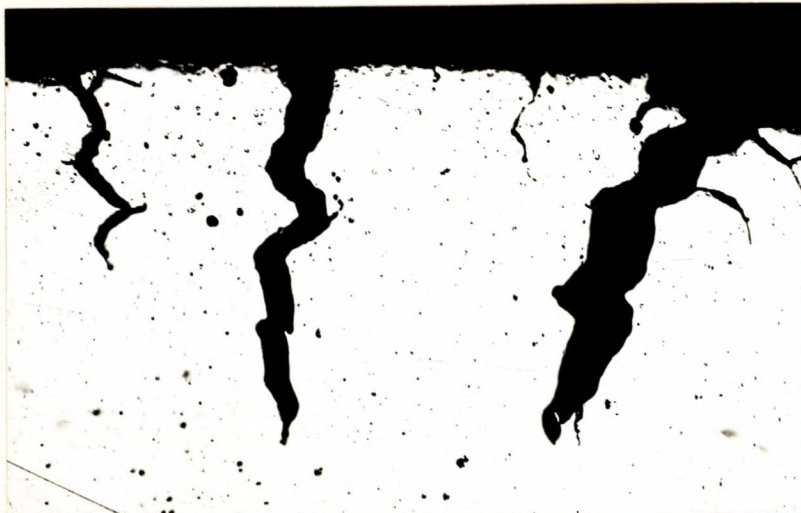
Figure 3.

Figures 3 and 4, taken at X50 and X100 magnifications respectively, show the typical transverse surface cracks occurring in the fillet area on the upper surface of the tooth adjacent to the fracture. Figure 4 illustrates the transcrySTALLINE nature of the cracks.

X50, unetched.

TYPICAL TRANSVERSE SURFACE CRACKS OCCURRING IN THE FILLET AREA ON UPPER SURFACE OF TOOTH ADJACENT TO THE FRACTURE.

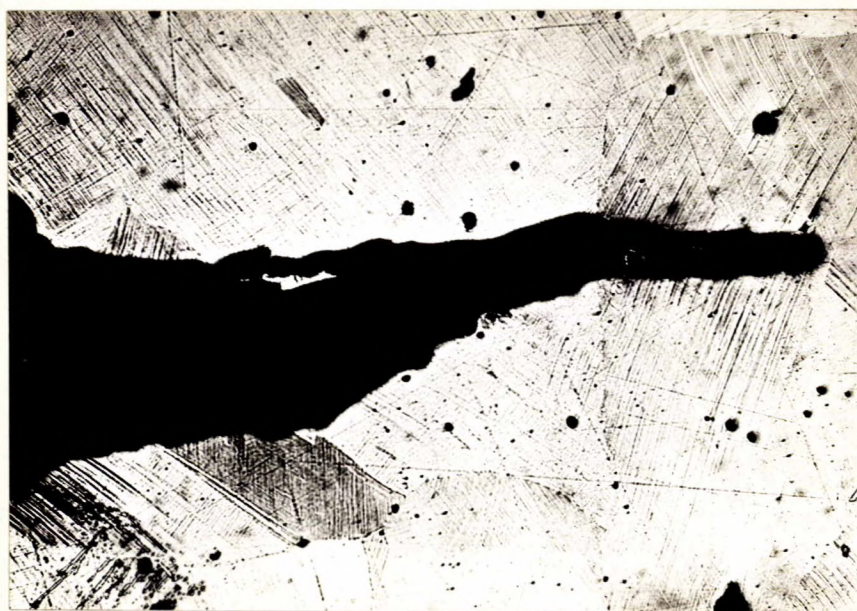
Figure 4.

X100, nital etch.

Note transcrystalline surface crack.

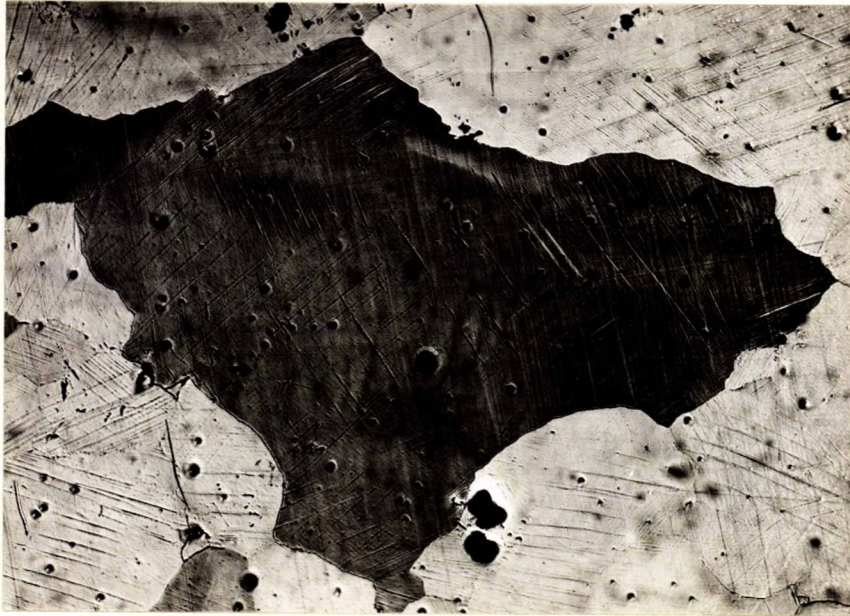
Figure 5.

Figure 5, taken at X50 magnification, indicates the large grain size resulting from high pouring temperature.

X50, nital etch.

LARGE GRAIN SIZE RESULTING FROM  
EXCESSIVE POURING TEMPERATURE

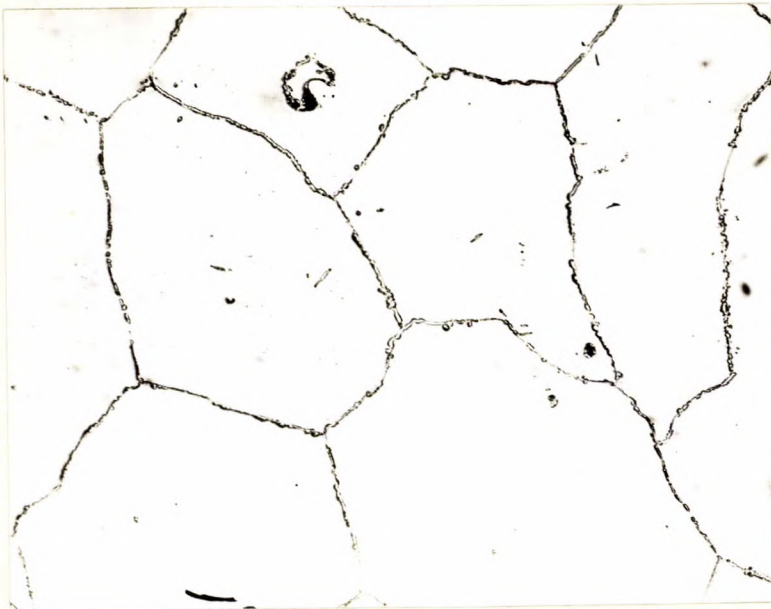
Figure 6.

Figure 6, taken at X100 magnification, shows brittle, intergranular excess carbides resulting from insufficient cooling rate. This condition is not representative of the structure of the steel in general.

The heat treatment was found to be satisfactory. Excess carbides, indicating insufficient cooling velocity, were found in one isolated case (See Figure 6). Since no carbides were noted in the areas where cracking occurred, little or no significance can be attached to this one isolated case.

X100, nital etch.

BRITTLE, INTERGRANULAR, EXCESS CARBIDES  
RESULTING FROM INSUFFICIENT COOLING RATE.

This is an isolated area and is not representative  
of all of the steel.

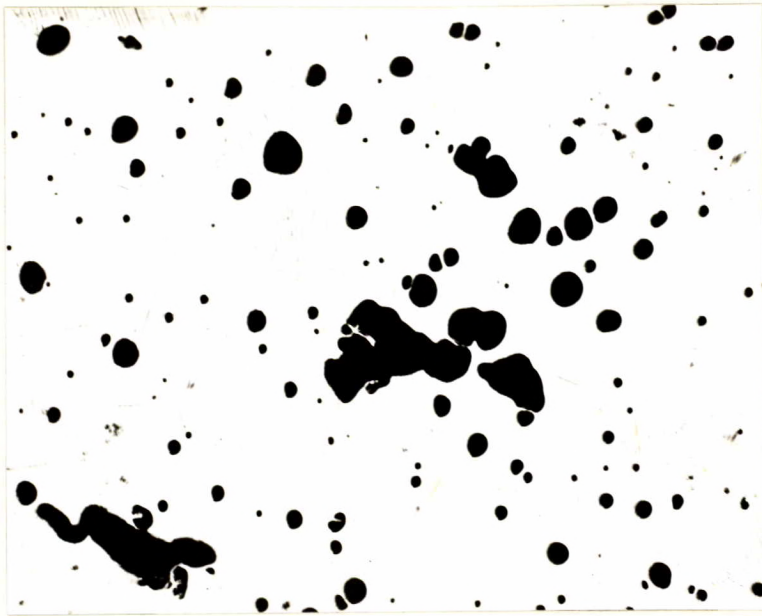
Figure 7.

Figure 7, taken at X50 magnification, shows porosity in the metal.

Casting porosity (See Figure 7) was also noted, but cannot be regarded as of much significance since a certain amount of porosity is to be expected.

X50, unetched.

CASTING POROSITY.
