R E P O R T
of the
ORE DRESSING AND METALLURGICAL LABORATORIES.

Investigation No. 2069.

Metallurgical Examination of Defec-
tive Steel Castings.

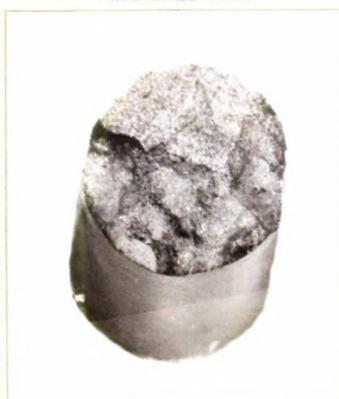
Figure 1.

TEST PIECE FRACTURE.
(Approximately twice
actual size.)

The appearance of the fracture is suggestive of high casting temperature which would result in a large austenite grain size. This large grain size would be obscured by the subsequent annealing operation, but the deleterious effect may, nevertheless, still be present.

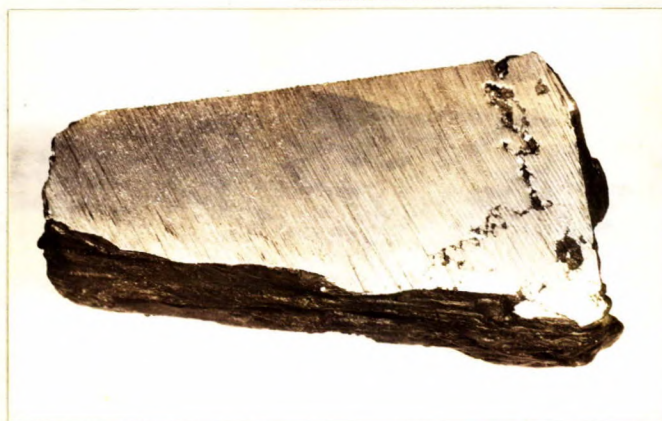
Figure 2.

On June 11, 1946, a sample of 0.40 per cent carbon steel casting which had cracked badly (see Figure 2) was also submitted for examination. The covering letter, dated June 7, contained the information that subsequent to the pouring of this casting the deoxidation practice had been altered.

CRACKED STEEL CASTING
SECTION.
(Approximately 1/2
actual size.)

The considerable depth of decarburization found existing along the cracked edge suggests that the crack most likely occurred while the casting was in the mould and that decarburization resulted during the subsequent annealing operation.

The letter also stated that cracking had been prevented by allowing the castings to remain in the sand for a minimum of 5 days before removal.

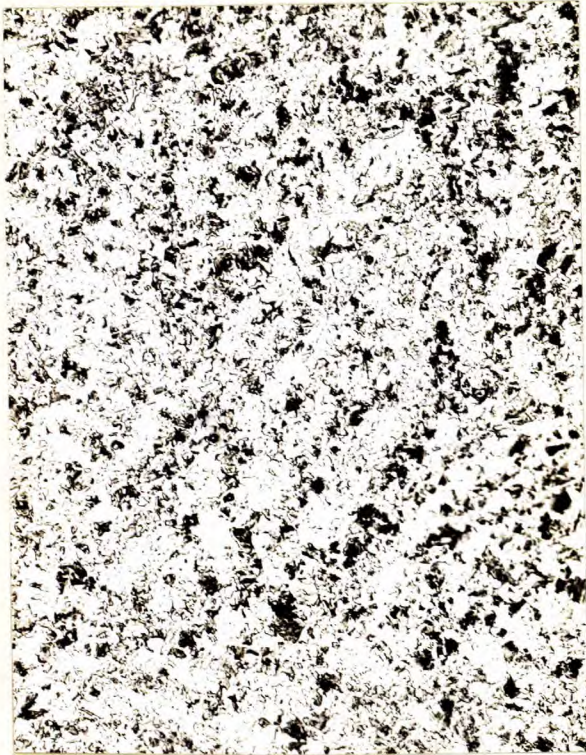
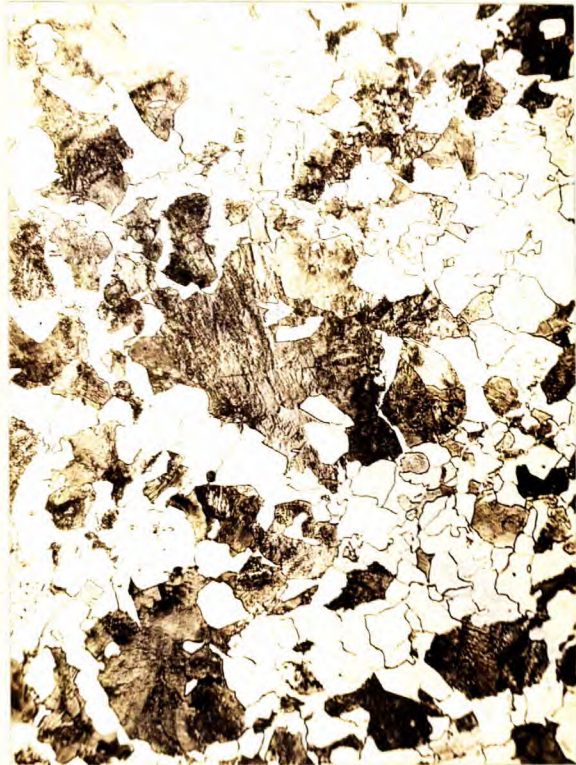
MICROSTRUCTURE OF TEST PIECE NO. 540.

Figures 3 to 8 show the microstructures of the test specimens at X50 and X250 magnifications.

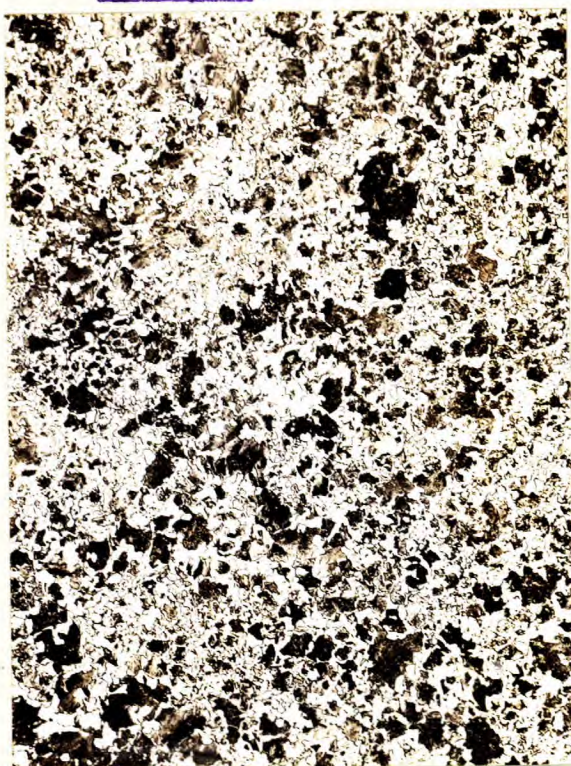
Figure 9.

Figures 9 and 10 show the microstructure of the cracked casting at X100 and X500 magnifications respectively.

MICROSTRUCTURE OF CRACKED CASTING.

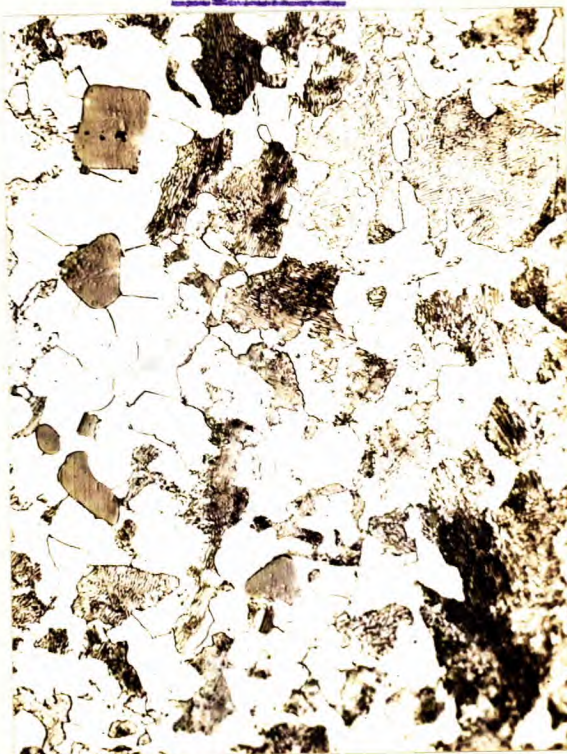
Figure 10.

Note the inclusions characteristic of this steel, probably manganese silicate.

Examination of the steels in the unetched condition revealed the presence of an unusually large quantity of non-metallic inclusions which appear to be manganese silicates (see Figure 10). Some of these inclusions seem to be arranged in such a way as to outline large grain boundaries, probably those of the original austenite grains. It is suggested that the presence of excessive quantities of these inclusions at the grain boundaries may be responsible for the low ductility and also the peculiar crystalline fracture. However, it is

Note: Manganese silicate inclusions.

In the light of the above statements it is felt that the low ductility may be accounted for by deoxidation and melting practice, and it is suggested that some changes, such as decreasing the aluminium content, might be tried. According to some authorities (see Reference 1), there is a critical amount of aluminium which will result in minimum ductility and impact resistance.

It is recommended that experiments be carried out to determine the effect of altering the deoxidation practice, such as decreasing the aluminium content. It is thought that

the reported use of three pounds of aluminium per ton
may be too high.

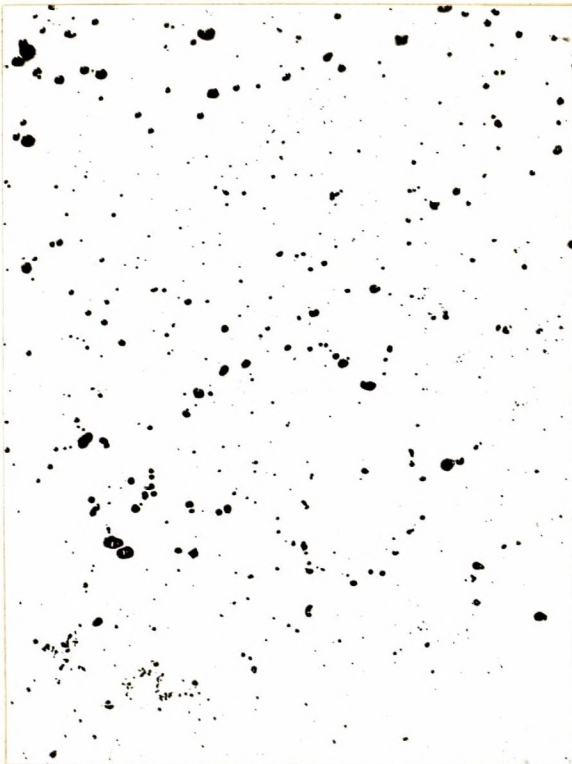
Figure 11.

Figures 11, 12 and 13 illustrate the degree of dirt or inclusions found in the test pieces and the cracked casting. The inclusions in some cases appear to outline large, original, austenite grains. This is shown in Figure 13.

SAMPLE NO. 540.

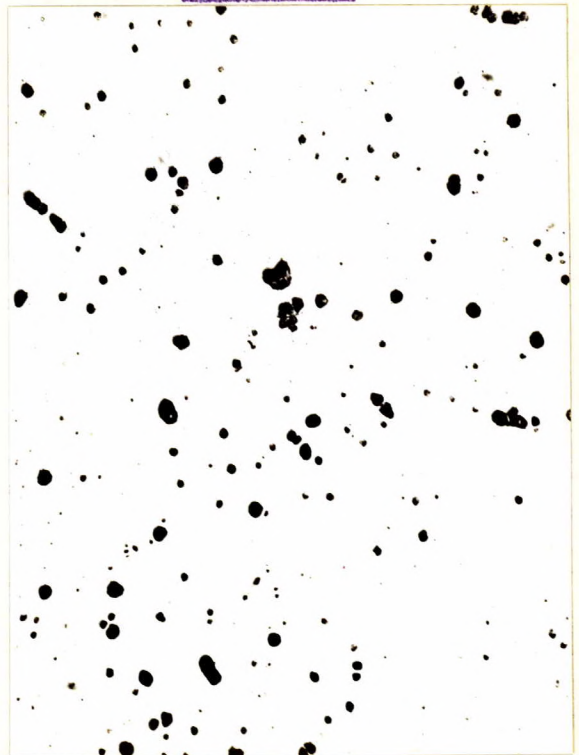
Figure 12.

Note excessive dirt in steel. Probably inclusions pulled out in polishing.

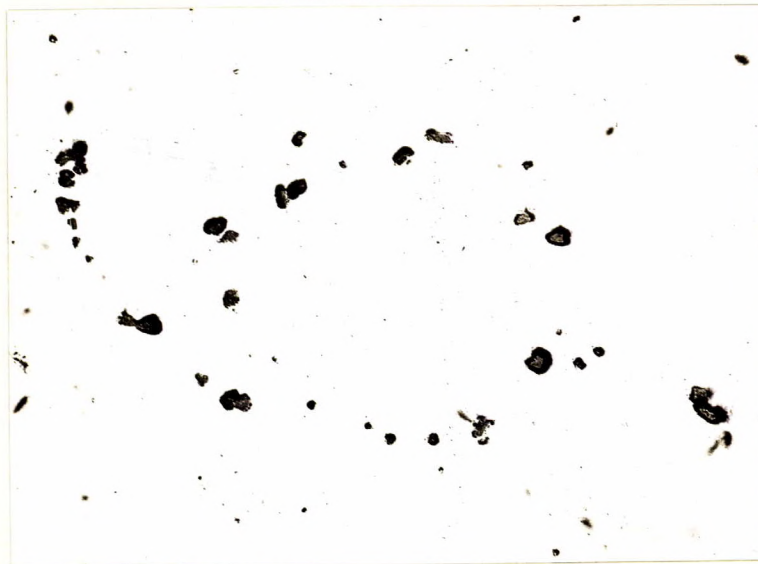
Figure 13.

Note non-metallic inclusions, partly pulled out during polishing, apparently outlining original austenite grain.

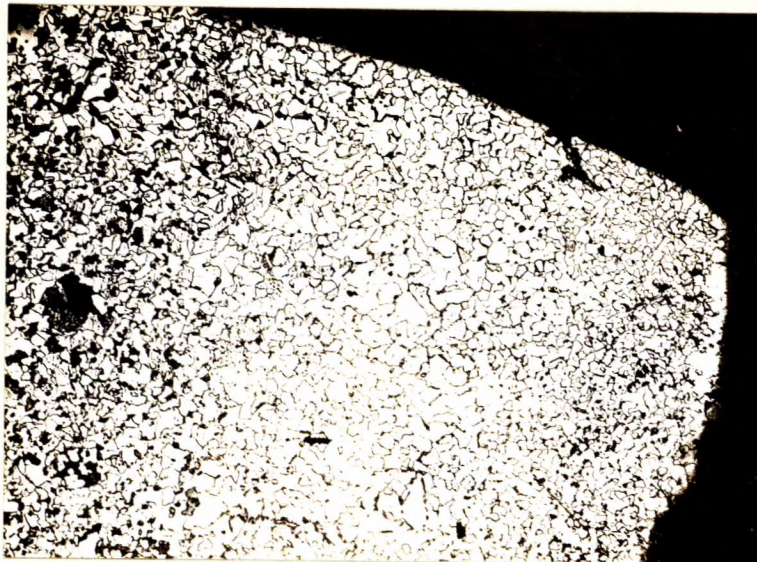
Figure 14.

Figure 14, taken at X100 magnification, clearly shows the depth of decarburization existing along the fractured edge of the cracked casting.

Showing depth of decarburization along
cracked edge.
