DEPARTMENT OF MINES AND RESOURCES  
BUREAU OF MINES  
CANADA

R E P O R T  
of the  
ORE DRESSING AND METALLURGICAL LABORATORIES.

Investigation No. 2072.

Investigation of Defects in Hot-Rolled Round.

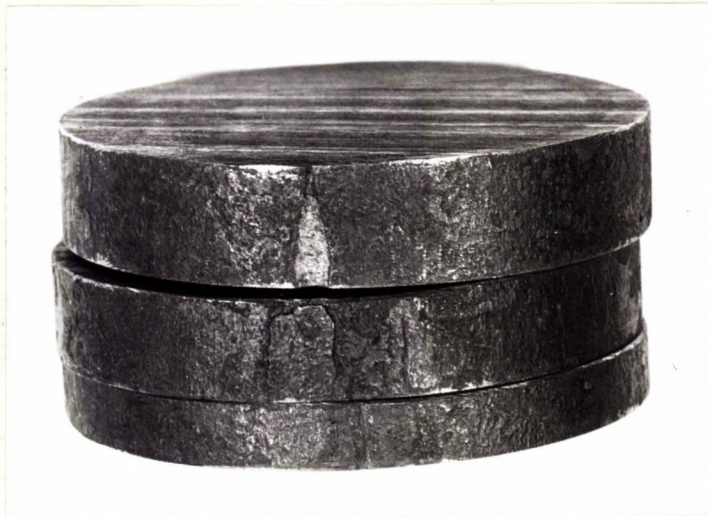
Figure 1.

Figure 1 is a photograph of the sections from the 2 $\frac{3}{4}$ " round, as received. Note the surface defects. Several such defects were visible and could be described as laps, folds or seams. The round was rolled from a 317-pound ingot, No. 4A. This ingot measured 46 inches in length with 5" and 5-7/8" square ends.

SECTIONS OF THE 2 $\frac{1}{4}$ " ROUND AS RECEIVED.

Note the visible surface defects.

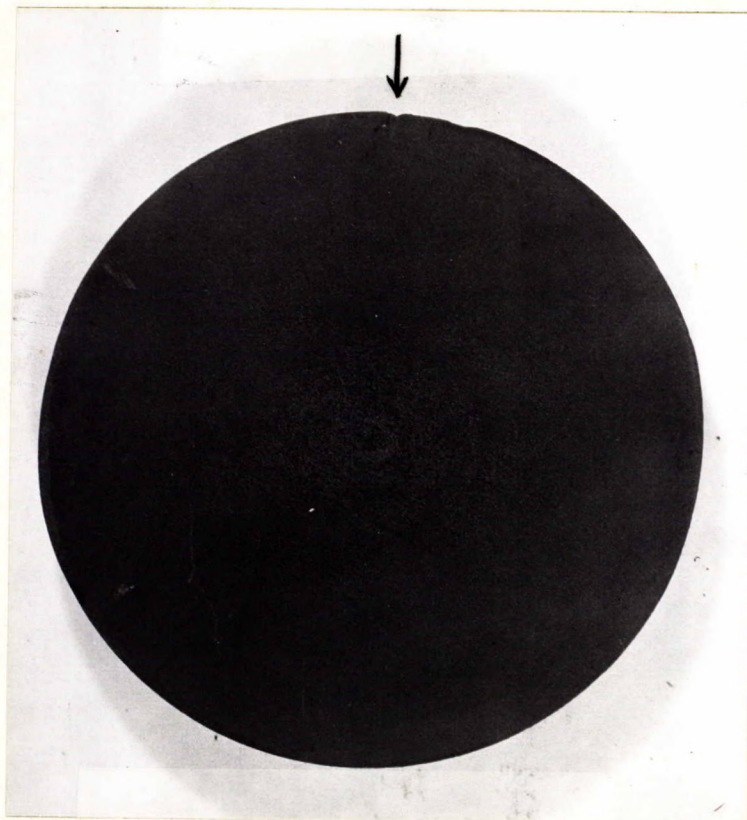
Figure 2.

A face of one section was ground to a smooth finish and the sample immersed in a 50 per cent HCl solution at 160° F. for 45 minutes. This treatment is used to reveal the presence of blowholes, cracks, porosity, or other evidence of internal unsoundness of the metal. Figure 2 is a photograph of the section after the hot HCl etch. With the exception of the surface lap noted, the round was sound, with no evidence of any unusual internal defects.

With the exception of the surface defects noted, the hot HCl test revealed a normal sound internal structure (Figure 2) with no evidence of internal cracks, porosity or blowholes.

TRANSVERSE SECTION OF ROUND AFTER ETCHING  
IN 50 PER CENT HCl AT 160° F. FOR 45 MINUTES.

Note the lap or fold.

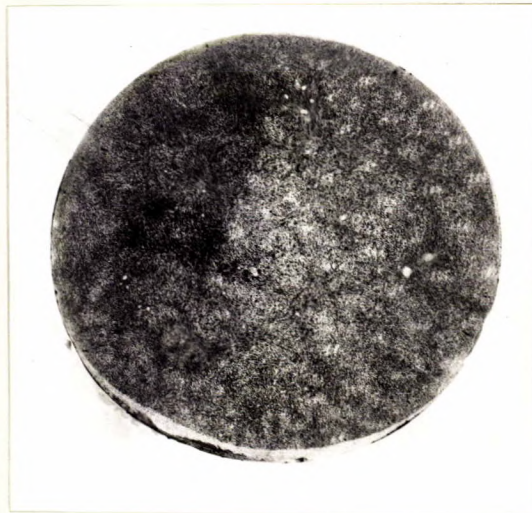
Figure 3.

relative distribution of the sulphides. The darker and heavier the marks, the more sulphur is present. A sulphur print was taken of the cross-section of the round and was photographed (see Figure 3).

The high sulphur content is counteracted by a high manganese content which reduces the sulphur to its least harmful form, manganese sulphide. Figures 3, 4, 5 and 6 substantiate this, while the photograph of the sulphur print, Figure 3, shows that there is uniform distribution of the sulphide inclusions. The sulphide inclusions with their lower melting point behave in the same manner as phosphorus, in solidifying later towards the centre of the ingot and acting as nuclei in the formation of ferrite. This explains the banded structure of ferrite and pearlite in the rolled product (see Figure 4). Ductility and impact resistance, compared with a more uniform structure, is decreased by this banding. The sulphide inclusions are distributed uniformly and would improve the machinability of the steel. However, their influence as stress raisers is well known and, under certain service conditions, this should be considered. In addition, if welding is used during industrial fabrication, these sulphide inclusions may act as a source of difficulty in producing porosity-free welds, particularly if the concentration of sulphur is high or if there is undue segregation.

PHOTOGRAPH OF SULPHUR PRINT.

Note the uniformity of distribution of the manganese sulphide inclusions.

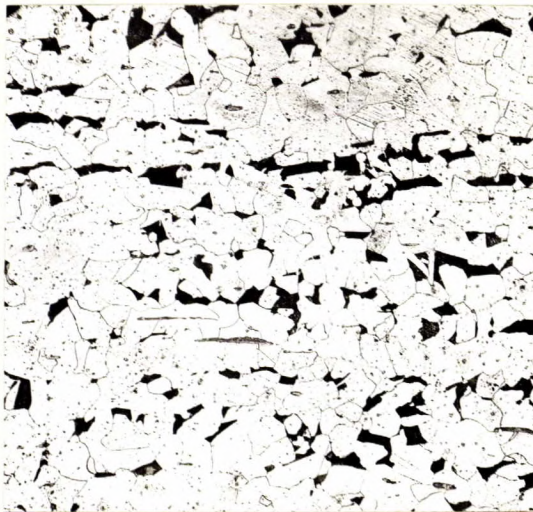
Figure 4.

X100, nital etch.

TYPICAL LONGITUDINAL STRUCTURE.  
Normal banded ferrite and pearlite structure with inclusions in the ferrite bands.

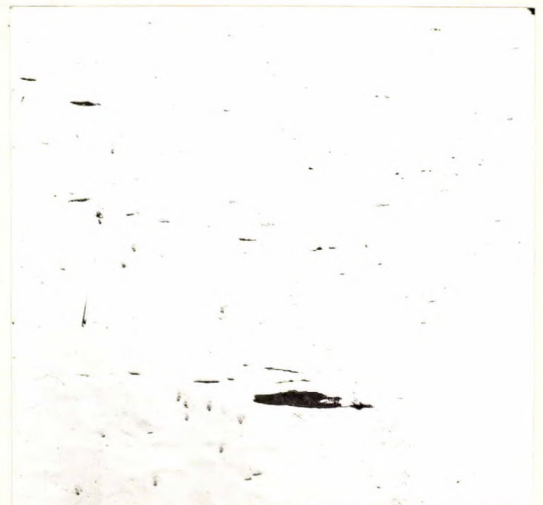
Figure 5.

X100, Unetched.

MANGANESE SULPHIDE INCLUSIONS  
TYPICAL OF A LONGITUDINAL  
SECTION.

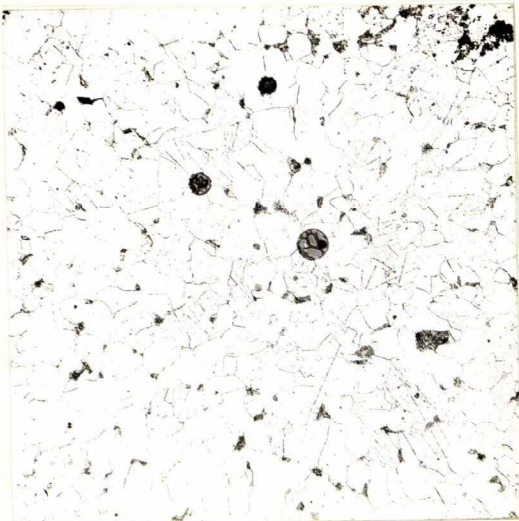
Figure 6.

X100, nital etch.  
TRANSVERSE AREA.  
Note the oxide inclusions.

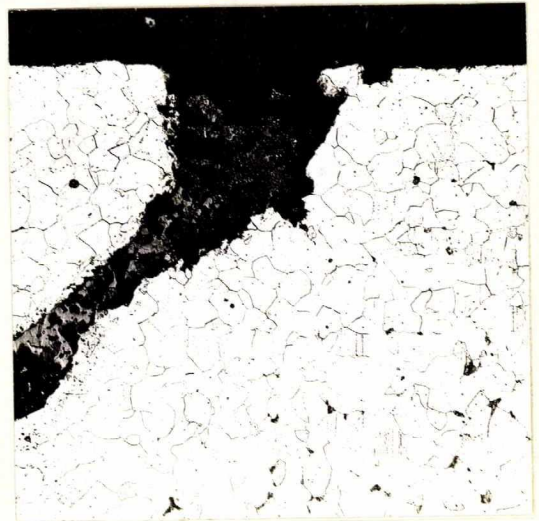
Figure 7.

The most serious defects noted were the laps, folds and seams on the surface of the round. (See Figures 7, 8 and 9. Decarburization and oxide inclusions, which are characteristic of such defects, are clearly evident.) These defects were the cause of the rejection of the round. Their origin can be either in the mould or in the rolling mill. There was no

With a cleaned ingot, further difficulties might be encountered on rolling, because of a poorly designed pass and/or misalignment of the rolls. Too rapid a reduction for a section entering a pass would cause a folding or lap on the surface which would remain unwelded during rolling.

X100, nital etch.  
UNWELDED FOLD OR LAP AT  
THE SURFACE.  
Note the decarburization.

evidence of dirt inclusion or rolled-in brick in the samples examined. If the ingots are being fouled through roof spalling of the reheating furnace, steps should be taken to eliminate this source of contamination. Fouling of the mould or the molten steel can be readily eliminated by greater care in these particular steps.

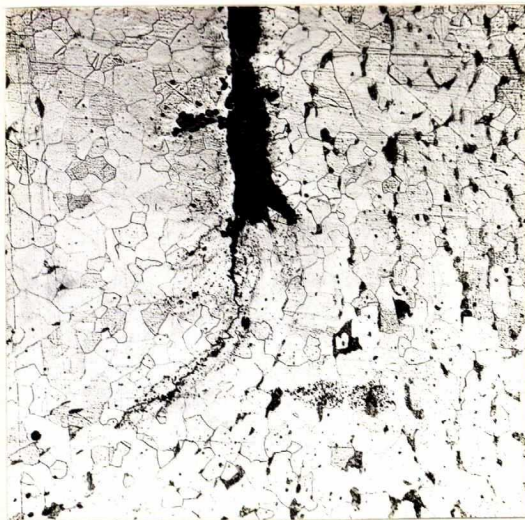
Figure 8.

X100, nital etch.  
TERMINATION OF UNWELDED LAP  
OR FOLD.  
Note decarburization and oxide  
inclusions.

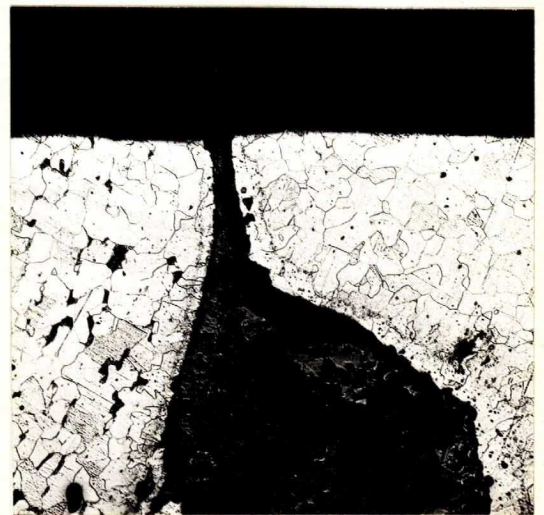
Figure 9.

X100, nital etch.  
SMALL BLOWHOLE NEAR THE  
SURFACE.
