R E P O R T  
of the  
ORE DRESSING AND METALLURGICAL LABORATORIES.

Investigation No. 2076.

Metallurgical Examination of a Defective  
Cylinder Head Casting.

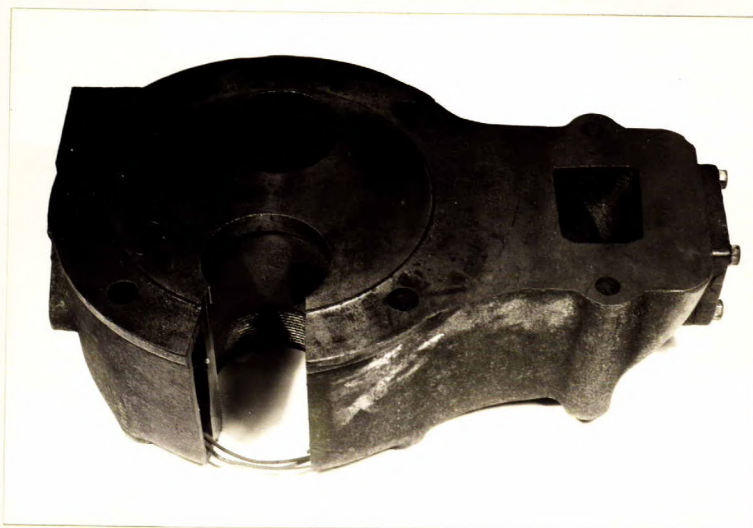
Figure 1.

The area of the casting which had exhibited leakage had been indicated with blue chalk. Three sections, approximately  $\frac{1}{2}$  inch in thickness, were cut from this area. Figure 1 is a photograph of the cylinder head with these sections removed. No visual evidence of any defect was found and hence two additional sections were cut from the casting. Figure 2 is a photograph of the casting with all five sections removed. Figure 3 is a photograph of Sections Nos. 4 and 5. There was definite evidence of porosity in Section No. 5 at the area indicated (see Figure 8 also).

PHOTOGRAPH OF DEFECTIVE CASTING.

(Sections Nos. 1, 2 and 3 are removed from porous area.)

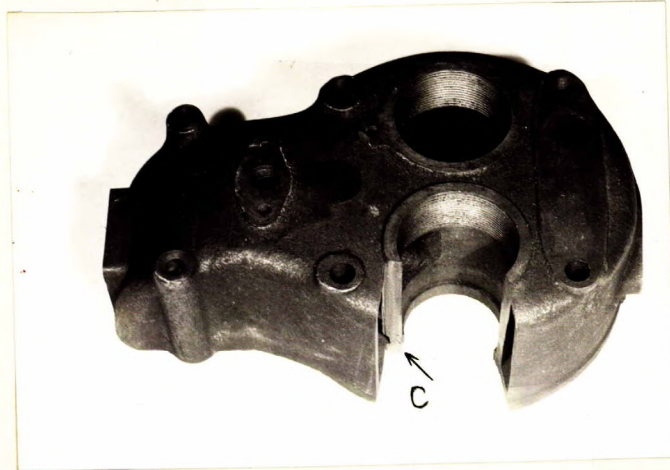
Figure 2.

SAME AS FIGURE 1.

(Sections Nos. 1, 2, 3, 4 and 5 removed.)

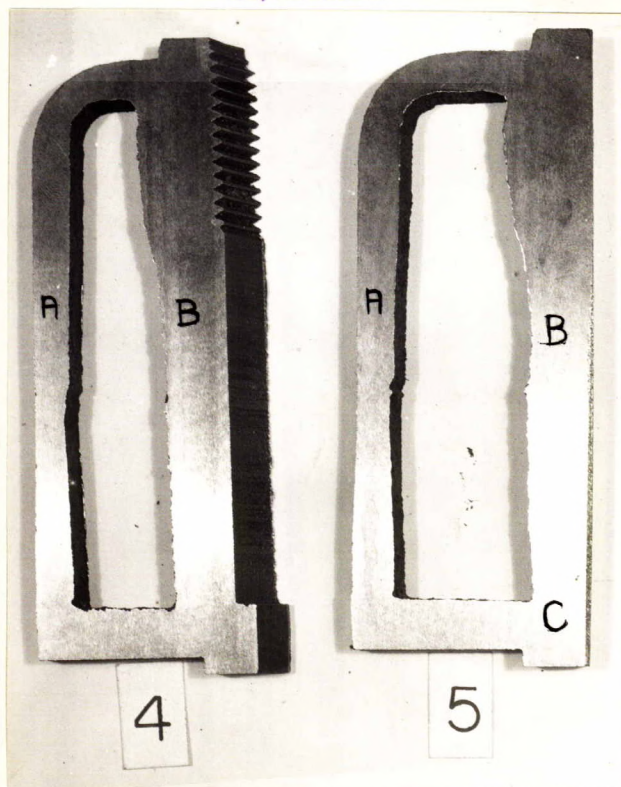
Figure 3.

PHOTOGRAPH OF SECTIONS NOS. 4 and 5,  
SHOWING LOCATION OF MICRO SAMPLES.

(Compare with radiographic print, Figure 8)

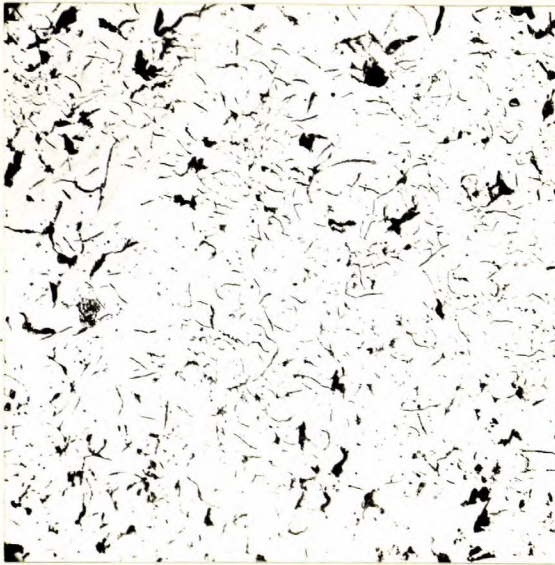
Figure 4. - Sample "A", unetched, X100, showing size and distribution of graphite flakes. Pattern corresponds to A.S.T.M. Classification Size 6, Type A.

X100, unetched.

SIZE AND DISTRIBUTION OF GRAPHITE  
FLAKES IN SAMPLE "A".

Pattern corresponds to A.S.T.M.  
Classification Size 6, Type A.

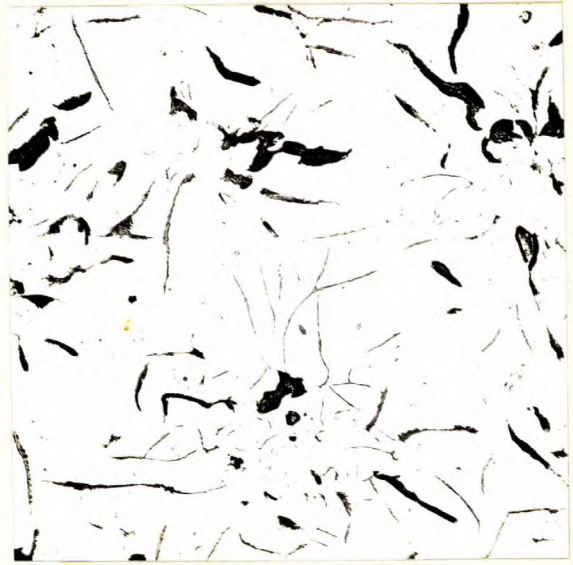
Figure 5. - Sample "B", unetched, X100, showing size and distribution of the graphite flakes. Pattern corresponds to A.S.T.M. Classification Size 4, Types A and B.

X100, unetched.

SIZE AND DISTRIBUTION OF GRAPHITE  
FLAKES IN SAMPLE "B".

Pattern corresponds to A.S.T.M.  
Classification Size 4, Types  
A and B.

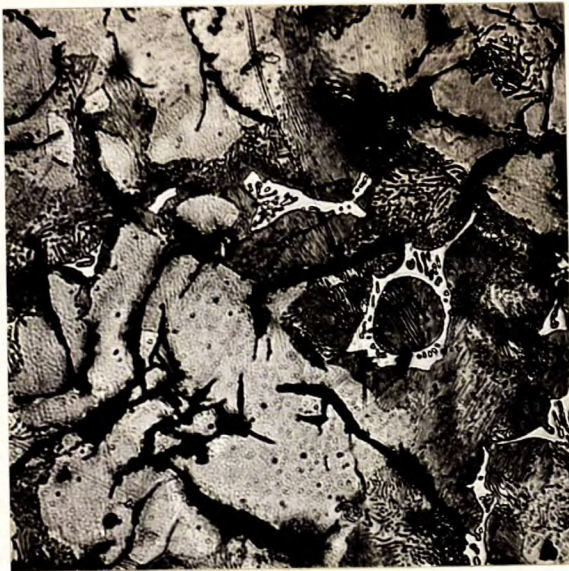
Figure 6. - Sample "A", nital etch, X500, normal structure of graphite, ferrite, pearlite and steadite (phosphide eutectic).

The microscopic examination, with the exception of the defects noted, revealed a normal pearlite grey iron structure (see Figures 6 and 7). The presence of ferrite in the outer web of the section examined is indicative of a slower cooling rate in that part of the casting. The size and distribution of the graphite flakes (see Figures 5 and 6) correspond to A.S.T.M. Classification Size 4-6, Type A-B, and are considered normal.

X500, nital etch

NORMAL STRUCTURE, SAMPLE "A".

Graphite, ferrite, pearlite and  
steadite (phosphide eutectic).

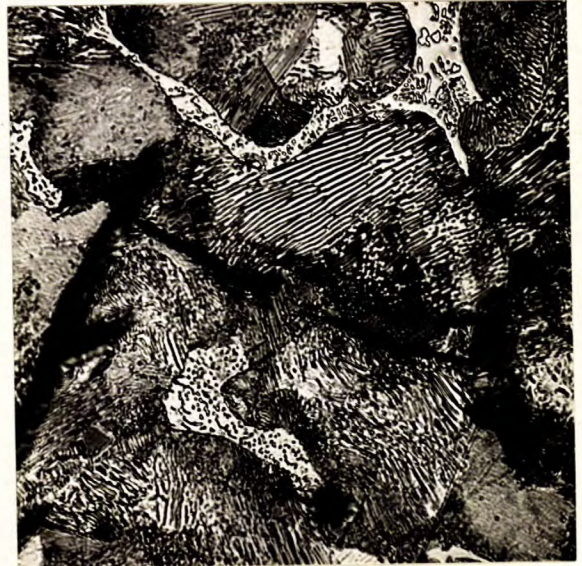
Figure 7. - Sample "B", nital etch, X500, normal structure of graphite, pearlite and steadite (phosphide eutectic).

X500, nital etch.

NORMAL STRUCTURE, SAMPLE "B".

Graphite, pearlite and stead-  
ite (phosphide eutectic).

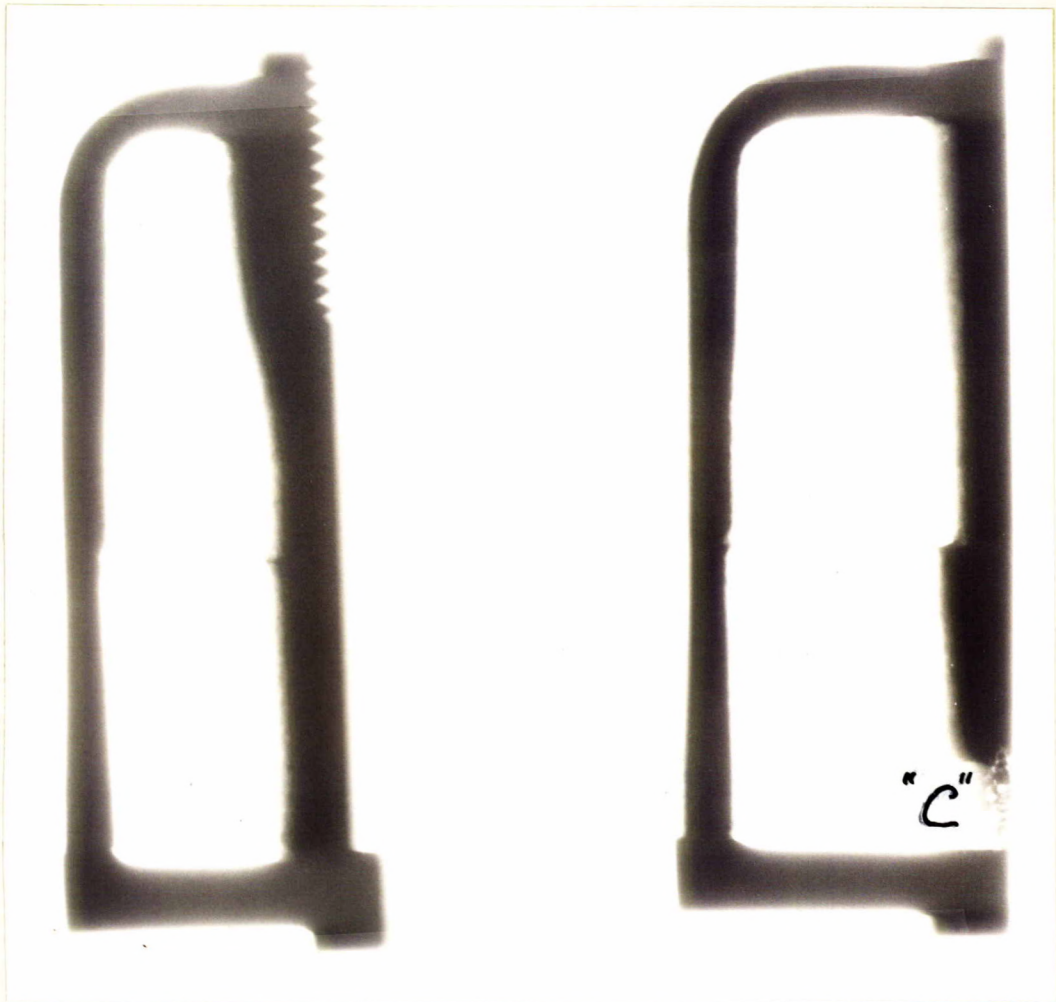
Figure 8.

Sections Nos. 4 and 5. "Porosity: some, more than can be expected for sound metal - particularly throughout relatively thin section bounding the core. Shrinkage: in toothed side near core surface about the centre of one specimen (Section No. 5). Piping: (Section No. 4) on the same side running from the square corner for  $\frac{1}{2}$  inch - quite severe, penetrating this wall completely in several places - apparently originated in the core side."

Fine detail ordinarily visible in a radiograph against the light is generally lost in printing. For this reason, the fine microporosity in Sections Nos. 2 and 3 is lost in printing, and hence no radiographic print of these sections is included. Figure 8 is a print of the radiograph of Sections Nos. 4 and 5 in which defects are clearly evident.

The most serious defects noticed were the porosity and shrinkage revealed by the sectional radiographic examination of Sections Nos. 4 and 5 (see Figure 8). Figures 9, 10 and 11 are photomicrographs of the porous area "C".

5. The porosity observed in Figures 8, 9, 10, 11 and 12 is probably due to metal shrinkage. Lacking details of gating, pouring, etc., it is not possible to state what remedial measurements should be taken, other than close attention to operational details.

RADIOGRAPHIC PRINT OF SECTIONS NOS. 4 and 5.  
(COMPARE WITH FIGURE 3.)

Note shrinkage cavities at area "C".

difficult to say what part these important variables had in causing shrinkage cavities and porosity. Careful check should be kept continuously on such variables as:

Pouring temperature.	Core hardness.
Pouring time.	Permeability of mould and core metal runout.
Mould temperature.	Shrinkage property of the iron.
Mould hardness.

It is well known that thin sections draw molten metal away from thick sections, resulting in porosity and voids in the latter unless precautions are taken. Chilling would overcome this but, more important, proper gating and feeding are necessary to arrive at the desired directional solidification of the casting.

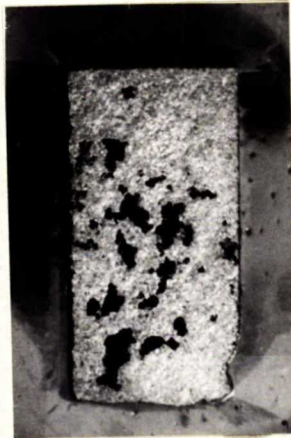
Figure 9. - Photograph of the porous area "C" from Section No. 5. Approximately X9.

PHOTOGRAPH OF MOUNTED SAMPLE, AREA C,  
SHOWING POROSITY.

(Approximately 9 times actual size).

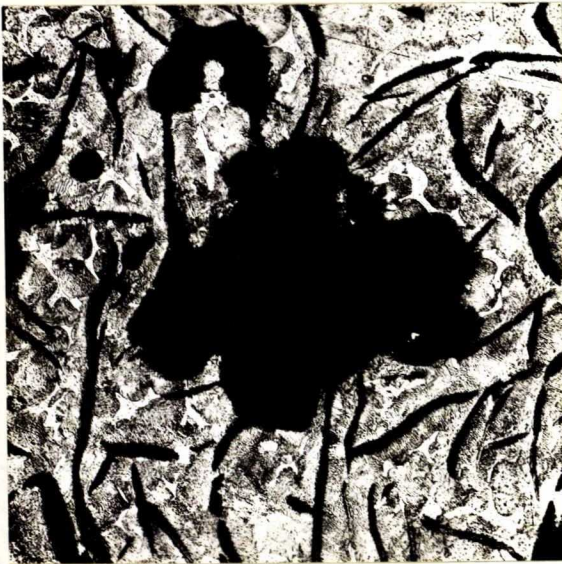
Figure 10.

Figures 10 and 11. - Sample "C", nital etch, X100, photomicrographs of porosity and shrinkage cavities.

X100, nital etch.

SHOWING NATURE OF THE CAVITIES  
OF AREA "C".

Note the small round cavity,  
evidence of gas porosity.

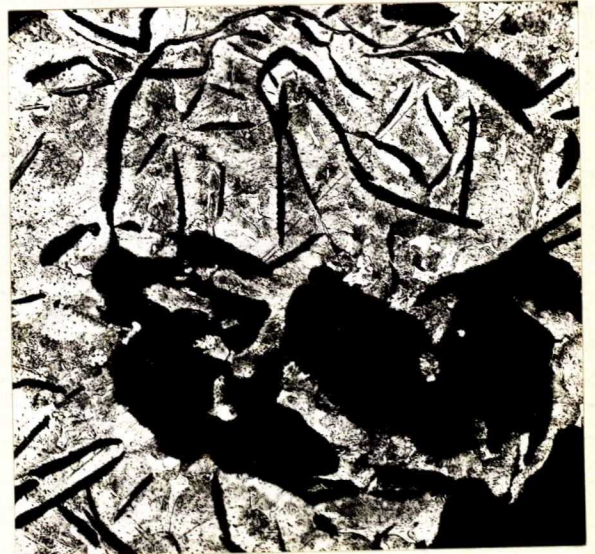
Figure 11.

X100, nital etch.

SAME AS FIGURE 10.

Cavities believed to be  
due to shrinkage.
