ORE DRESSING AND METALLURGICAL LABORATORIES.

Investigation No. 2085.

Metallurgical Examination of Defective Steel Casting.

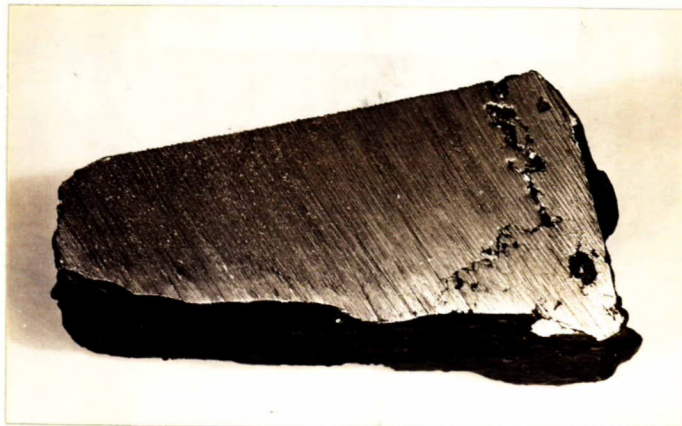
Figure 1.

On June 11, 1946, William Kennedy & Sons Limited, Owen Sound, Ontario, per M. W. Hollands, metallurgist, submitted for metallurgical examination, a sample of 0.40 per cent carbon steel casting which had cracked badly in the mould. (see Figure 1). This casting was typical of a series of medium carbon-steel castings which showed unusually low ductility even after careful annealing. A metallurgical examination was made and reported in Investigation No. 2069, dated June 26, 1946.

SECTION OF CRACKED STEEL CASTING.

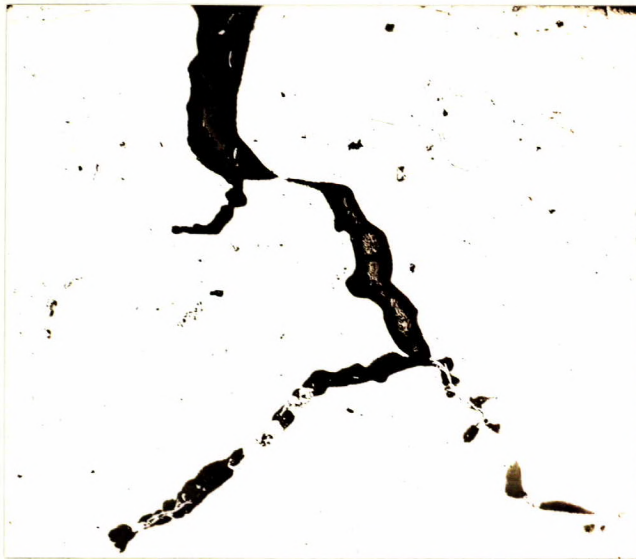
Figure 2.

Figure 2, taken at X30 magnification shows a crack found in a tensile bar after breaking in the tensile machine. The crack was found at the surface and appears to be inter-crystalline.

CRACK IN TENSILE BAR AFTER TENSILE TEST. CRACK EXTENDS INWARDS FROM THE SURFACE AND APPEARS TO BE INTERCRYSTALLINE.

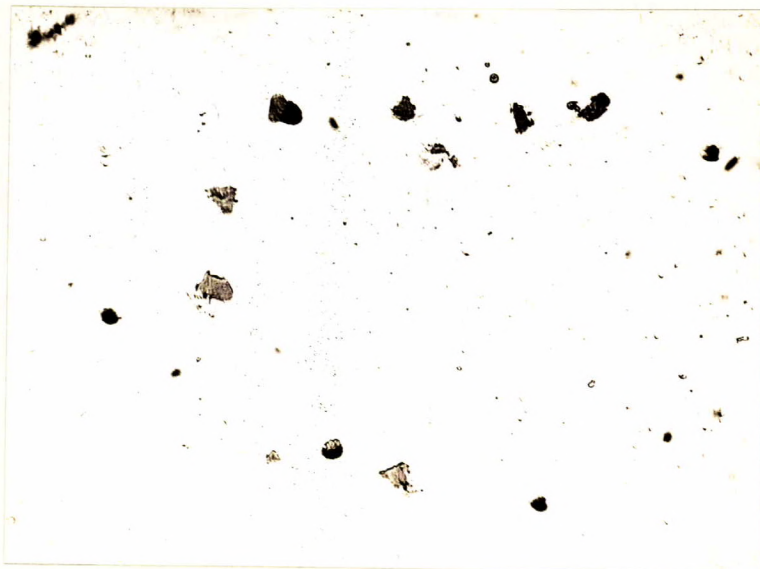
Figure 3.

Figures 3, 4 and 5 taken at X250 magnification show typical inclusions found in the steel. The inclusions in Figure 3 appear to surround a large austenite grain.

Since the writing of Investigation No. 2069, it has been learned that a similar problem had been encountered in another steel foundry, and it was recognized that very low ductility was caused by the presence of grain-boundary inclusions, which were due to faulty deoxidation practice. In each case, where low ductility occurred, it was found that the aluminium had not reached the steel but had been burnt off at the top. High ductility was obtained by increasing the quantity of aluminium and by taking special precautions to ensure complete immersion of the aluminium.

INCLUSIONS IN STEEL CASTING. INCLUSIONS APPEARS TO OUTLINE A LARGE AUSTENITE GRAIN.

1. It is recommended that special precautions be taken to ensure complete immersion of the aluminium in the molten metal.

2. The effect of increasing the aluminium content to 4 pounds per ton should be determined.
3. A study of the melting practice should be made to determine the existence of any deviations from the normal standard practice.

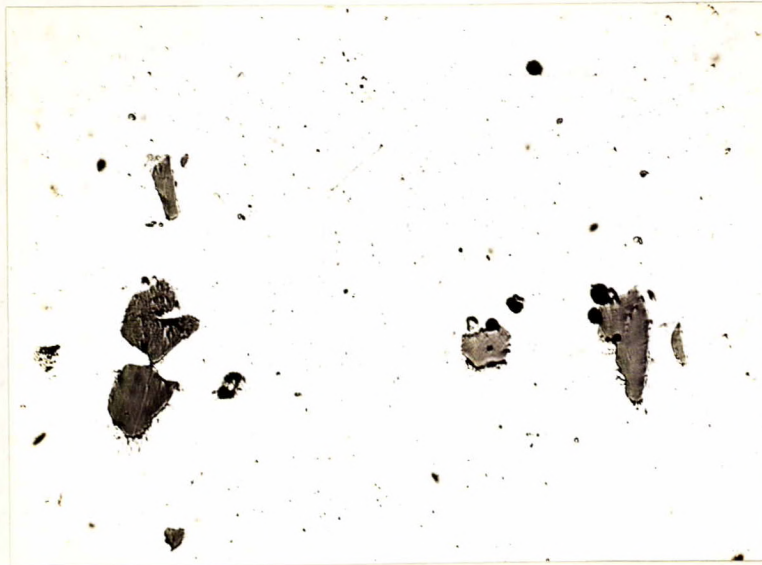
Figure 4.

TYPICAL INCLUSIONS FOUND IN THE STEEL.
(PROBABLY MANGANESE SILICATE WITH SMALL
DARK ALUMINA PARTICLES).

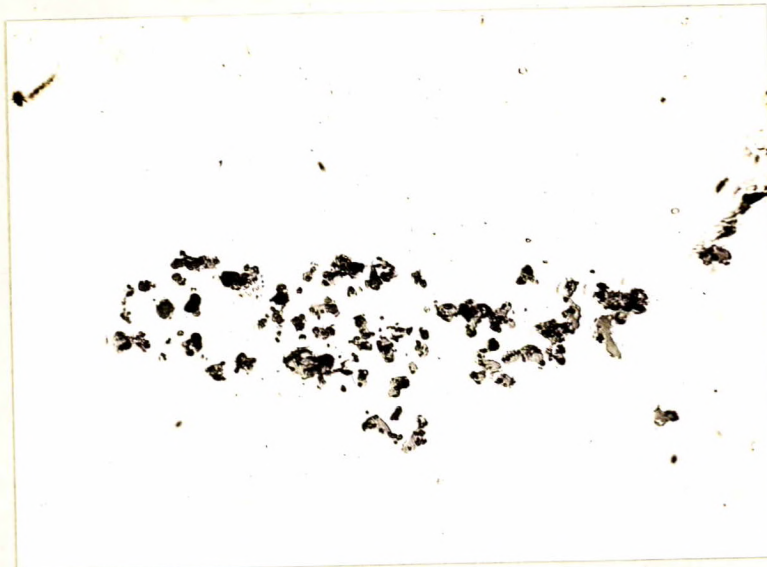
Figure 5.

TYPICAL INCLUSION CLUSTERS
FOUND IN THE STEEL. (PROBABLY
MANGANESE SILICATE ASSOCIATED
WITH ALUMINA).
