DEPARTMENT OF MINES AND RESOURCES
BUREAU OF MINES
CANADA

R E P O R T
of the
ORE DRESSING AND METALLURGICAL LABORATORIES.

Investigation No. 2094.

Metallurgical Examination of Sound and
Broken Malleable Castings.

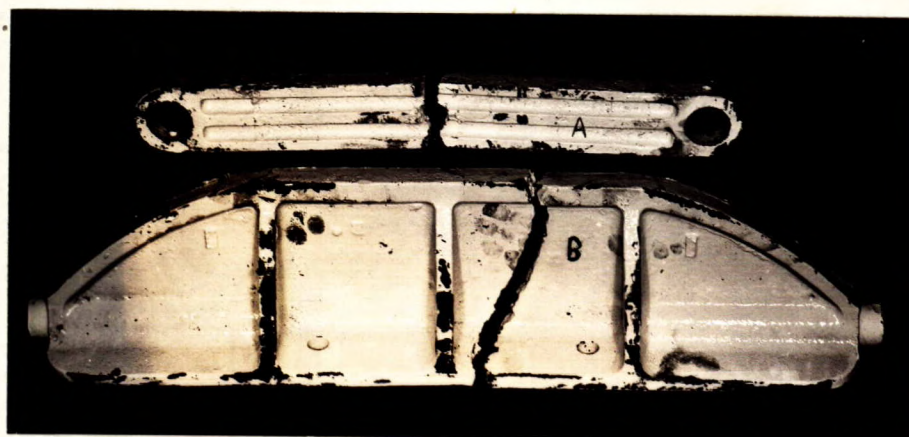
Figure 1.

On July 12, 1946, the Brantford Coach and Body Limited, Brantford, Ontario, per F. W. Knechtel, production manager, submitted for metallurgical examination some broken malleable castings (see Figure 1) as well as some satisfactory castings. The covering letter dated July 8, 1946, stated that the castings painted white which were of recent pour were representative of many which had broken prematurely, whereas those painted black are of pre-war quality and were found to be satisfactory. A metallurgical examination was requested in order to determine the possible cause of failure.

BROKEN MALLEABLE CASTINGS.

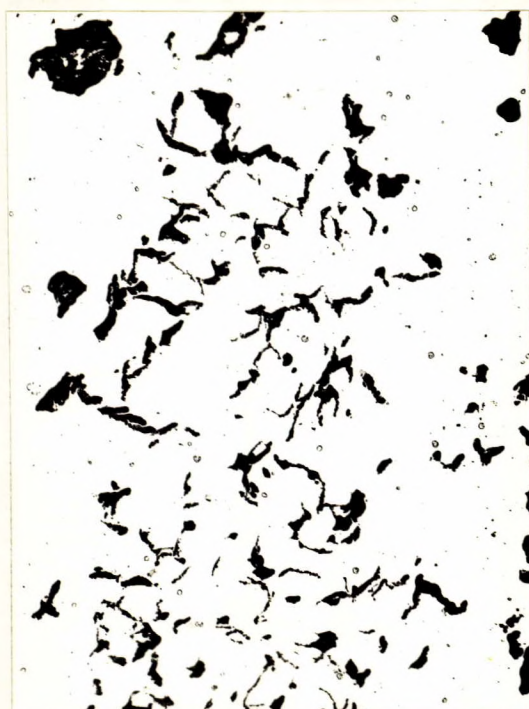
Figure 2

Figures 2, 3 and 4 taken from the broken casting (A) illustrate the presence of free graphite, decarburization, and porosity, respectively.

The microscopic examinations revealed the presence of two conditions in the broken castings which are undoubtedly responsible for the lower mechanical properties. The first is the presence of primary graphite (see Figures 2 and 5), a condition which is carried over from the melting practice and which is very harmful, and must therefore be rectified. Secondly, both visual and microscopic examination has revealed the presence of very extensive decarburization, extending in the case of casting (A) to a depth of approximately 3/16 inch. This may be due to over-annealing or air leakage during the annealing cycle.

3. The presence of primary graphite is undoubtedly responsible for the low mechanical properties of the metal.

X100, unetched.
PRIMARY GRAPHITE

1. A close check should be made on the white cast iron before annealing to ensure the absence of primary graphite.

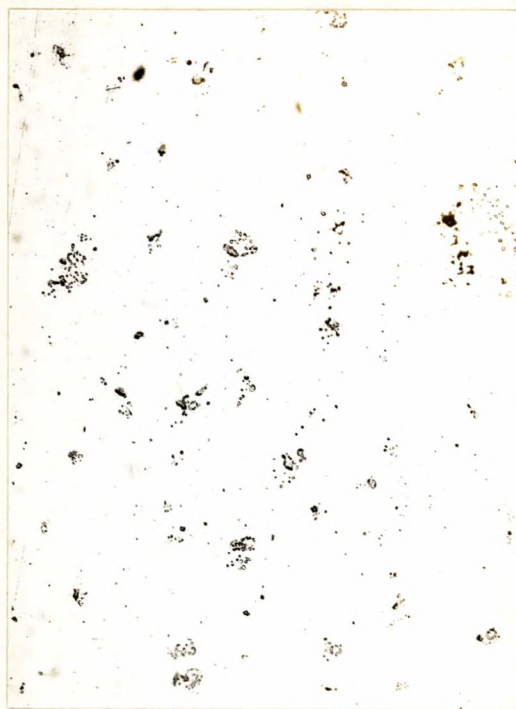
Figure 3

2. The carbon content of the broken castings is low due to decarburization. This condition may be due to over-annealing or leakage of air during the annealing cycle.

X100, unetched.
DECARBURIZED LAYER EXTENDING TO A DEPTH OF APPROXIMATELY 3/16 INCH.

2. A check on the annealing practice should be made to determine the cause of the decarburization.

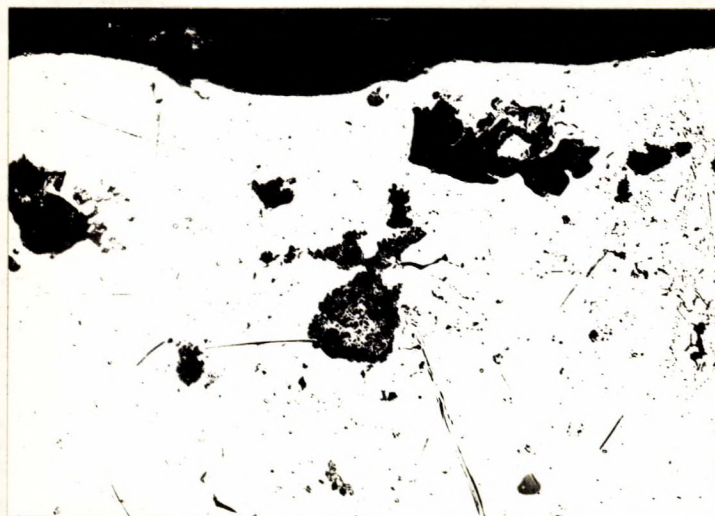
Figure 4

X100, unetched.
DECARBURIZED LAYER AND CASTING POROSITY NEAR SURFACE.

Microphotos taken from broken casting. (A)

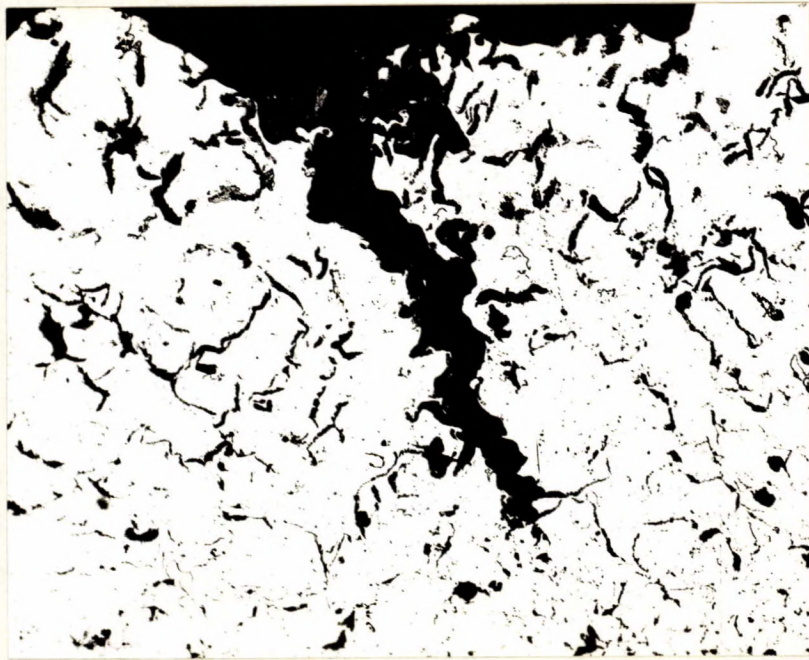
Figure 5 shows a crack extending from the surface through a layer of metal containing primary graphite. (Broken casting B).

SURFACE CRACK EXTENDING THROUGH
AREA OF PRIMARY GRAPHITE.

Broken Casting B.

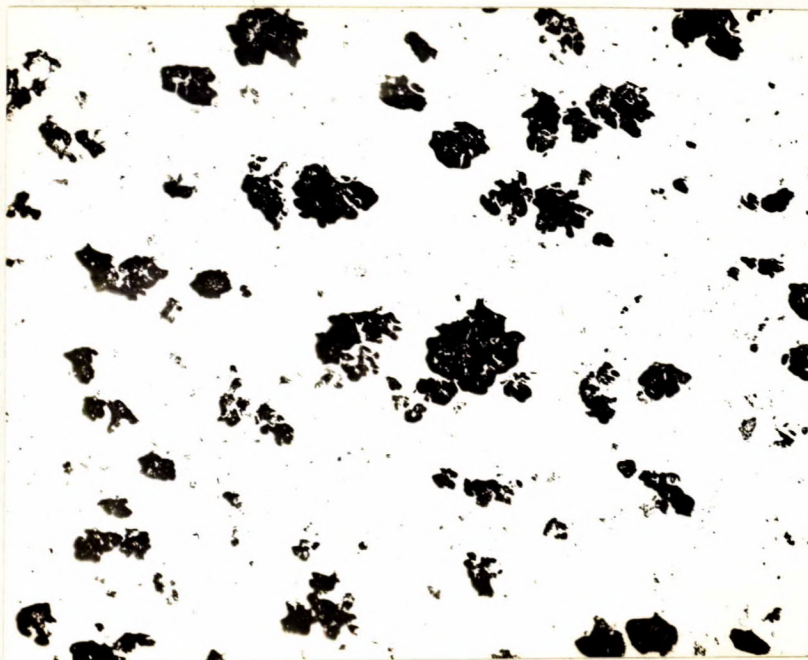
Figure 6 shows the microstructure of a satisfactory casting.

MICROSTRUCTURE OF SATISFACTORY CASTING.
