ORE DRESSING AND METALLURGICAL LABORATORIES.

Investigation No. 2105.

Research on Optimum Thread Form for Proposed
Anglo-American-Canadian Screw Thread.

PART V. - Metallurgical Examination of Five
Low-Tensile Threaded Studs, Failed in Fatigue.

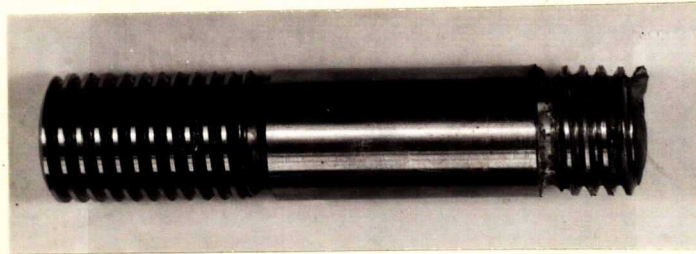
Figure 1.

Figures 1 and 2 are typical of the fracture obtained in these tests.

TYPICAL FRACTURE.

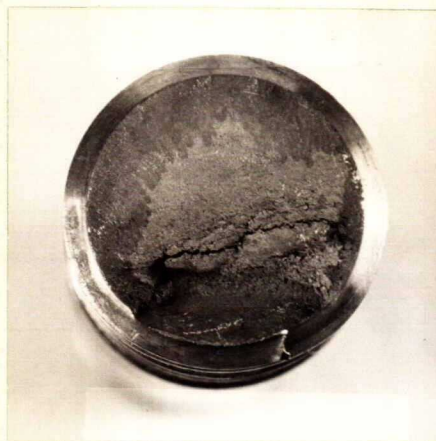
Figure 2.

TYPICAL FATIGUE FRACTURE IN
LOW-TENSILE STUD.

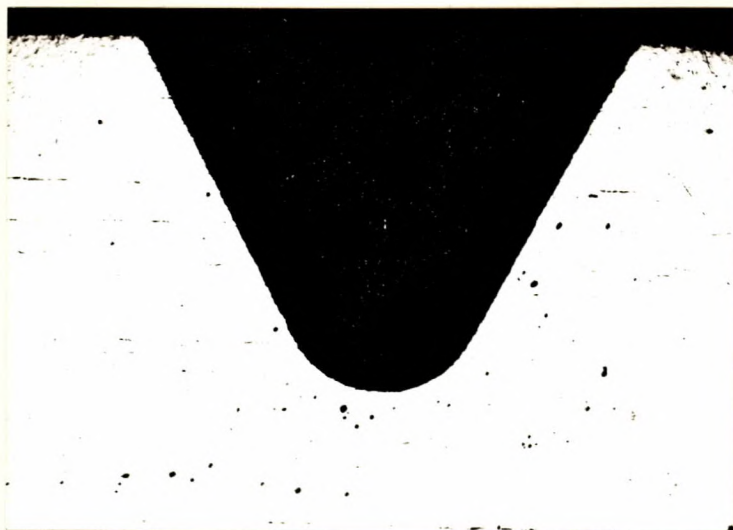
Figure 3.

Figure 3, taken at X30 magnification, shows a typical satisfactory thread.

LATHE-CUT, LOW TENSILE, 55° STUD
(NO. L 3B2/5) SHOWING A TYPICAL
SATISFACTORY THREAD.

The form of the threads as revealed by the microscopic examination was found to be satisfactory in all five studs (see Figures 3 and 4), and no evidence of faulty machining was apparent. However, the microscopic examination revealed the presence of long stringers of inclusions (see Figures 5, 6, and 7). The majority of these stringers were located in the centre of the studs but some were found to exist near the surface. The presence of such stringers extending into the threaded areas (see Figure 7) may be responsible for the premature failures of the studs in question.

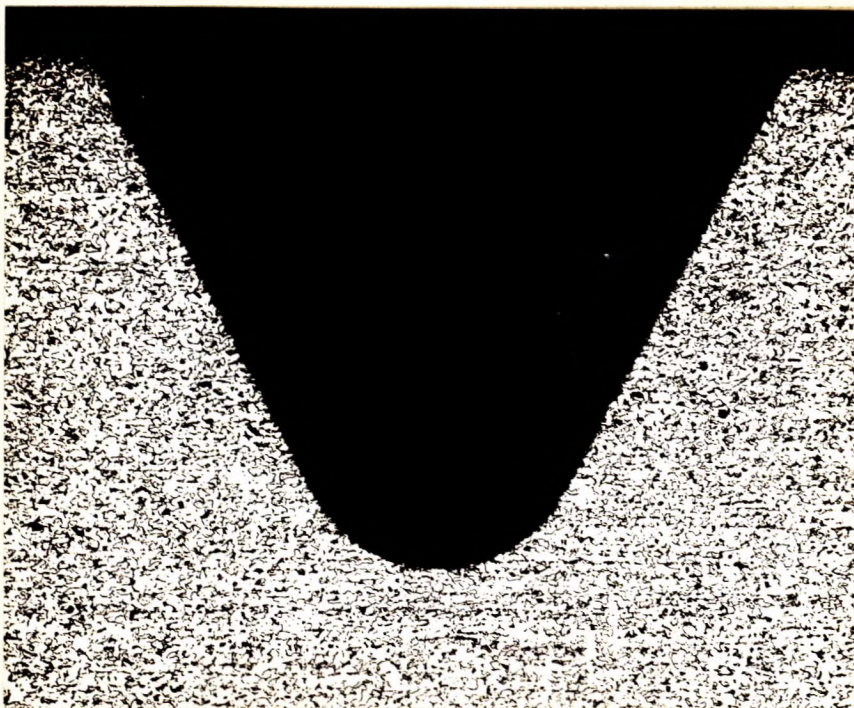
Figure 4.

Figure 4, taken at X50 magnification, shows the microstructure of the steel and the form of thread.

LATHE-CUT, LOW TENSILE, 55° STUD
(NO. L 3B2/5) SHOWING MICROSTRUC-
TURE AND FORM OF THREAD.

Although the microstructure (see Figure 4) and the chemical analysis are satisfactory, the presence of excessive

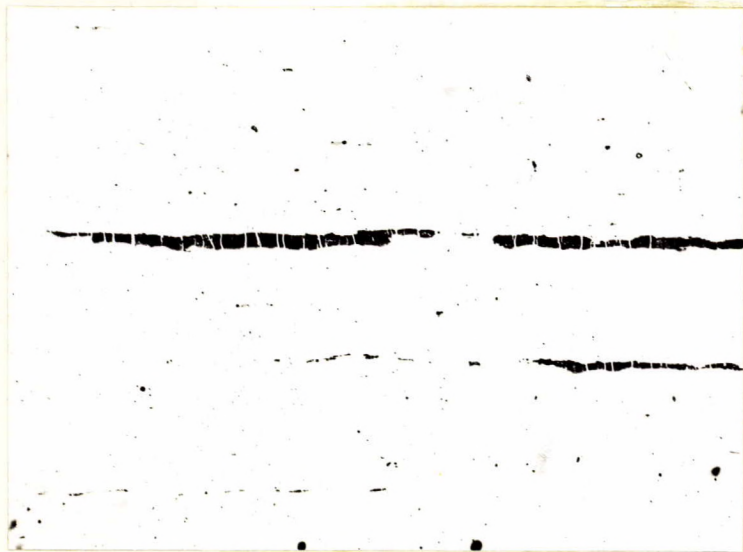
Figure 5.

Figures 5 and 6, taken at X100 magnification, show typical inclusions encountered in the steel.

LATHE-CUT, LOW TENSILE, 65° STUD
(NO. L 5B3/6) SHOWING TYPICAL
INCLUSIONS.

quantities of inclusions is highly undesirable and can only be detected by a microscopic examination. It would therefore appear desirable to subject samples of steel which are to be used for fatigue tests to a thorough microscopic examination.

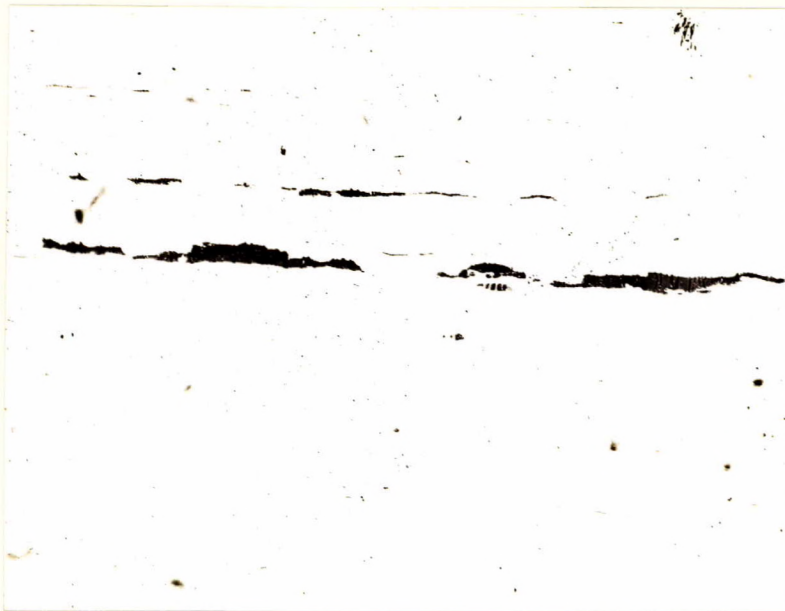
Figure 6.

LATHE-CUT, LOW TENSILE, 65° STUD
(NO. L 5B3/3) SHOWING INCLUSIONS.

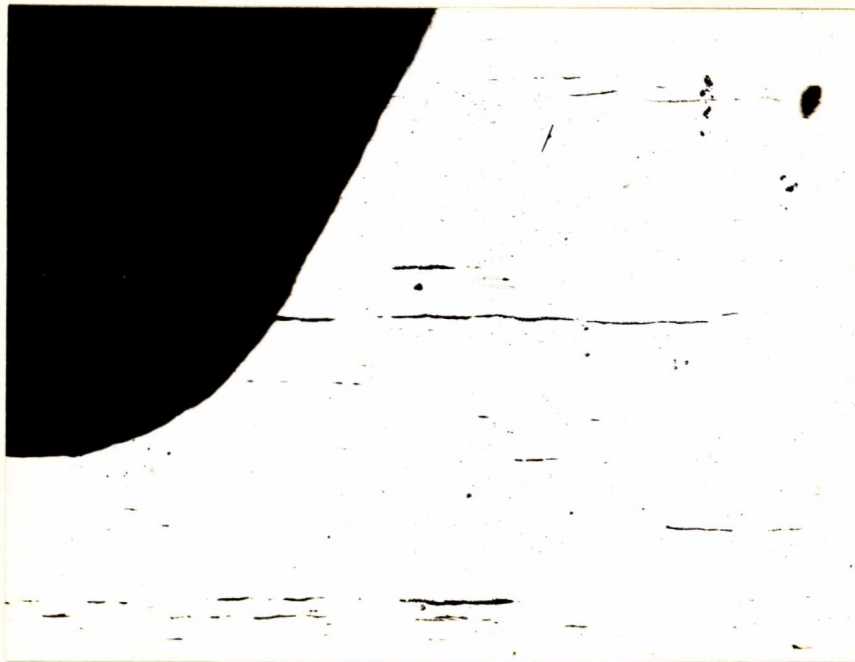
Figure 7.

Figure 7, taken at X100 magnification, shows typical non-metallic inclusions extending into the threaded area.

LATHE-CUT, LOW TENSILE, 55° STUD
(NO. L 3B2/5) SHOWING TYPICAL
NON-METALLIC INCLUSIONS EXTEND-
ING INTO THREADED AREA.

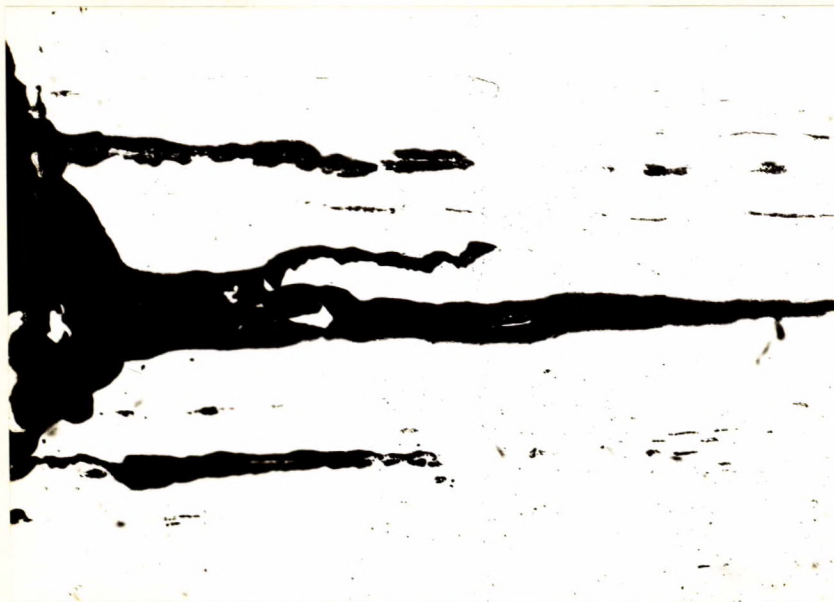
Figure 8.

Figure 8, taken at X100 magnification, shows cracks in the centre of stud No. L 5B3/3 following the paths of the inclusions at right angles to the fracture.

LATHE-CUT, LOW TENSILE, 65° STUD
(NO. L 5B3/3) CRACKS IN CENTRE OF
STUD FOLLOWING THE PATHS OF THE
INCLUSIONS AT RIGHT ANGLES TO THE
FRACTURE.

The cracks, shown in Figure 8, which occur near the centre of the stud at right angles to the break appear to follow the path of the inclusions in the steel.

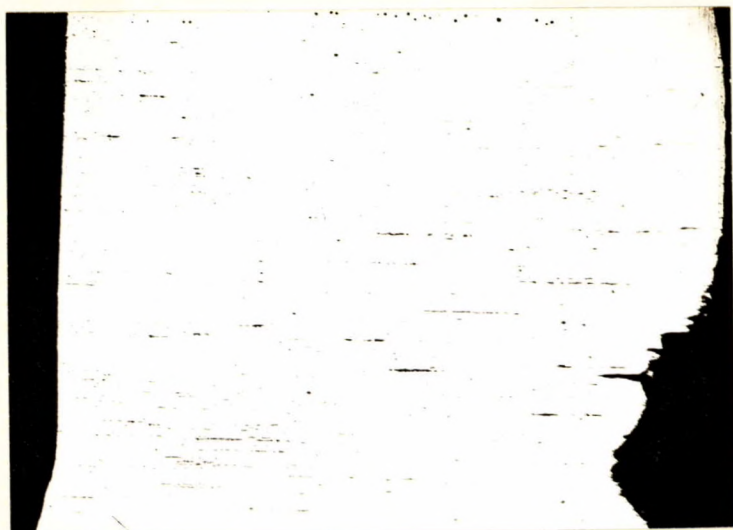
Figure 9.

Figure 9 shows the appearance of inclusions in stud No. L 5B3/3, at X6 magnification.

LATHE-CUT, LOW TENSILE, 65 STUD
(NO. L 5B3/3) SHOWING INCLUSIONS?
