DEPARTMENT OF MINES AND RESOURCES

Investigation No. 2108.

Corrosion Resistance and Other Properties  
of Military Buttons.

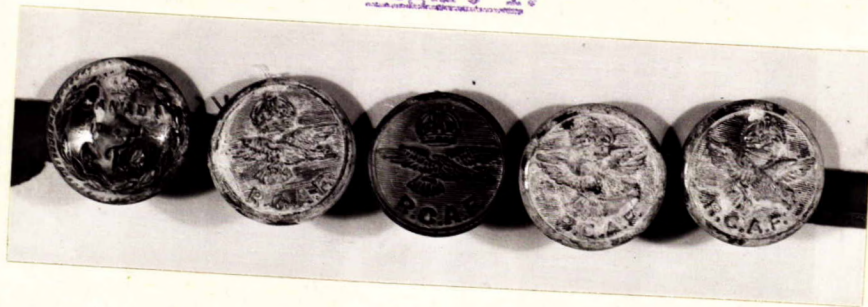
After 100 hours - The corrosion of the various samples is shown in Figure 1.

Sample No. 5-273-1 had considerable brass corrosion product on the surface.

Sample No. 5-318-21 was partially covered with white material and there was a slight evidence of brass corrosion product.

Sample No. 5-318-22 was rather badly tarnished.

Samples No. 5-314-24 were partially covered with white material. A very slight amount of brass corrosion product was visible.

greatly corroded in the case of the 5-318-21 and 5-314-24 samples. However, there was a considerable amount of white material, probably containing lacquer or deterioration product from the lacquer, on these samples.

BUTTONS AFTER 100 HOURS IN THE SALT SPRAY.

1. Type 5-273-1.
2. Type 5-318-21.
3. Type 5-318-22.
- 4.) Type 5-314-24.
- 5.)
