Ottawa, September 23, 1946.

Investigation No. 2112.

Metallurgical Examination of Stainless Steel
and Inconel Exhaust Stubs Used on Mosquito Aircraft.

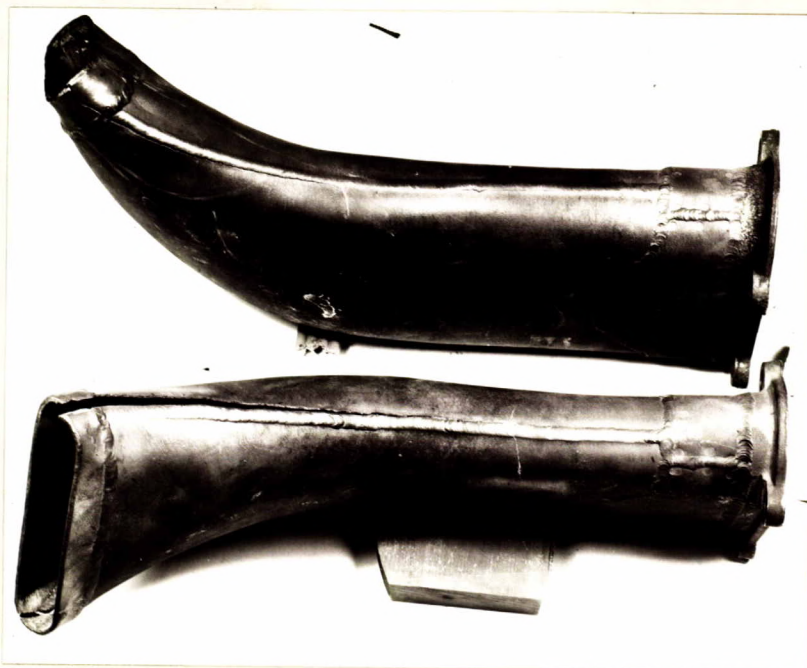
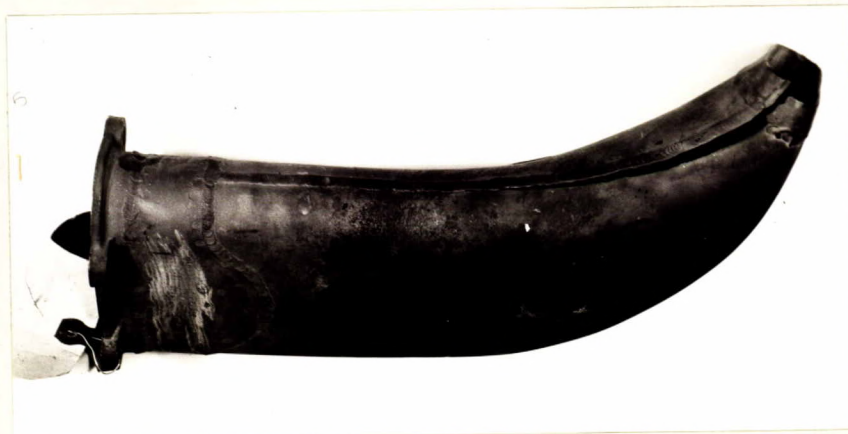
On examination of the failed stainless steel exhaust stacks, it was found that the mechanism of failure was exactly similar in every case, including the single port 18-8 and the double port 20-15. Failure in every case originated at the trailing edge in the welded area, then followed the weld longitudinally, and then spread out at right angles, very often resulting in complete severance of the outlet end from the fixed end (see Figures 1, 2, 3 and 4). This mechanism of failure also applied to the Inconel stack, as is shown in Figure 6.

1. Failures in flight of the stainless steel exhaust manifolds used on the Mosquito Aircraft were undoubtedly due to the use of stainless steel lacking in stabilizing elements such as titanium and columbium, or containing insufficient quantities of these elements.

2. Failures originated at the trailing edge of the manifolds, where the temperature was a maximum, and followed the welds longitudinally along the stack, then spread at right angles, very often resulting in bisection of the manifold.

3. The immediate cause of failure is due to intergranular corrosion in the weld areas caused by the precipitation of carbides during the welding operation. Such failures can be minimized by the use of stabilized stainless steels.

SINGLE PORT STAINLESS STEEL EXHAUST STACKS
FAILED PREMATURELY IN SERVICE, SHOWING
TYPICAL FAILURES.

2. In the manufacture of stainless steel exhaust stubs the use of unstabilized materials must be strictly prohibited.

3. If titanium-stabilized steel is employed the titanium content should be in the neighbourhood of 0.5 to 0.6 per cent.

4. The carbon content should be kept as low as possible (around 0.04 per cent).
5. Electric arc welding should be used in preference to gas welding.
6. Columbiu-bearing welding rods should be employed.

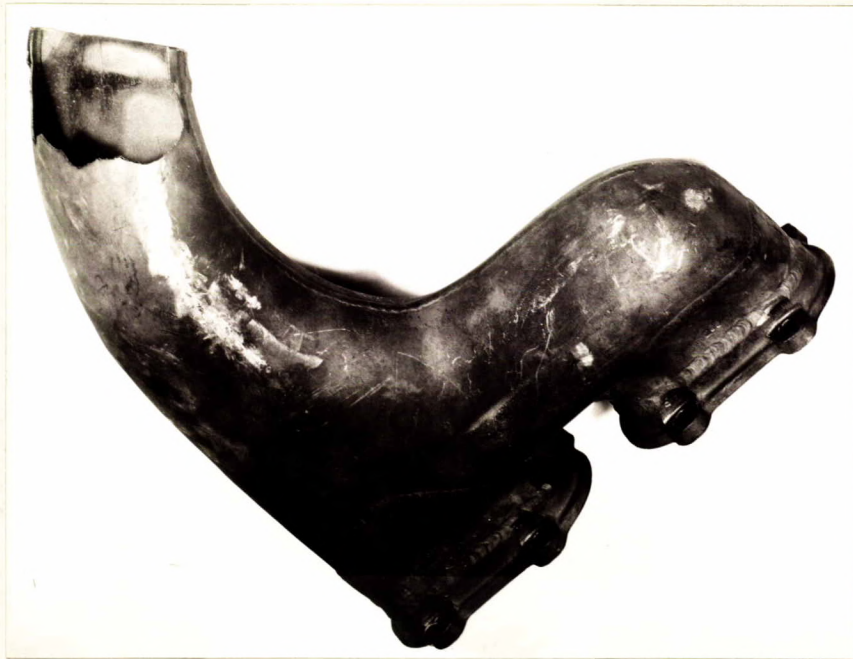
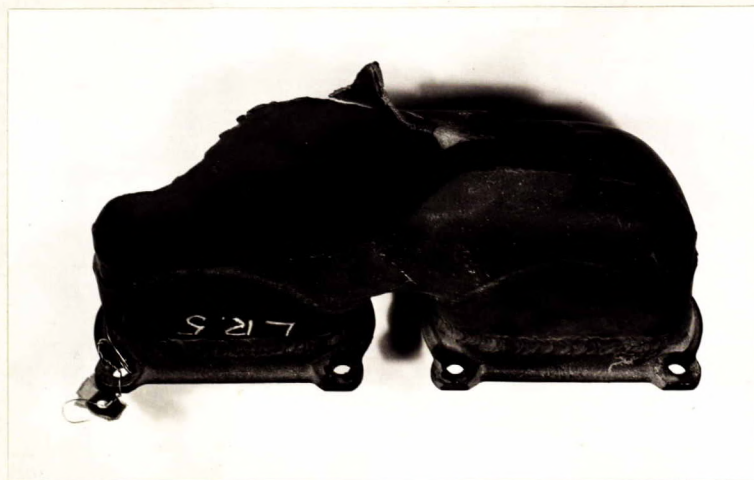
DOUBLE PORT STAINLESS STEEL EXHAUST STACKS
FAILED PREMATURELY IN SERVICE, SHOWING
TYPICAL FAILURES.

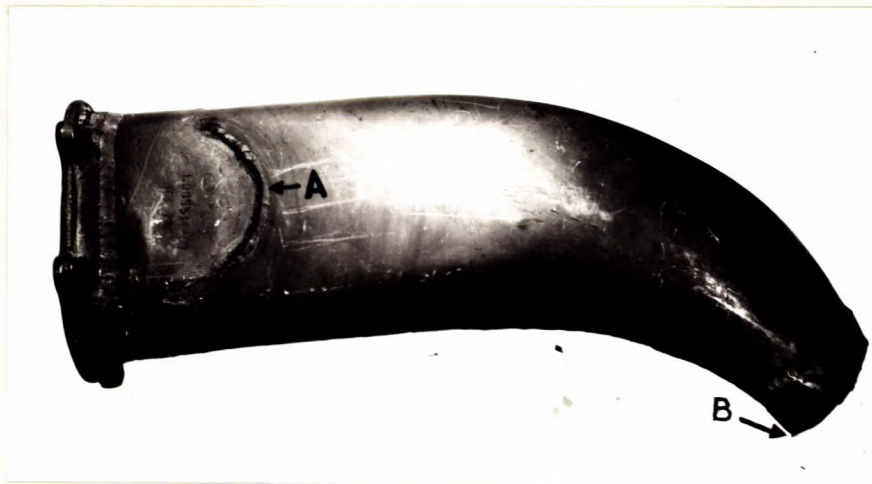
Figure 5.

"Metallurgical Examination of Welded Inconel Exhaust Stub for Mosquito Aircraft," contained the results of an investigation on an Inconel exhaust stub which had been submitted by De Havilland Aircraft (see Figure 5). Cracks which developed after service in flight, and which occurred at the welded areas A and B, were attributed to faulty welding technique. The investigation revealed the existence of cracks in the fusion zones of the weld at the trailing edge in the area marked B, (see Figures 5 and 6). The photomicrograph in Figure 6 clearly shows that the crack originated on the interior surface, that is, the surface exposed to the corrosive exhaust gases.

INCONEL EXHAUST STACK, SHOWING LOCATION OF CRACKS AT WELDED AREAS.

Cracking in stainless exhaust stacks originates in the area of the trailing edge at B.

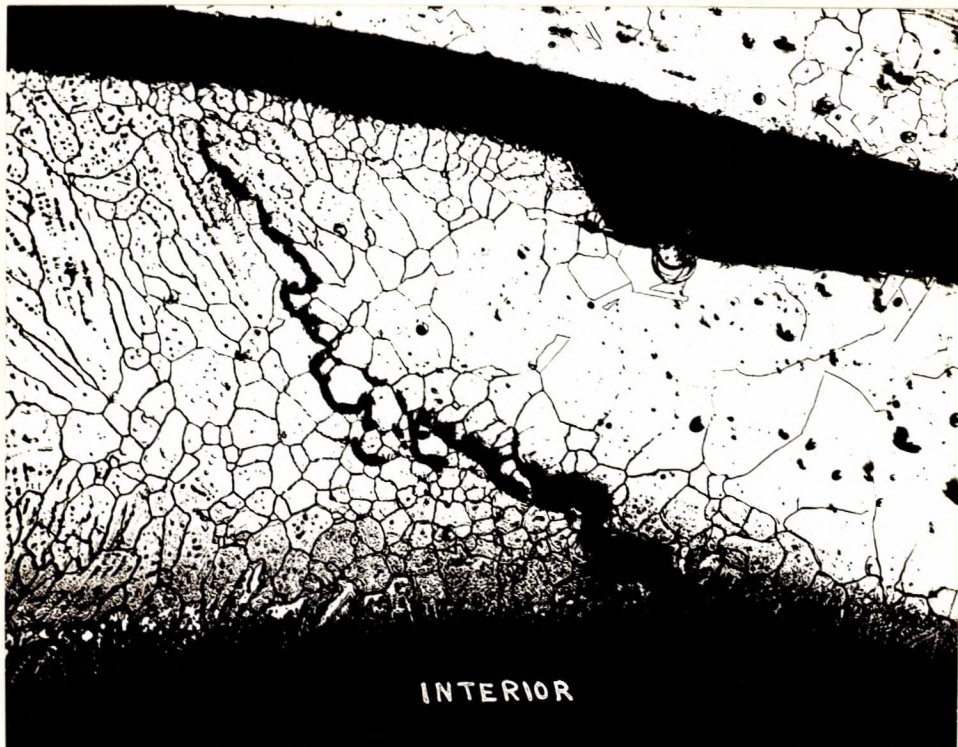
Figure 6.

Figure 6, taken at X50 magnification, shows cracking in an Inconel exhaust stack, occurring in the fusion zone of the weld at the trailing edge B. The corrosive attack of the gases on the interior of the manifold is also evident. This photograph was taken from Investigation Report No. 1748.

INCONEL EXHAUST STACK, SHOWING CRACKING OCCURRING IN THE FUSION ZONE OF THE WELD AT THE TRAILING EDGE, B.

Note corrosion along interior of manifold.

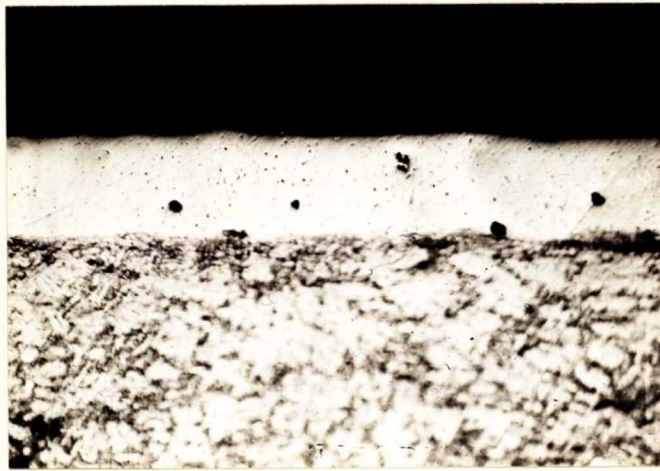
Figure 7.

Figure 7, taken at X200 magnification, shows the thickness of the nickel coating, which was applied electrolytically in these Laboratories, on a set of unused stainless 18-8 mosquito exhaust stacks.

NICKEL-PLATED STAINLESS STEEL 18-8 EXHAUST
STACKS, SHOWING THICKNESS OF NICKEL LAYER
(APPROXIMATELY 0.0025 INCH).

In addition to the above, one set of exhaust manifolds involving 16 stacks (only single port stubs were so treated) were nickel-plated and forwarded to De Havilland Aircraft on April 2, 1945. The object of this measure was to prevent access of the corrosive gases to the stainless steel, and thus prolong the service life. After considerable delay it was ascertained from Mr. F. H. Burrell, technical service manager of De Havilland Aircraft Limited, that this set which had been installed on aircraft KA385 was tested in flight for a period of 5 hours and 40 minutes and had been found to "behave perfectly in every respect."

1. Since the indications are that useful information may be obtained, some consideration should be given to the advisability of continuing the test of the nickel-plated exhaust stubs, attached to plane KA385, in order to determine the effectiveness of this method of salvaging unstabilized stainless steel manifolds.
