ORE DRESSING AND METALLURGICAL LABORATORIES.

Investigation No. 2113.

Metallurgical Examination of a Cyanided Steel
Engraving Plate Which Had Cracked
Prematurely in Service.

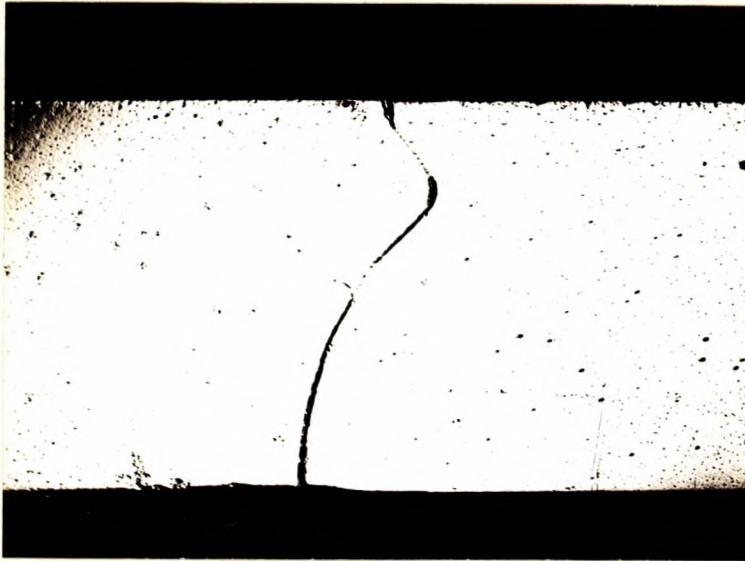
Figure 1.

Figure 1, taken at X8 magnification, shows that the crack extends completely through the plate.

X8 (unetched).

TRANSVERSE SECTION OF CYANIDE-HARDENED ENGRAVING PLATE WHICH CRACKED IN SERVICE, SHOWING THAT THE CRACK HAS PENETRATED COMPLETELY THROUGH THE STEEL.

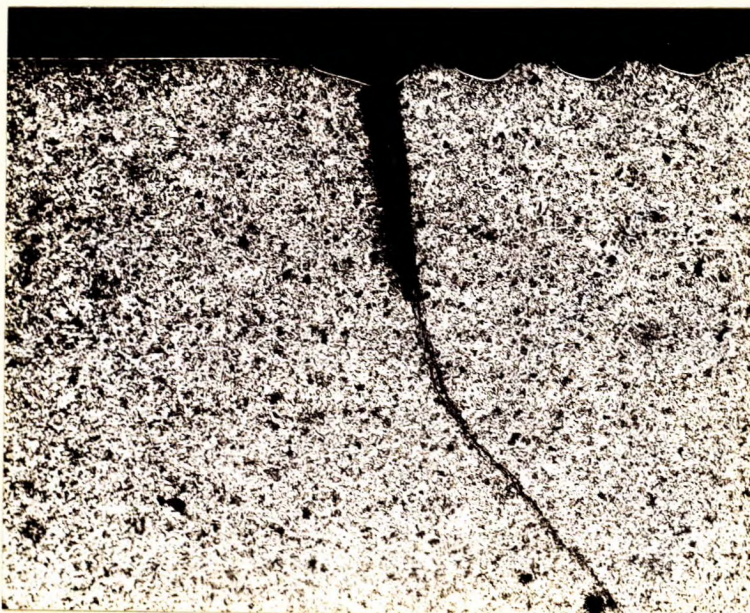
Figure 2.

Figures 2 and 3, taken at X100 magnification, show the appearance of the crack at both surfaces.

X100. Nital etch.

TRANSVERSE SECTION OF CRACKED CYANIDE-HARDENED ENGRAVING PLATE, SHOWING APPEARANCE OF CRACK AT THE ENGRAVED SURFACE.

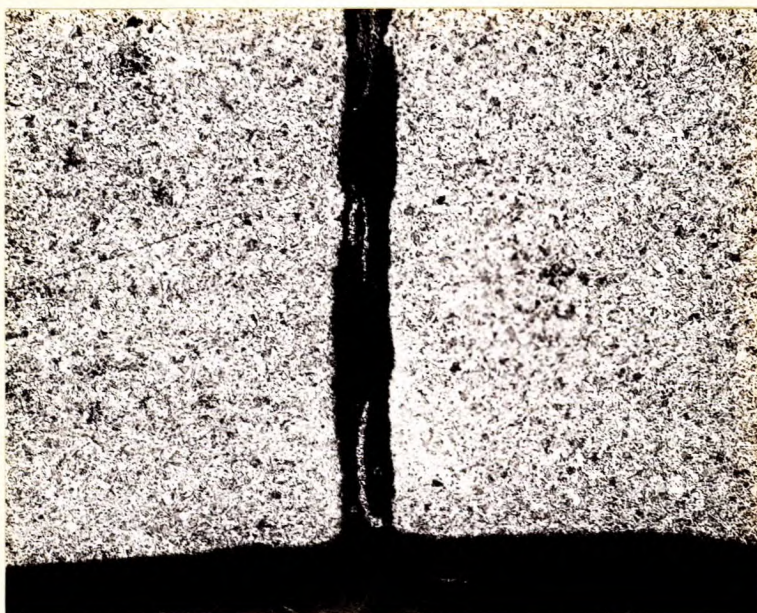
Figure 3.

X100. Nital etch.

TRANSVERSE SECTION OF CRACKED CYANIDE-HARDENED ENGRAVING PLATE, SHOWING APPEARANCE OF CRACK AT THE REVERSE SURFACE.

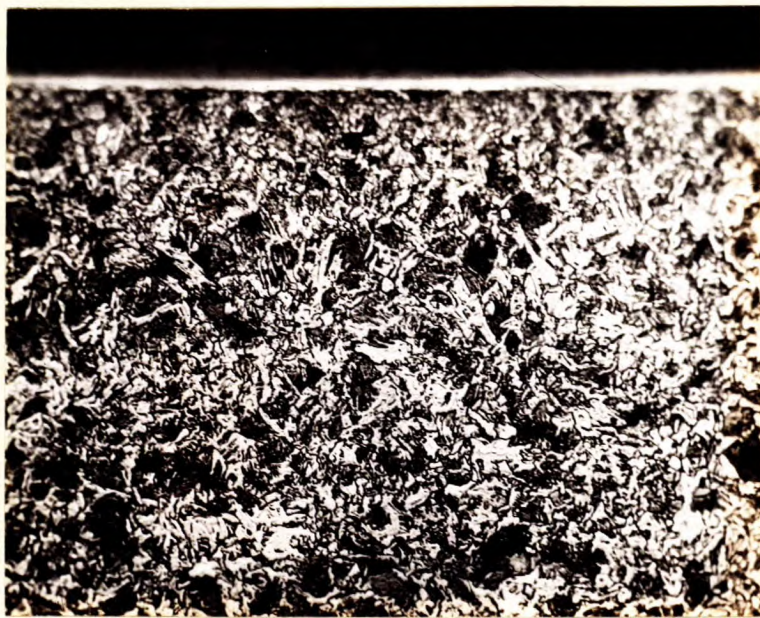
Figure 4.

Figure 4, taken at X500 magnification, is intended to show the extent of the cyanide case. The white layer is chromium plating.

X500. Nital etch.

TRANSVERSE SECTION OF CRACKED CYANIDE-HARDENED ENGRAVING PLATE, SHOWING EXTENT OF CYANIDED CASE.

(White layer is chromium plating.)

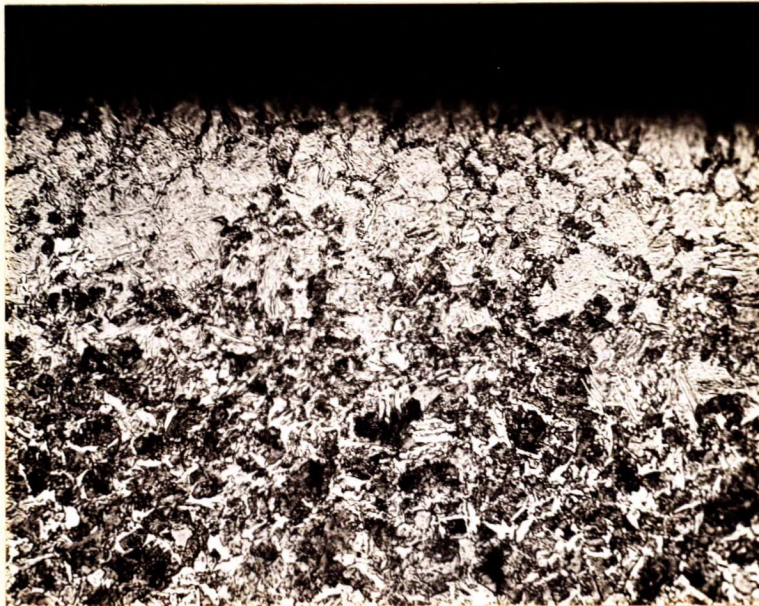
Figure 5.

Figure 5, taken at X500 magnification, shows the extent of the cyanide case in the plate used for the tempering experiments.

X500. Nital etch.

CYANIDE-HARDENED ENGRAVING PLATE USED
IN THE TEMPERING EXPERIMENTS, SHOWING
EXTENT OF CASE.
