DEPARTMENT OF MINES AND RESOURCES  
BUREAU OF MINES  
CANADA

R E P O R T  
of the  
ORE DRESSING AND METALLURGICAL LABORATORIES.

Investigation No. 2125.

Metallurgical Examination of a 'Bug Blitzer' Cylinder.

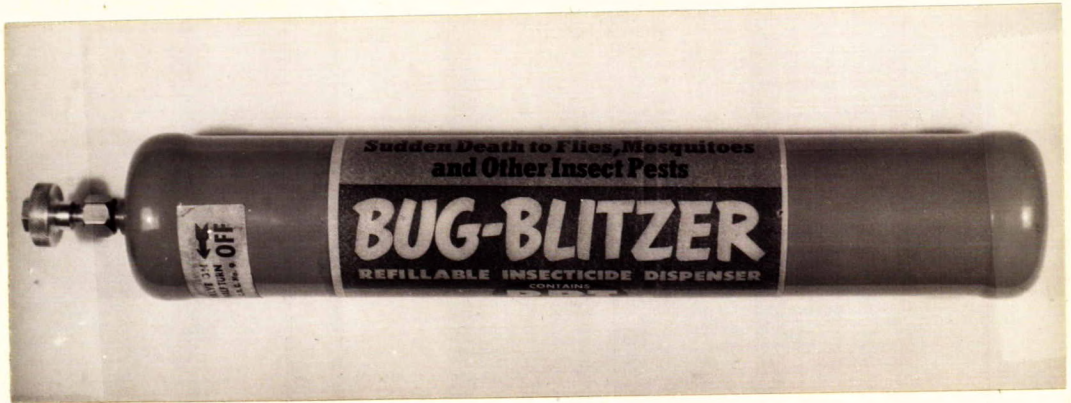
Figure 1.

PHOTOGRAPH OF CYLINDER 'AS RECEIVED', SHOWING GENERAL SHAPE.

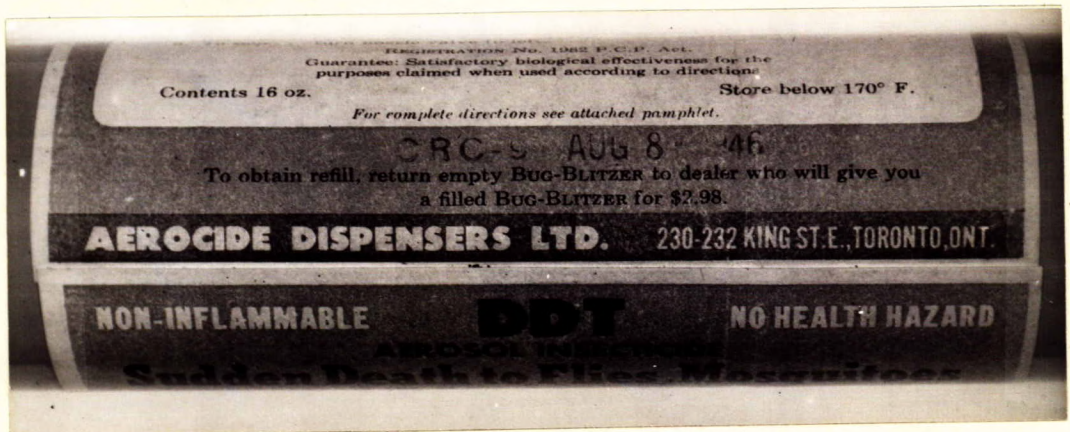
Figure 2.

The label on the cylinder described the cylinder as the "Bug Blitzer Reliable Insecticide Dispenser" made by Aerocide Dispensers Limited, 230-232 King Street E., Toronto, Ontario, and besides general directions for use bore a typed or stamped legend "CRC-9, Aug. 8-1946" and a warning to "store below 170° F."

PHOTOGRAPH OF CYLINDER LABEL, 'AS RECEIVED'.

Note typed or stamped legend "CRC-9 Aug. 28, 1946" and warning to 'store below 170° F.'.

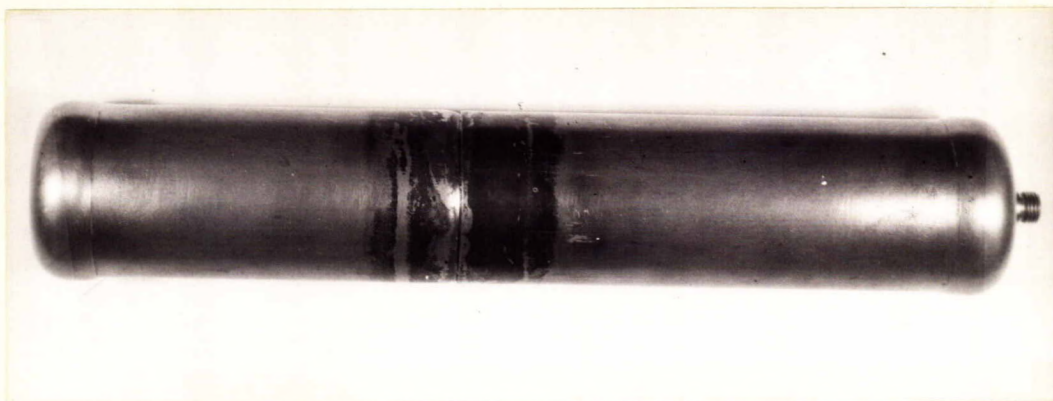
Figure 3.

PHOTOGRAPH OF CYLINDER AFTER CHEMICAL REMOVAL OF PAINT.

Note joint joining two halves of shell.

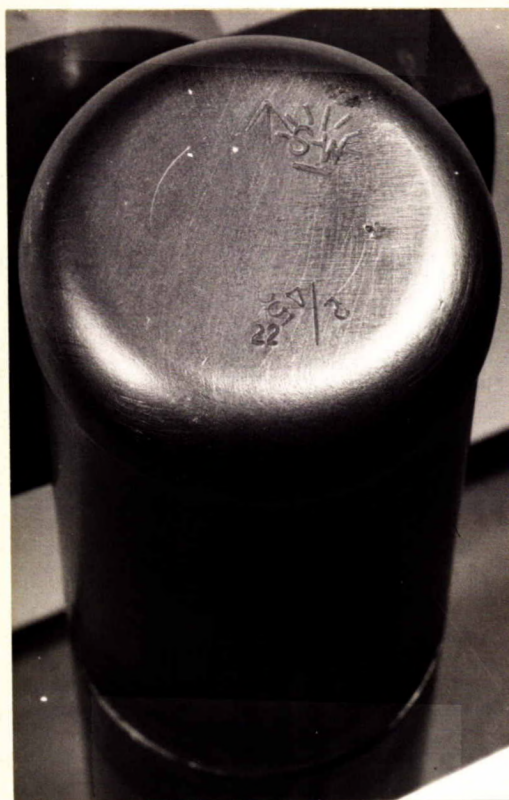
Figure 4.

- (1) The cylinder is not permanently marked with regard to specification number, manufacturer's and owner's symbols.
- (2) There is no safety device of any kind incorporated in the cylinder.

GOVERNMENT MARKINGS ON ENDS OF CYLINDER.

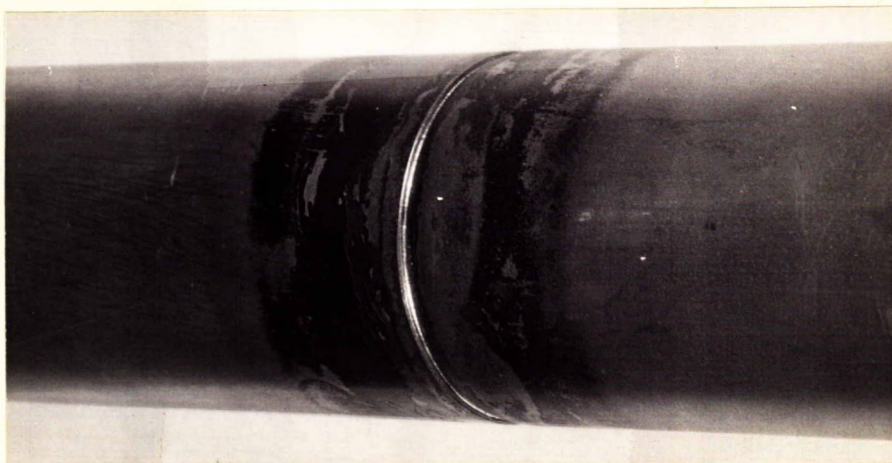
Figure 5.

CLOSE-UP OF JOINT JOINING THE TWO HALVES OF THE SHELL.  
Apparently a silver brazed joint.

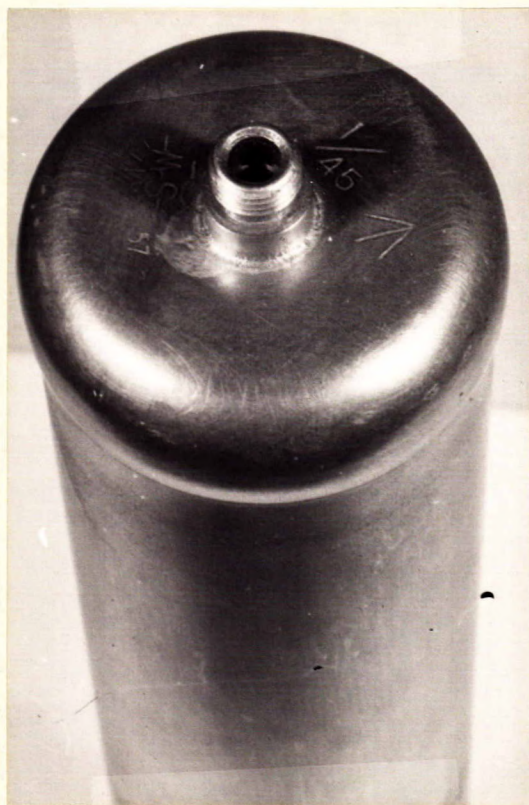
Figure 6.

CYLINDER DISCHARGE VALVE JOINED TO STEEL SHELL BY WHAT  
APPEARS TO BE A SILVER BRAZE.

Note government markings on the end of the shell.

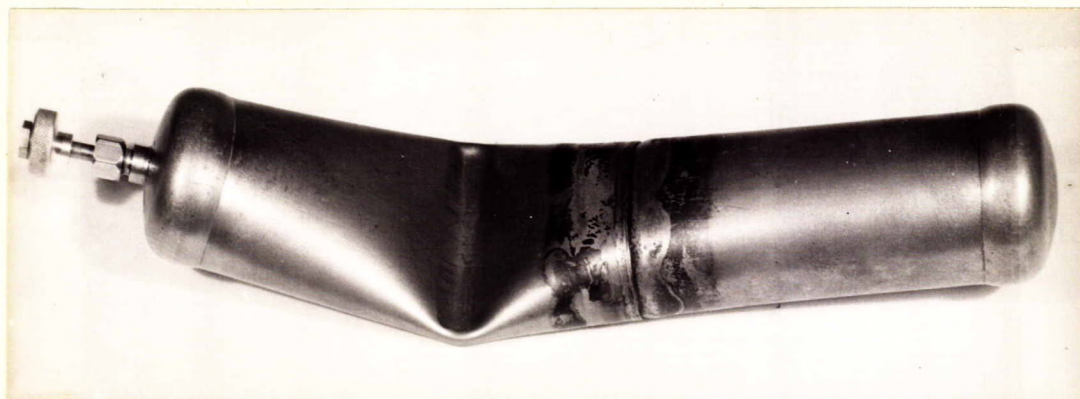
Figure 7.

(6) The cylinder was subjected to a flattening test between knife edges shaped, 45° angle, rounded to a 3/8" radius. The cylinder was flattened until the two inside walls were in contact (Figure 7). This test was more severe than that specified. After flattening there was no evidence of cracking of the cylinder walls.

APPEARANCE OF CYLINDER AFTER FLATTENING TEST.

No cracks were detected in the cylinder walls at area of greatest deformation.

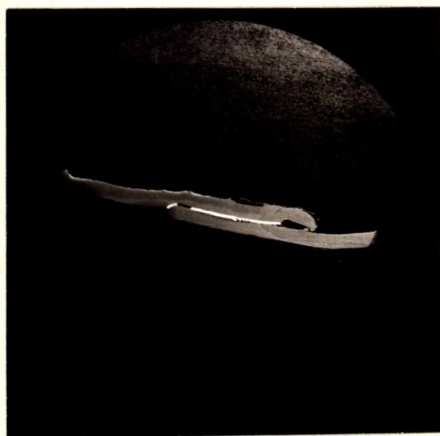
Figure 8.

(9) Typical cross-sections of the brazed joints were machined, mounted, polished and etched. Figure 8 shows a cross-section of the braze joining the two halves of the cylinder and Figure 9 the braze joining the outlet to the cylinder end. A microscopic examination of similar samples revealed that a good bond had been secured between the component parts. It will be noted that the depth of brazing is considerably greater than the specified minimum of four times the thickness of the shell metal with regard to the braze joining the two halves of the shell.

PHOTOGRAPH OF SILVER BRAZE JOINING TWO HALVES OF THE CYLINDER SHELL.

Note that depth of braze exceeds specified minimum of 4 times the wall thickness.

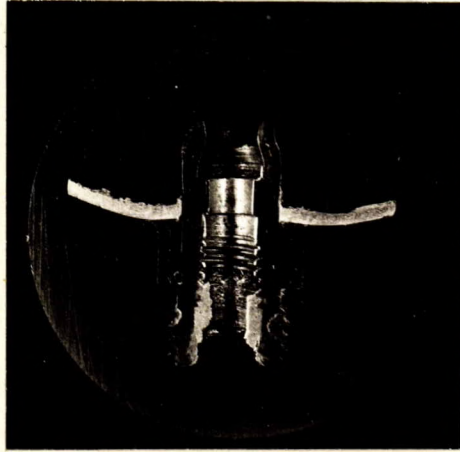
Figure 9.

PHOTOGRAPH OF SILVER BRAZE JOINING THE CYLINDER  
DISCHARGE VALVE TO THE SHELL BODY.

Braze length approximately 3 times wall thickness of shell.
