BUREAU OF MINES

Investigation No. 2126.

Metallurgical Examination of a No. 2 Catalyst
Steel Column used for Ammonia Synthesis.

PART II. - Microscopic Examination.

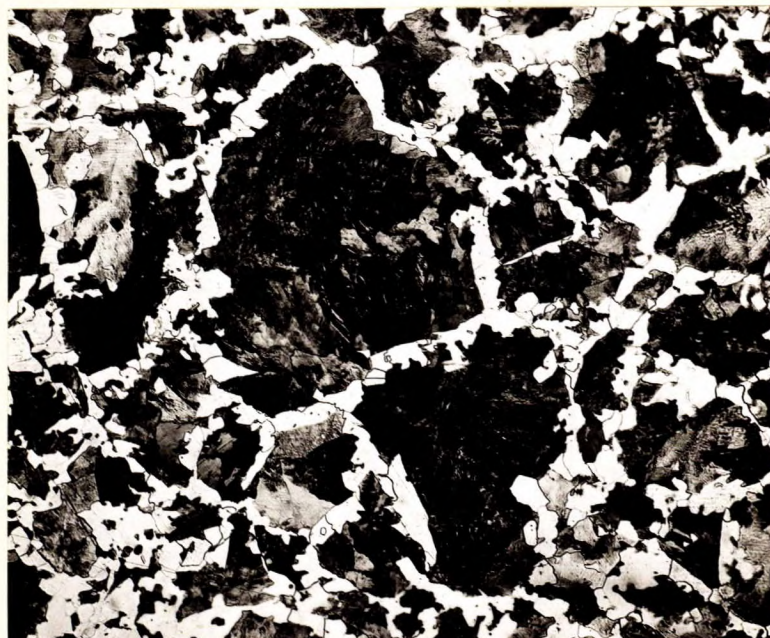
Figure 1.

Figure 1, taken at X100 magnification, shows the microstructure of the steel in the column. Microscopic examination of samples cut from various localities in the section failed to disclose any variation in the microstructure, and Figure 1 may be considered representative of the steel used in the column.

The coarse-grained structure of the steel in the column (see Figure 1) is to be expected for a casting of this size, since the deformation ratio resulting from the forging operation is comparatively small and very little breaking up of the original cast austenite grain had actually taken place. Because of this, and also because of the very long soaking time in the annealing operation, the refinement of the grains would not be very complete.

MICROSTRUCTURE OF THE FAILED AMMONIA STEEL
COLUMN (ANNEALED).

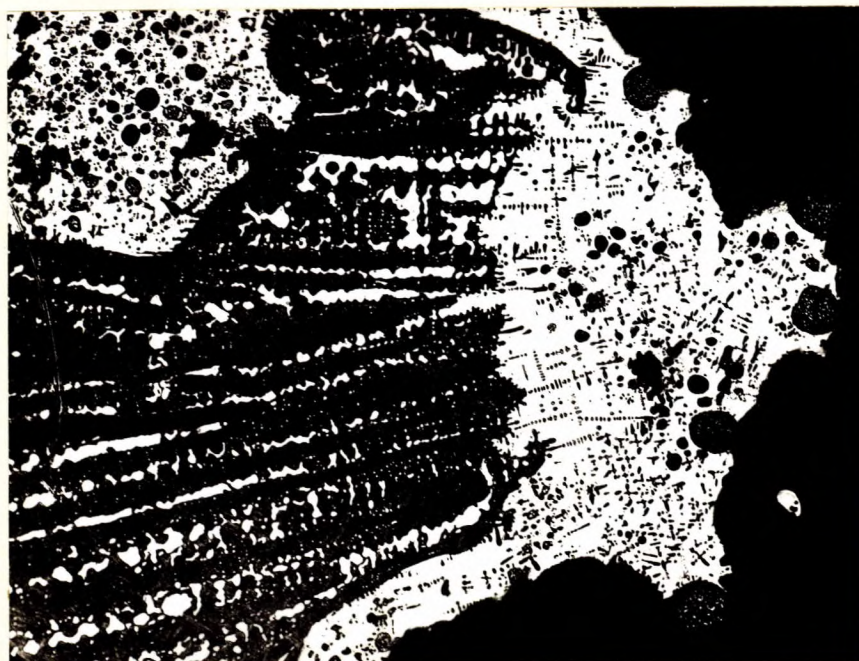
Figure 2.

Figures 2 to 7, inclusive, are taken from the small sample of the diffused copper and steel area of the lead-in port. Figure 2, taken at X100 magnification, shows the copper (light) and the copper-steel area (dark). The copper which has formed a solid solution with the steel, causes it to etch up very dark.

GENERAL VIEW OF DIFFUSED COPPER (LIGHT) AND COPPER STEEL
(DARK) AREA OF THE ELECTRICAL LEAD-IN PORT.

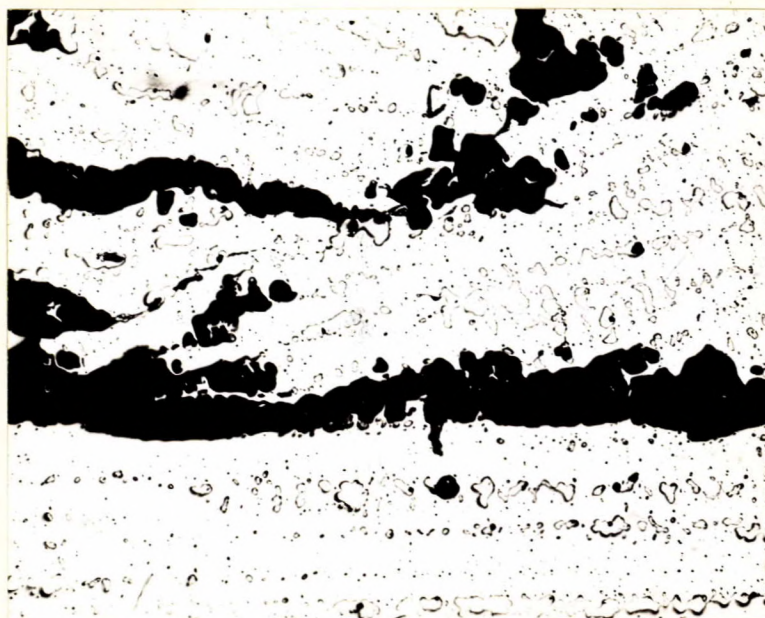
Figure 3.

Figure 3 shows large cracks in the copper-steel zone.

The microscopic examination proves very conclusively the existence of numerous cracks in the diffused copper-steel areas as well as in the adjacent heat-affected zone which extends to a depth of approximately 5/8 inch around the lead-in port. The penetration of the copper into the steel and the formation of a hard, brittle, crack-filled alloy leaves very little reason to doubt this as being the source of the

LARGE CRACKS IN THE COPPER-STEEL ZONE.

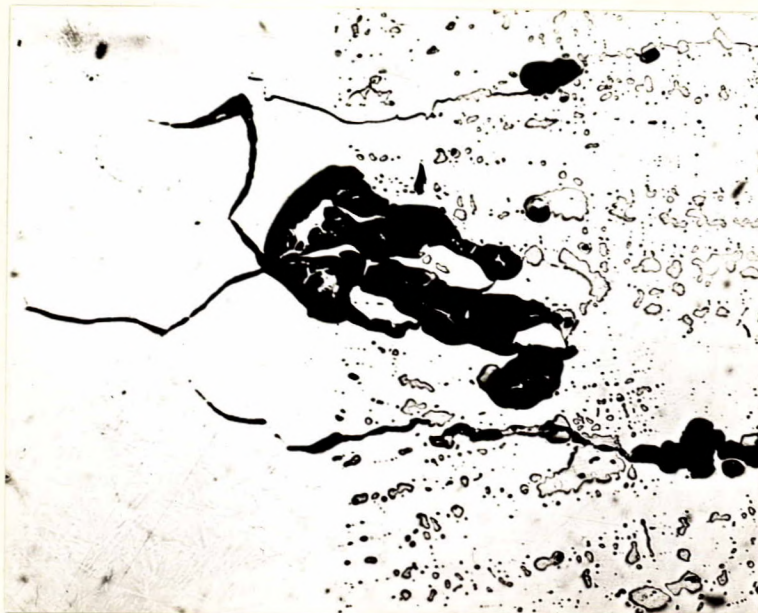
Figure 4.

Figures 4 and 5 show cracks in the copper-steel zone extending into the heat-affected steel areas.

Note continuation of cracks from copper-steel zone (right) into steel area (left).

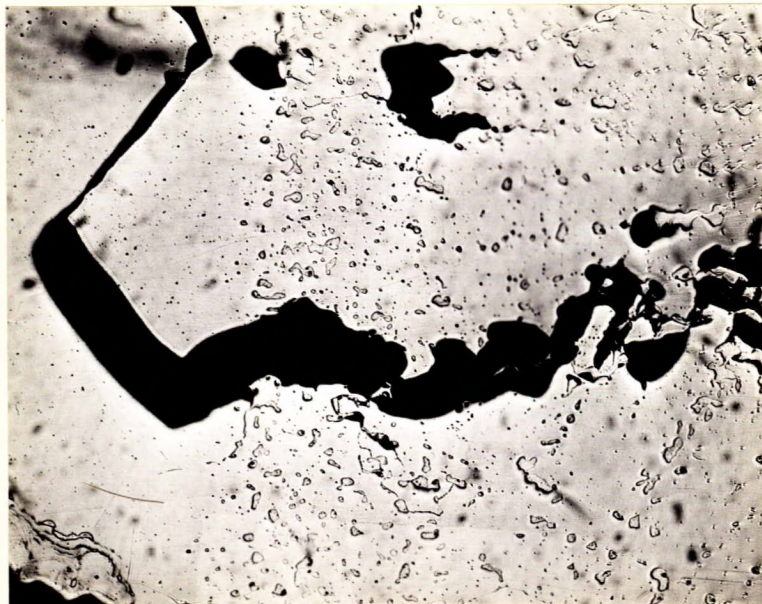
Figure 5.

Note continuation of cracks from copper-steel zone
(right) into steel area (left).

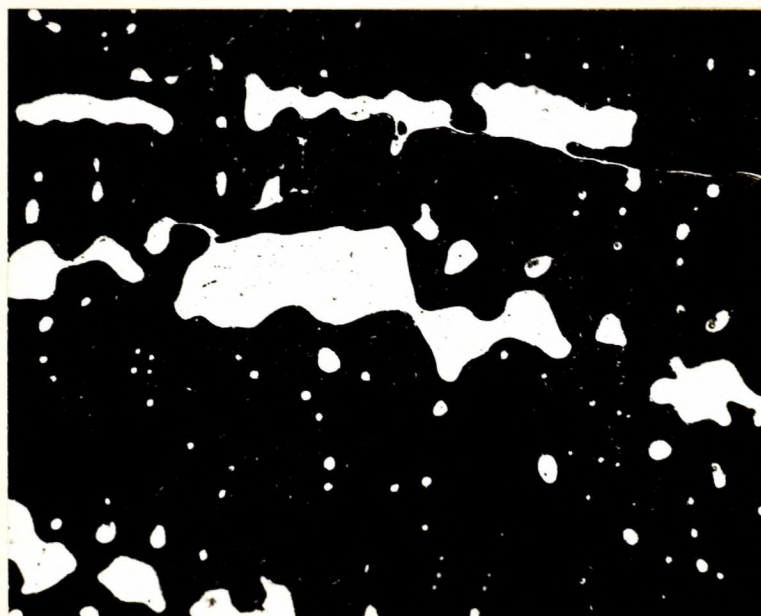
Figure 6.

Figure 6, taken at X500 magnification, illustrates the structure of the copper-steel zone, consisting of undissolved copper in a background of martensite.

COPPER-STEEL ZONE SHOWING UNDISSOLVED COPPER (WHITE)
IN A BACKGROUND OF MARTENSITE (DARK).

Hardness, 40-56 Rockwell "C".

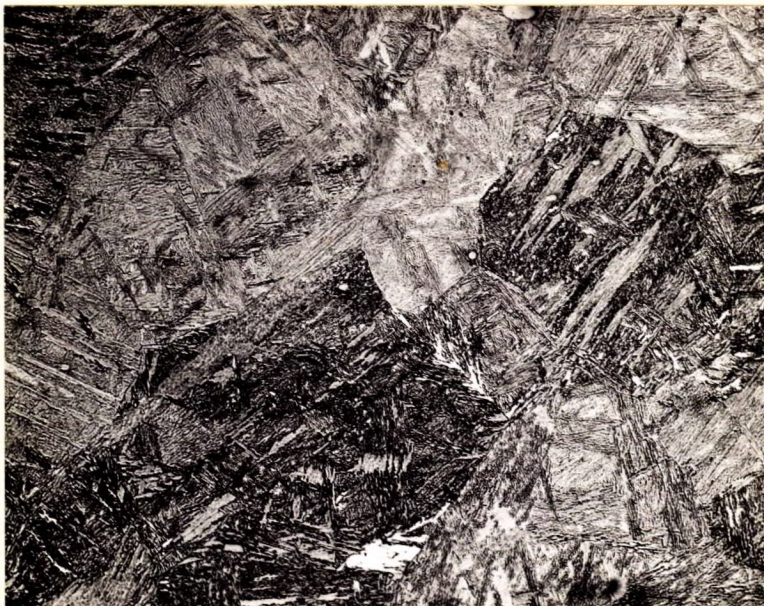
Figure 7.

Figure 7 shows the heat-affected zone immediately adjacent to the copper-steel area.

HEAT-AFFECTED STEEL PORTION IMMEDIATELY ADJACENT
TO THE COPPER-STEEL ZONE AND PROBABLY CONTAINING
SOME DISSOLVED COPPER.

Note large grain size.
Hardness, 40-50 Rockwell "C".

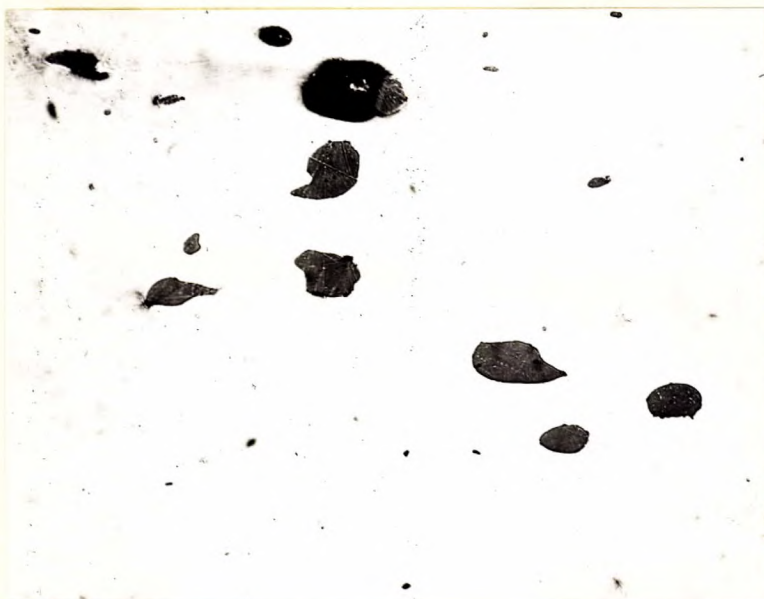
Figure 8.

Figure 8 illustrates typical manganese sulphide inclusions found in the steel. These inclusions, although large in size, are to be expected in a casting of this size.

SHOWING TYPICAL LARGE INCLUSIONS, PROBABLY MAN-
GANESE SULPHIDE.
