DEPARTMENT OF MINES AND RESOURCES
BUREAU OF MINES
CANADA

R E P O R T
of the
ORE DRESSING AND METALLURGICAL LABORATORIES.

Investigation No. 2128.

Metallurgical Examination of a
Rock Drill Piston Hammer.

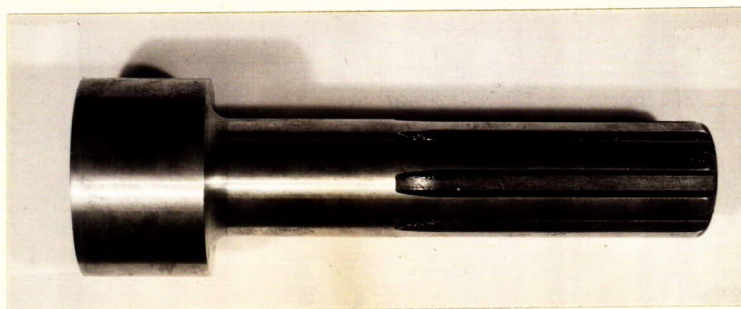
Figure 1.

PISTON HAMMER.

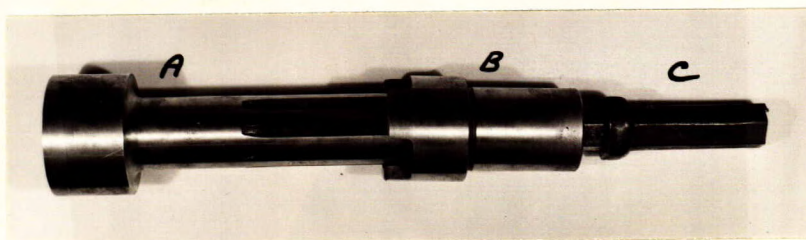
Figure 2.

ROCK DRILL ASSEMBLY.

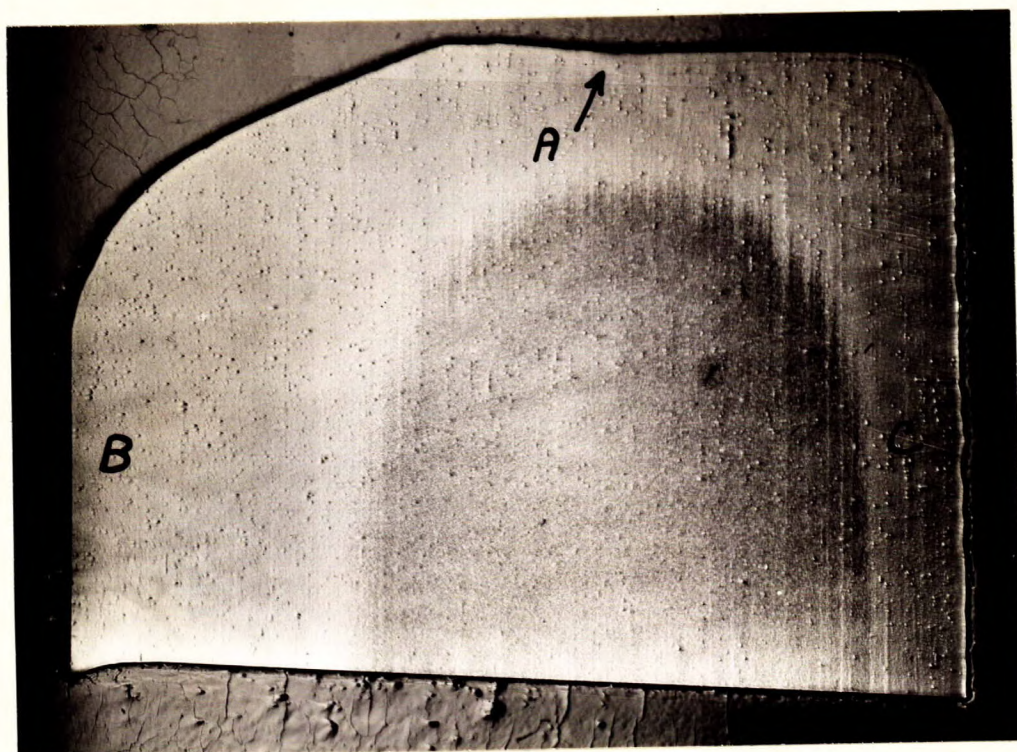
Figure 3.

Examination of the face of the piston hammer seemed to indicate an uneven line of wear when progressing from the centre of the face towards the outside circumference. In order to check this, a longitudinal sample was cut through the face down the shaft of the piston. It was polished on the inner surface which is perpendicular to the face of the piston. The sample was etched in 2 per cent nital and examined under the microscope. Figure 3(X7 $\frac{1}{2}$) is a macro-graph of this surface. The arrow at A points to the section on the peening face where the wear appears to be greatest. The surface at B is the spline. The surface at C is the hole down the centre of the piston hammer. THE ETCH INDICATES THAT THE DEPTH OF HARDNESS PENETRATION IS NARROWEST (0.090 INCH APPROXIMATELY) AT THAT SECTION OF THE FACE (POINT A) WHERE THE WEAR APPEARS TO BE GREATEST.

Note arrow at section A.

From Figure 3 it appears that the peening face has given unsatisfactory service not due to unusually rapid wear but rather due to another phenomenon, namely, "brinelling." This is a term given to the pushing in of a hardened surface layer on impact. It will be noted, in Figure 3, that maximum compression at the surface has taken place at Section A where the hardened layer was thinnest. A thicker hardened section could be expected to have the strength to withstand the blows and prevent "brinelling." It might be mentioned that this effect usually occurs rather early in the service life of the part. After a period of use the subsurface layers work-harden and prevent any further collapsing of the surface layers.

5. What appears to be wear is actually a "brinelling" effect (collapsed surface).

In order to increase the depth of the hardened layer, two possibilities are available:

- (1) Increase the severity of the quench on heat treatment.
- (2) Change to a steel having somewhat greater hardenability.

1. To obtain a greater depth of the hardened layer, increase the severity of the quench in heat treatment.

2. If the above is not possible, change to a steel having somewhat more hardenability.

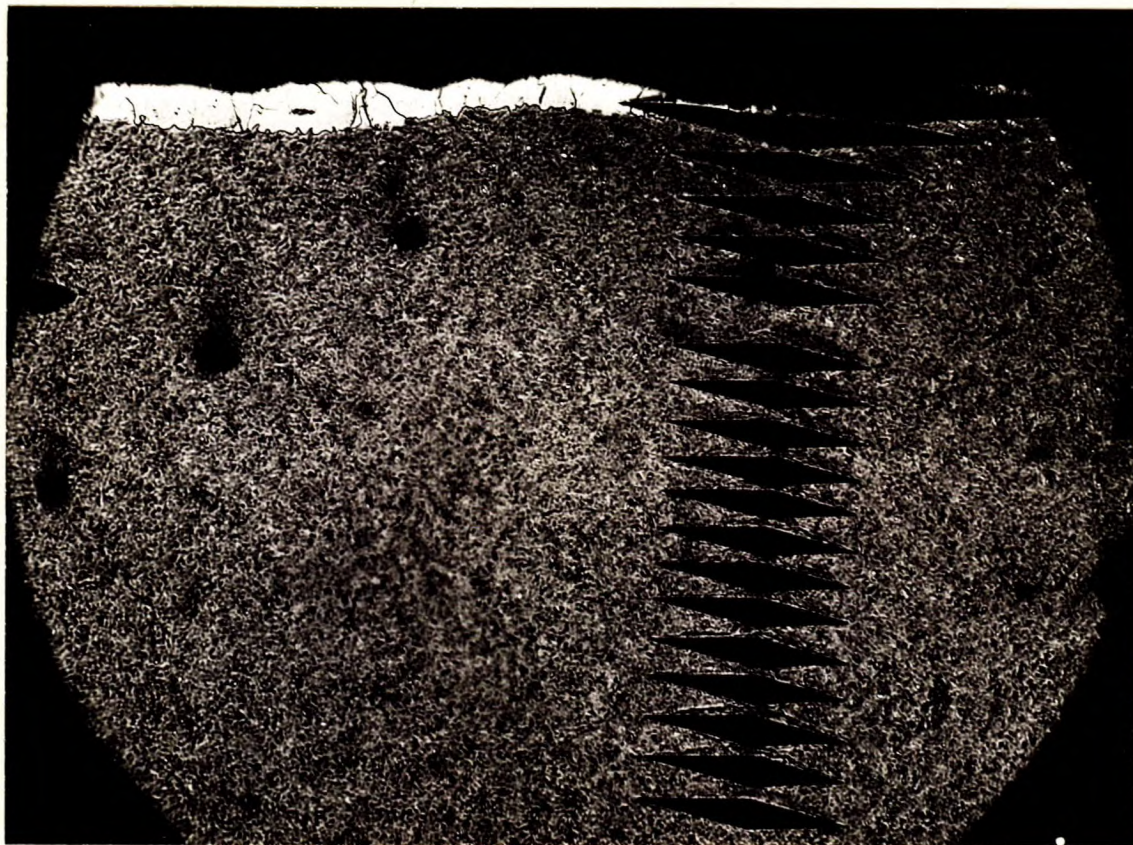
Figure 4.

In order to check the surface for decarburization, Tukon hardness tests were made toward the exposed but unground surface of the central hole of the piston face C in Figure 3 and a photomicrograph was taken. It can be assumed that the condition found at this face would be similar to that of the wearing (peening) surface prior to its having been placed in service. Figure 4 (X300) illustrates the decarburized layer at the surface (white colour) and the Tukon hardness impressions. The decarburized layer is less than 0.001 inch deep.

DECARBURIZED LAYER.

Less than 0.001 inch deep.

4. The amount of decarburization found at an unground exposed surface is less than 0.001 inch. Therefore, the original peened surface could be expected to have the same small amount of decarburization. This small decarburization would not contribute greatly to an excessive wear condition.

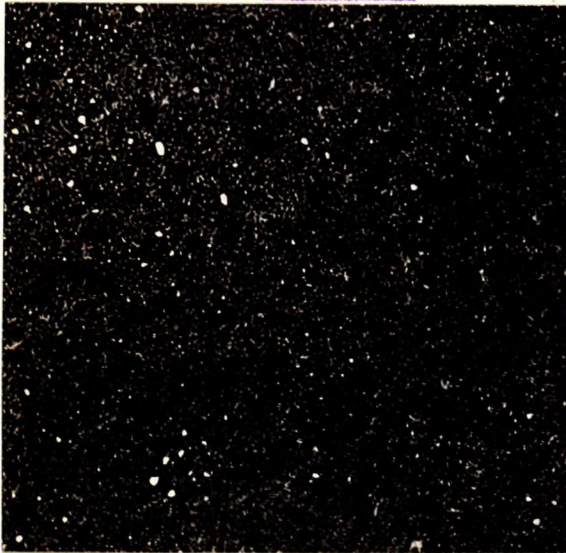
Figure 5.

Figure 5 (X500) is a photomicrograph showing the structure of the hardened layer. It is composed of tempered martensite with nodules of free carbides (white constituent).

STRUCTURE OF HARDENED LAYER.

6. The structure of the hardened layer is tempered martensite with nodular carbides.

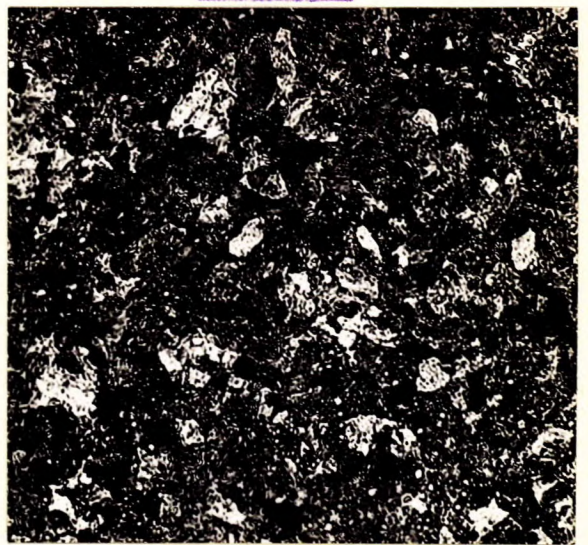
Figure 6.

Figure 6 (X500) shows the structure of the softer interior of the piston. This consists of fine pearlite with small nodules of free carbides throughout.

STRUCTURE OF INTERIOR.

7. The structure of the core is fine-grained pearlite with nodular carbides.
