DEPARTMENT OF MINES AND RESOURCES

BUREAU OF MINES

Investigation No. 2129.

Metallurgical Examination of 20-mm. A/P Shells,
to Determine Cause of Difficulty Encountered in
Hardening.

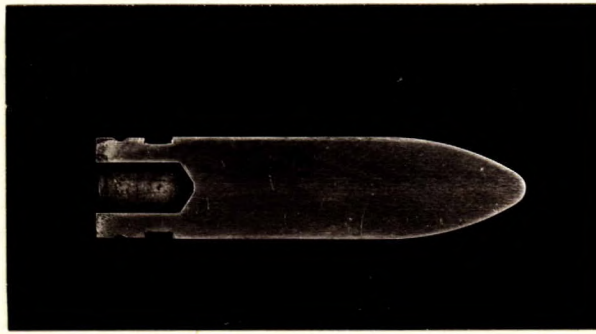
Figure 2.

Etched in 2
per cent nital.

Note white etching layer around
the outside.

To check the extent of this decarburized layer, 0.005-inch layers were successively machined from the outside of an unheat-treated shell and analysed for carbon content. The following results were obtained:

Low hardness results were obtained due to a decarburized layer on the outside of the unheat-treated shell. The depth of this layer will vary from shell to shell. The shell examined by carbon determination showed a decarburized layer of 0.035 inch in depth. It is probable that in the heat treatment for the drop forging operation decarburization was extremely severe and the subsequent machining was not deep enough to entirely remove the lower-carbon material.

1. A decarburized layer was present in all the shells examined, both prior to and after heat treatment.
2. The shell which was carefully examined by carbon determination was decarburized 0.035 inch.
3. Inability to obtain the proper hardness is due to this decarburization.

It would not be possible to heat-treat the shells in this condition to give the hardness gradient requirements. It is recommended that new shells be obtained. These should be taken from (a) a batch which have not been decarburized to such an extent prior to machining, and (b) a batch in which the machining operation has removed all the decarburization. If difficulty is found in heat-treating these shells, these Laboratories should be consulted again, in order to establish the proper heat treatment cycle. It should also be mentioned that these shells should be heat treated in a neutral atmosphere for the hardening operation.

A new batch of shells should be obtained, making sure that machining has eliminated all the decarburized material. Should trouble be encountered in obtaining the proper hardness gradient, these Laboratories should be consulted to establish the proper heat treatment conditions.
