DEPARTMENT OF MINES AND RESOURCES
BUREAU OF MINES
CANADA

R E P O R T
of the
ORE DRESSING AND METALLURGICAL LABORATORIES.

Investigation No. 2134.

Composition and Corrosion-Resisting
Properties of Oils to Specification
A.X.S. 934.

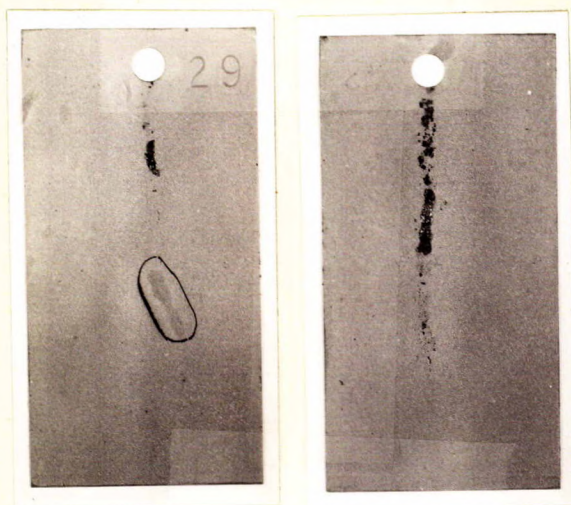
Figure 1.

Differential - One panel perfect and the other one had rust under suspension hole on both sides. (See Figure 1.)

From Differential.

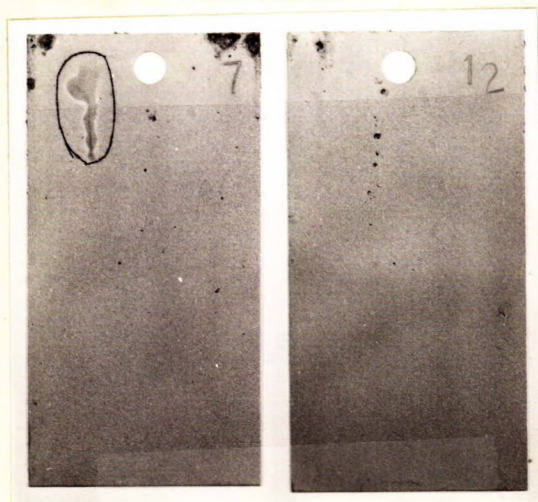
(a)

Transmission - The panels had a few rust spots on both sides. These spots increased as the test was continued for an extra 50 hours. (See Figures 2a and 2b.)

From Transmission.

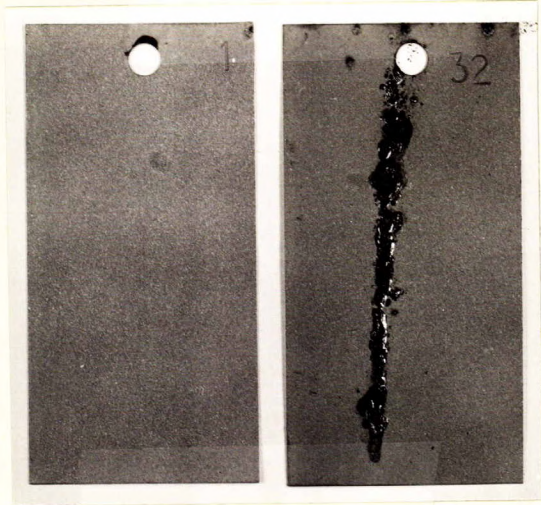
(a)

Crankcase - One panel perfect on one side and the other side rusted under suspension hole and a few spots on surface. The other panel had rust under suspension hole on both sides; also, a few spots over surface. These spots continued to increase slightly as test was continued for an extra 50 hours. (See Figures 3a and 3b.)

From Crankcase.

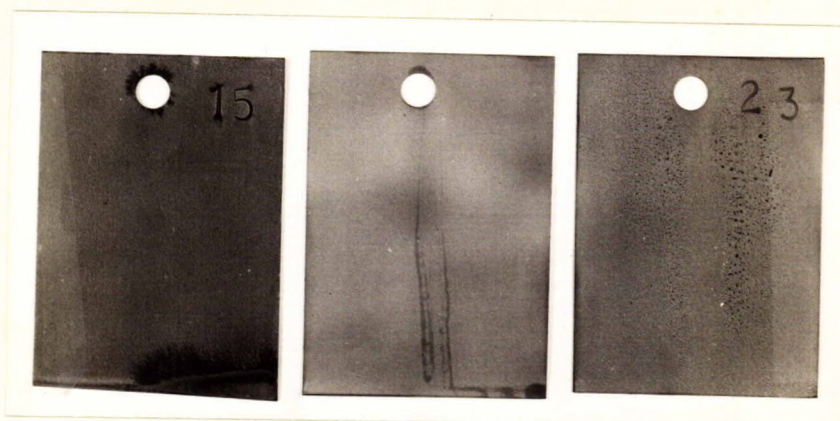
Figure 4.

Differential - One panel rusted and other one practically unaffected. (See Figure 4.)

In Figures 4, 5 and 6, a panel treated with hydrobromic acid but not with oil is included for comparison. It will be noted that this panel is much more severely corroded than any of those that were treated with hydrobromic acid and then with oil.

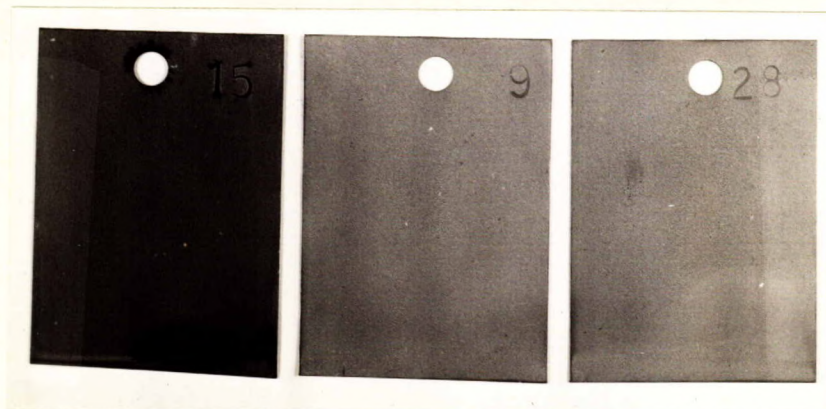
Figure 5.

Transmission - Both panels practically unaffected. (See Figure 5.)

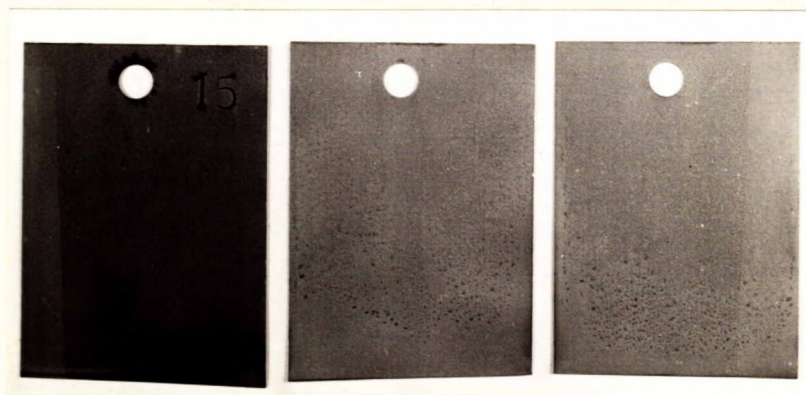
Figure 6.

Crankcase - Both panels rusted. (See Figure 6.)

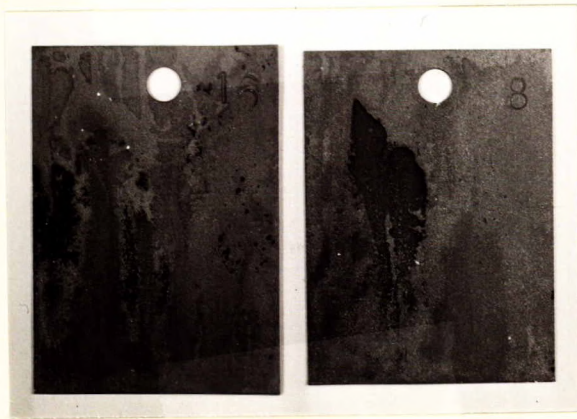
Figure 7.

Differential - Considerable rust on both panels.

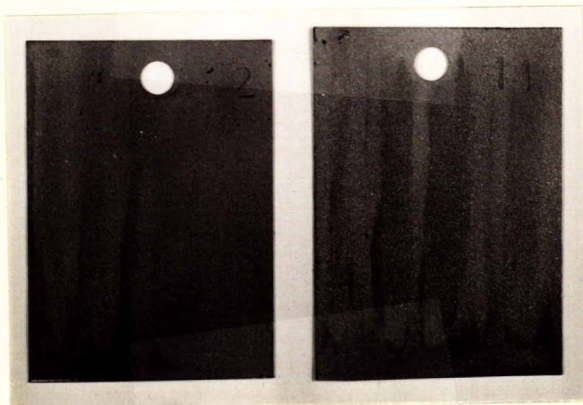
Figure 8.

Transmission - Small amount of rusting. (See Figure 8.)

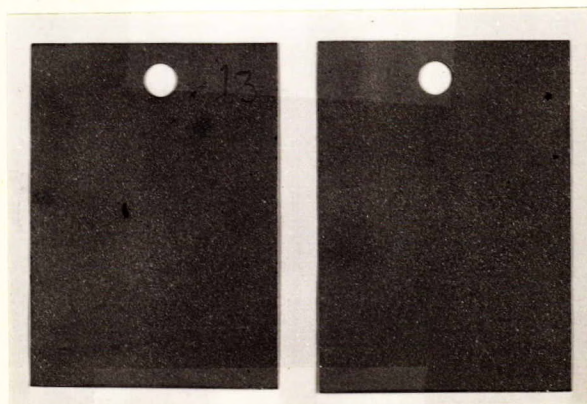
Figure 9.

Crankcase - A few fairly large rust spots.
