DEPARTMENT OF MINES AND RESOURCES  
BUREAU OF MINES  
CANADA

R E P O R T  
of the  
ORE DRESSING AND METALLURGICAL LABORATORIES.

Investigation No. 2142.

Metallurgical Examination of a Defective  
Cast Bronze Screen Plate.

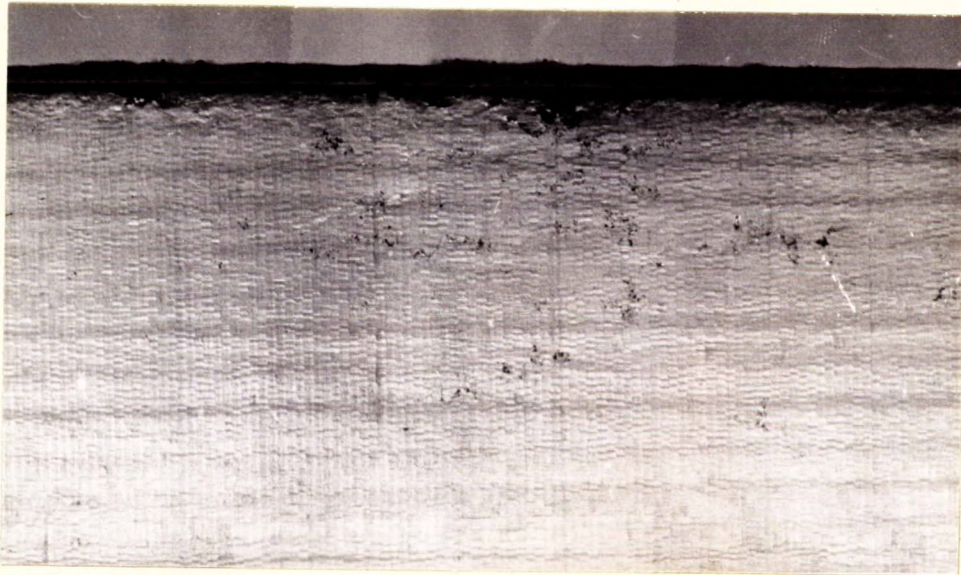
Figure 1.

Figure 1 shows part of a section through the defective central area of the plate.

PART OF A SECTION THROUGH THE DEFECTIVE  
CENTRAL AREA OF PLATE.TESTING RESULTS:1. Chemical Analysis -

The microscopic examination and the fracture tests show that the defects in the casting are caused by oxides accumulated in the centre of the cast plate.

The source of these oxides may easily be from entrapped air, from gas-forming compounds, or from steam generated from the moisture added. The escape of gases or steam formed may not be sufficiently facilitated, for such reasons as (a) the particular shape of the casting with its large surface area, (b) the gating or pouring methods employed, (c) possible varying sand conditions.

Judging from the mass of locally concentrated oxidized metal within the centre of this cast plate, the source of the trouble appears to lie not in the melting or deoxidizing practice used at present but rather in some variables in the sand practice or in the moulding or gating operations.

The defective area in the submitted cast plate was caused by an accumulation of oxide inclusions.

Definite and constant control over moisture content, mould hardness, ramming and venting should be maintained so that these control factors can be established at safe operating limits.

Slight changes in casting practice, such as mould drying, mould tilting, placing of "whistlers" or small vents at the casting end, or use of dry sand cores, may help to alleviate the effect of oxidation.

It appears that changes in the moulding and casting practice would be beneficial in avoiding these defects.

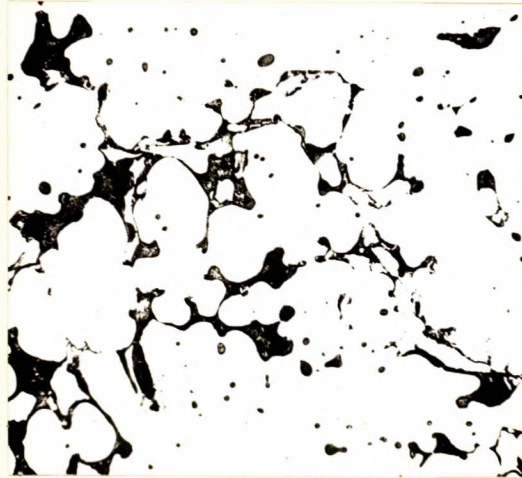
Figure 2.

A small section, approximately a half-inch square, was cut from the defective area for microscopic examination. A photomicrograph of the defective area is shown below:

PHOTOMICROGRAPH OF DEFECTIVE AREA.
