DEPARTMENT OF MINES AND RESOURCES

BUREAU OF MINES

Investigation No. 2147.

Corrosion Resistance of Slide Fasteners When
Subjected to Salt Spray Conditions.

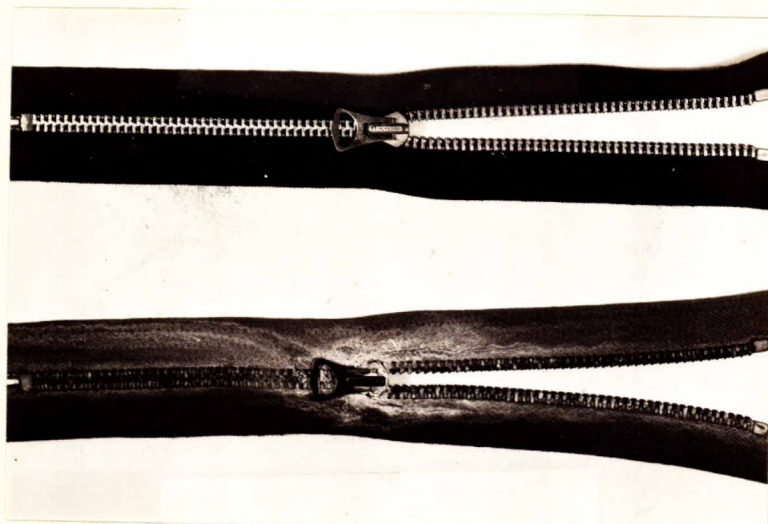
Figure 1.

A trace of green corrosion product appearing over the surface of the brown slide fastener. Also a trace of white corrosion product over the slider and pull tab.

Considerable green corrosion product over the full length of the brown slide fastener. Also the white corrosion product at the slider and pull tab had increased.

1. The scoops, open end stops, and closed end stop on the brown slide fastener had considerable corrosion product over surface.

The slide and pull tab were severely corroded. (See Figure 1.)

BROWN SLIDE FASTENER BEFORE AND AFTER
FOURTEEN DAYS IN SALT SPRAY.

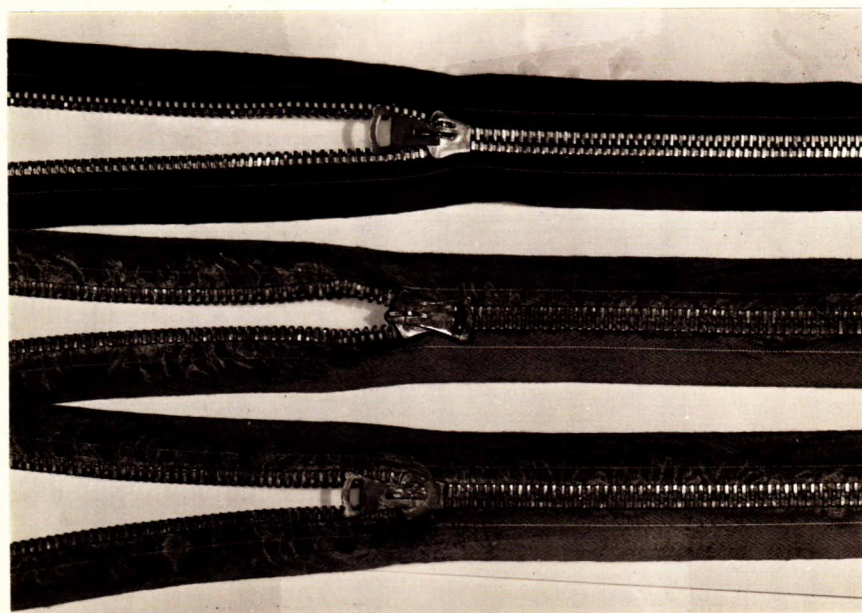
Figure 2.

2. The green slide fastener with closed end stop had corrosion product over most of the surfaces. (See Figure 2.)

3. The green slide fastener with riveted retainer and separating pin had corrosion product over all surfaces. (See Figure 2). The rivets through retainer and separating pin parts were severely corroded.

GREEN SLIDE FASTENERS BEFORE AND AFTER
FOURTEEN DAYS IN SALT SPRAY.

(a) With end closed.

(b) With riveted retainer and
separating pin.

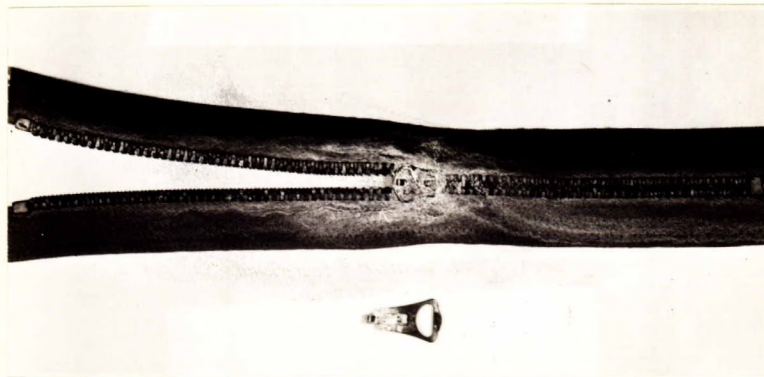
Figure 3.

- (1) The slide on the brown slide fastener broke apart, releasing the tab. Slide did not move and could not be moved by hand.
(See Figure 3.)
- (2) The operation of the corroded green slide fasteners only required slightly more effort to open and close them.
- (3) The retainer and separating pin were tested for fastness and found to pull apart very easily where the rivets were corroded.
(See Figure 4.)

BROWN SLIDE FASTENER AFTER TESTING FOR FORCE
REQUIRED TO OPEN AND CLOSE IT.

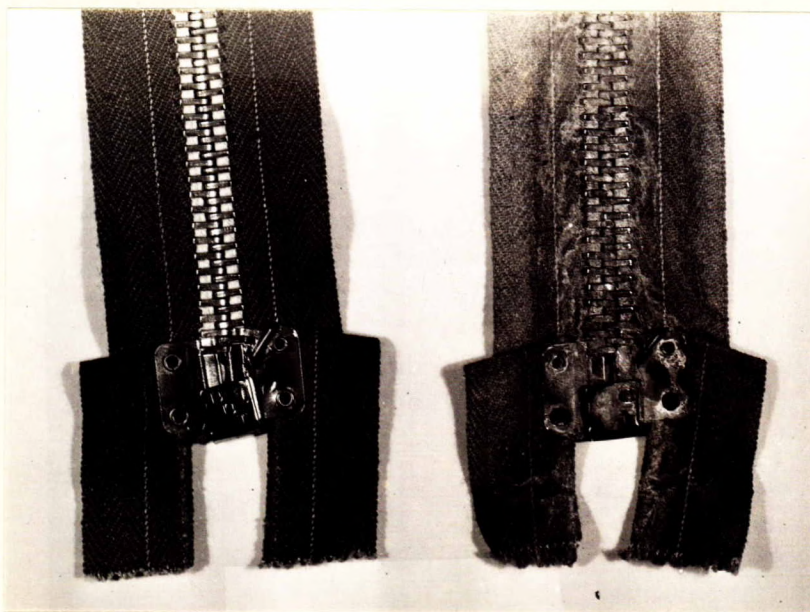
Figure 4.

RETAINER AND SEPARATING PIN BEFORE AND AFTER
TESTING THE STRENGTH OF THE RIVETS.
