R E P O R T
of the
ORE DRESSING AND METALLURGICAL LABORATORIES.

Investigation No. 1960A.

Distortion in Flame Hardening Naval
Gun Racer Plates.

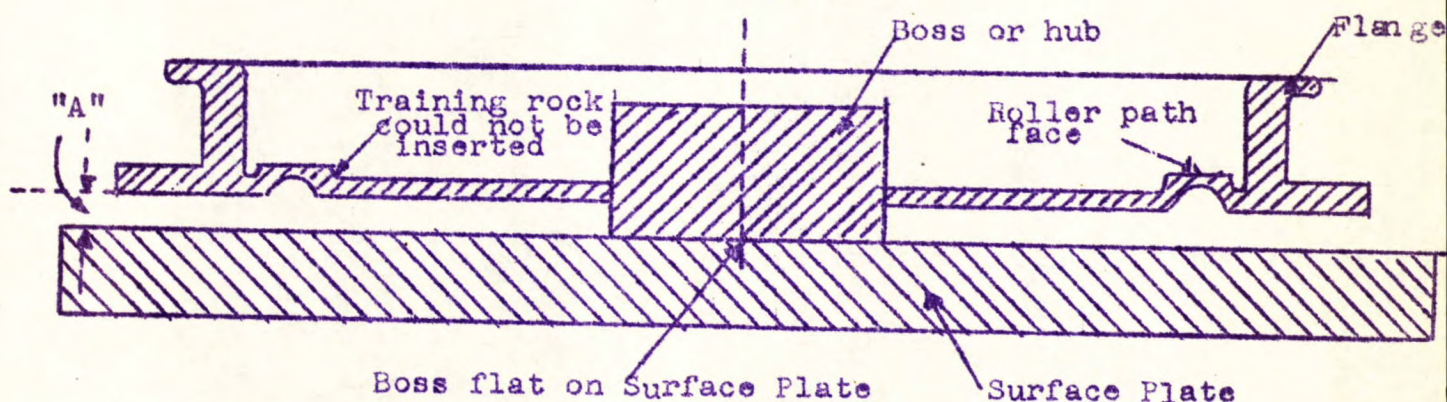
Sketch No. 1.

the surface plate was level and accurate to within 0.001 inch. Since the outside rim of the racer plate was not in contact with surface plate this upward distortion was measured by means of thickness feelers (see Sketch No. 1 below). The distortion measured at the eight stations are shown in the following table.

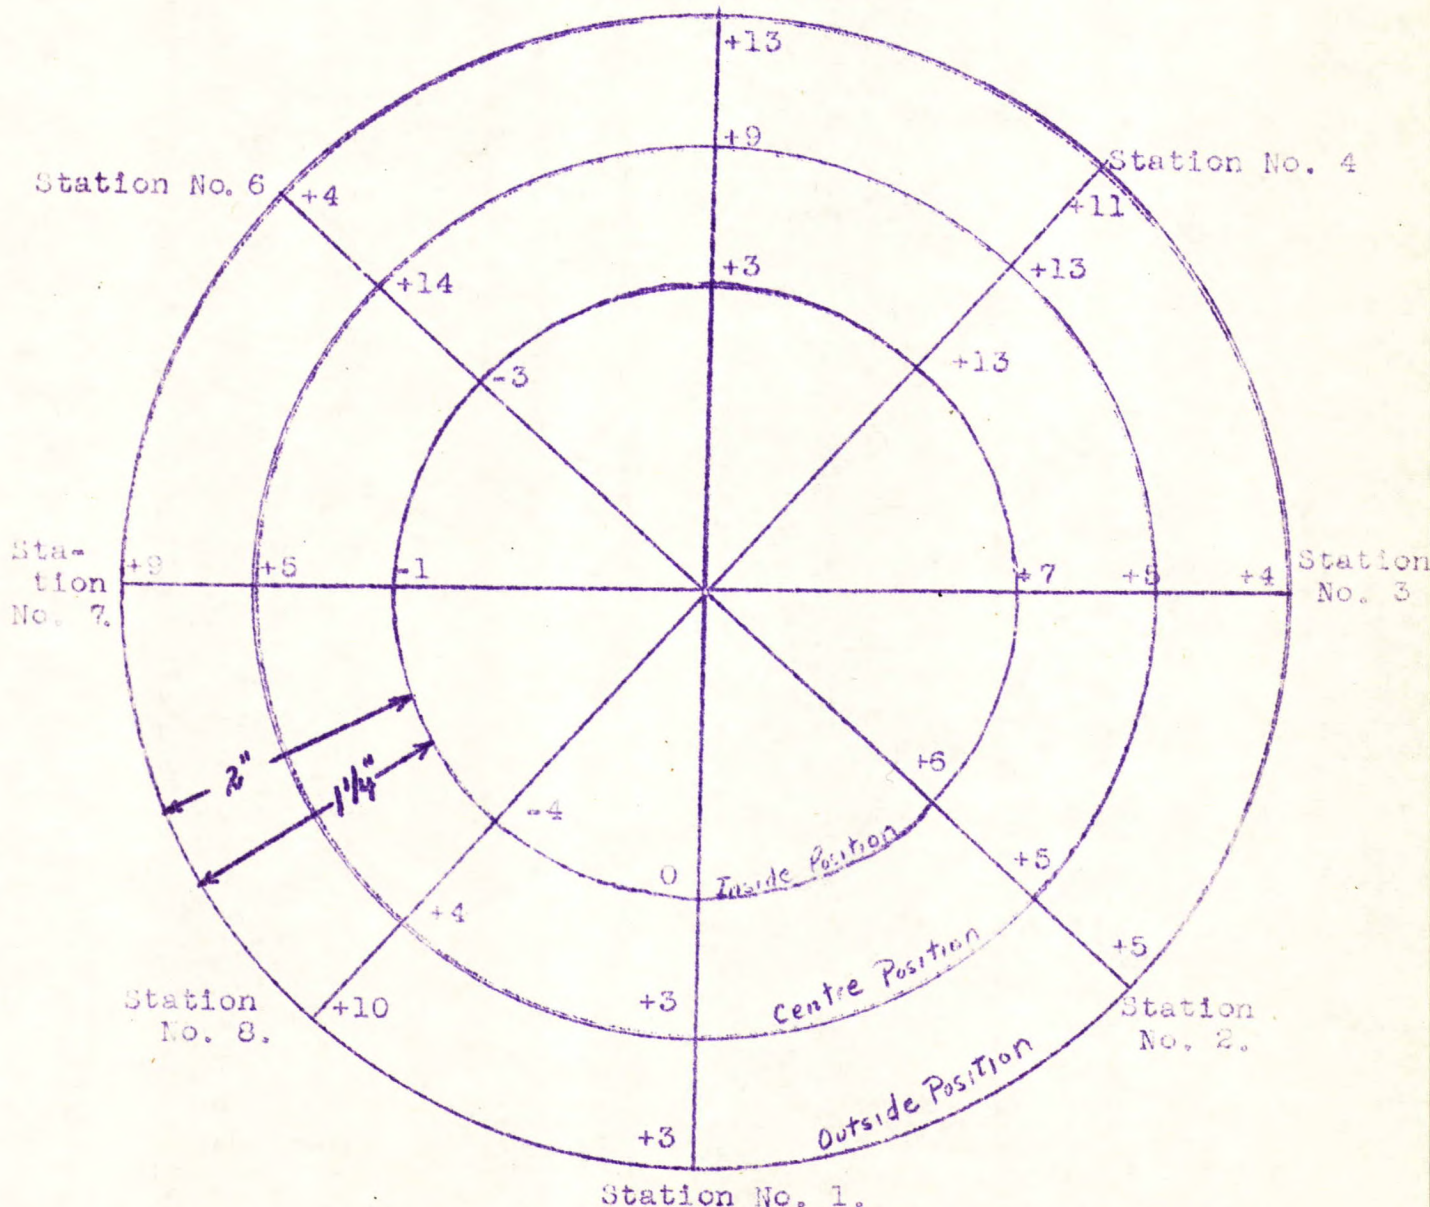
Sketch No. 2.

Note that at every station the centre and outside positions reveal an upward distortion.

It will be noted from Sketch No. 2 and Table VI that there is an upward distortion of the race surface towards the

outside edge. This confirms the general trend of the readings of Table V. Table VI also reveals that there is a considerable variation in the level of the race surface in a transverse direction at the various stations, ranging from 0.001 to 0.014 inch. It would appear that this distortion is approximately one half that of Plate No. 3 but of a different nature, in that Plate No. 3 exhibited an upward bulge in the centre of the race. No explanation of this difference can be advanced. Table III also reveals a variation in level of 0.009 inch, 0.0085 inch and 0.010 inch respectively of the inside, centre and outside positions before hardening. Whether these differences at the various stations should be subtracted from the readings at the same station in Table VI is a matter of conjecture due to the entirely different system of measurements used. However, the fact that differences in level were detected prior to hardening is difficult to ignore.

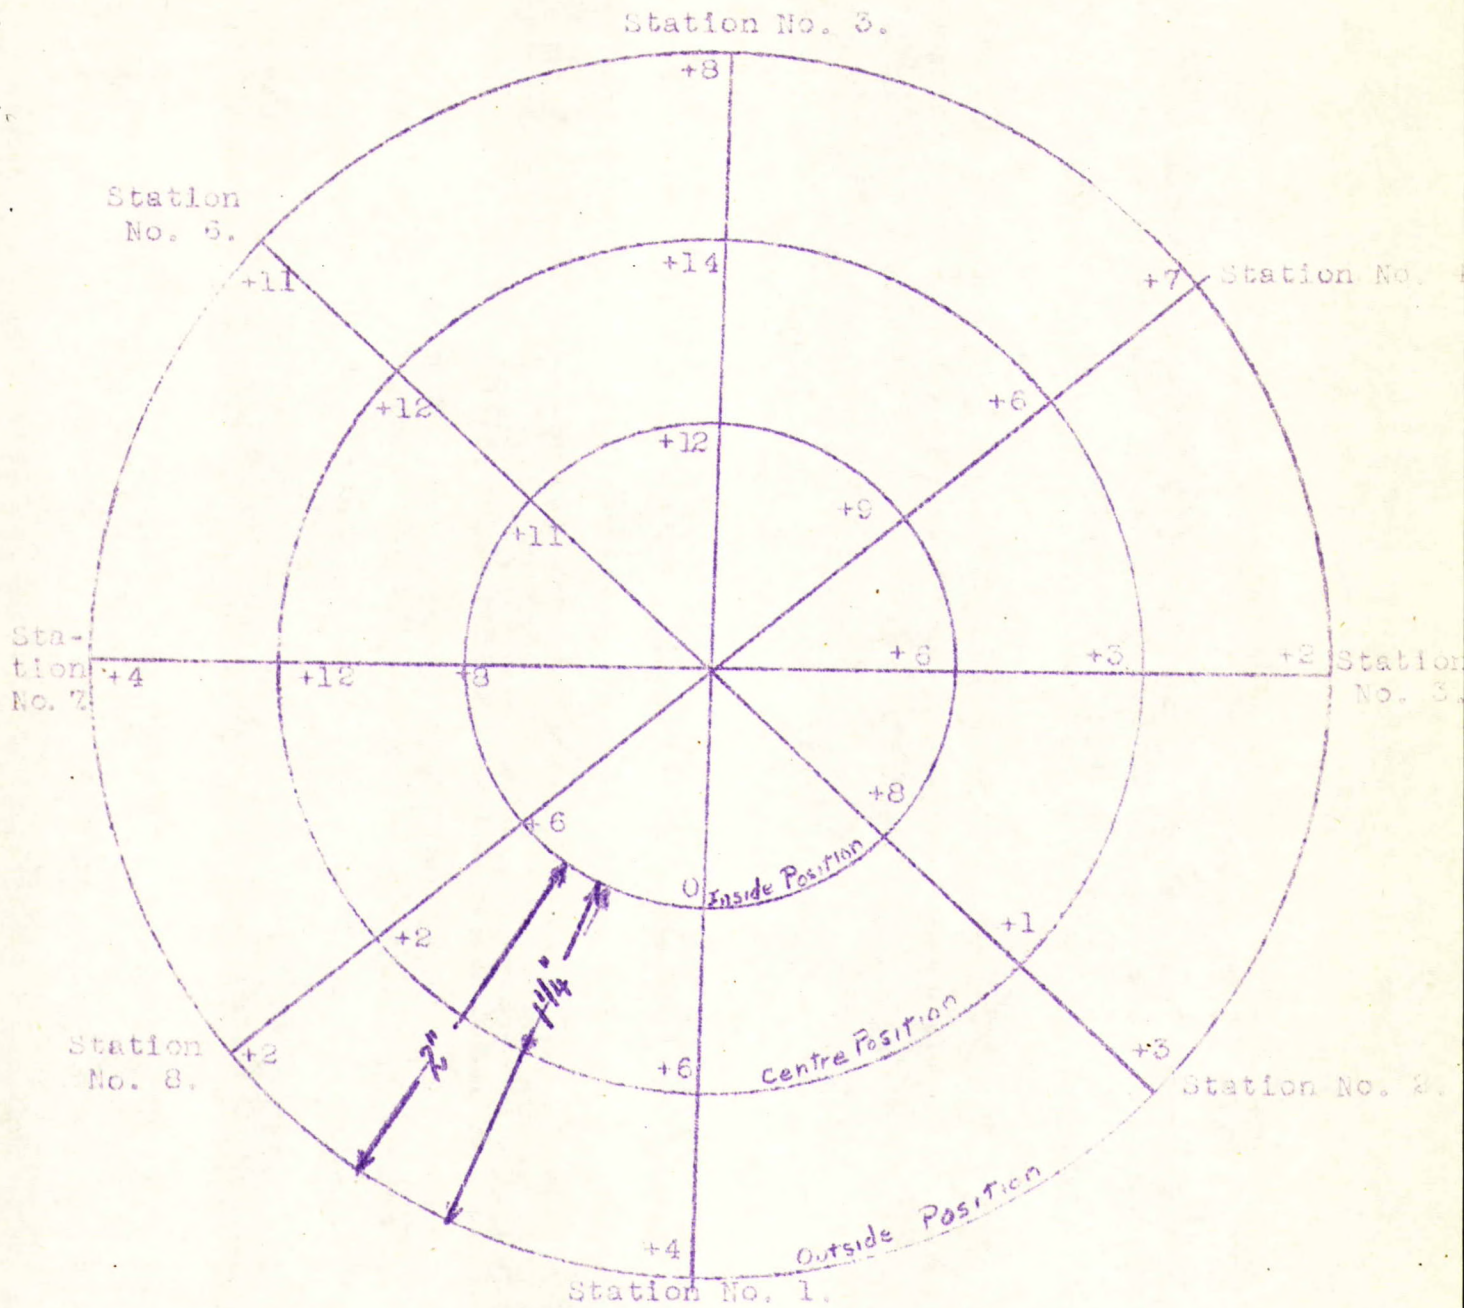
Sketch No. 3.

Race face measurements, by the method previously described, are stated to have produced the results reported below in Sketch No. 3 and Table No. VIII.

The reported results of measurements after the drawing at 500° F. are somewhat obscure. They apparently show that at the rim there has been a consistent tendency to correct the upward distortion noted after flame hardening. One would logically expect that this would be accompanied by a similar, even if smaller, change in the measurements of the race surface. However, a comparison of Tables VI and VIII reveals that there

is no such consistent change. This might be explained on the basis of a twisting action during drawing but it is difficult to see how such an action could take place against the restraint of heavy sections such as the flange and the spokes. It is believed, however, that it has been demonstrated that some correction of distortion may be expected from drawing but that this procedure will not eliminate it entirely.

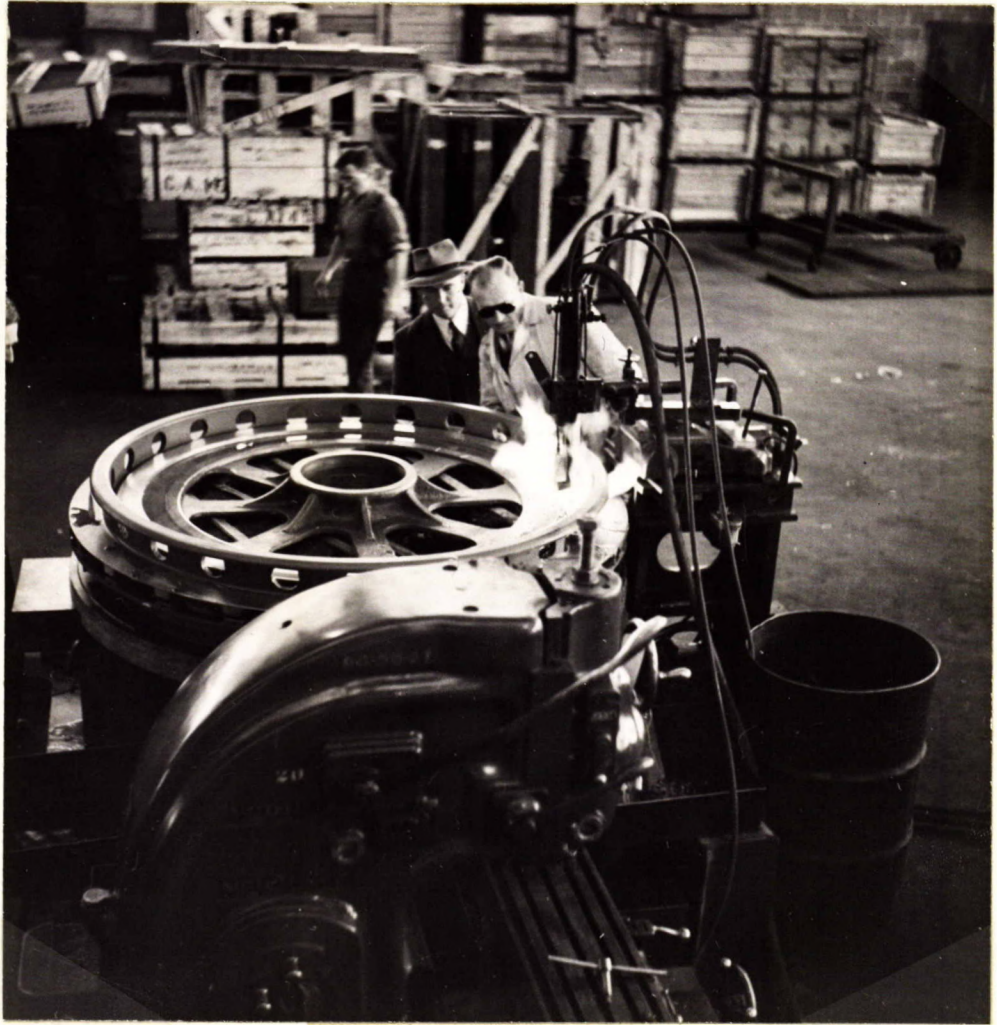
Figure 2.

Figure 2 shows the operation in progress. It will be noted that the back flare of the flame is playing on the inside surface of the flange. When the operation was completed it was estimated that the flange was at a temperature of at least 300° F. This degree of heat is highly undesirable in that a heavy member at this temperature can cause severe distortion of thinner sections.

Note back flare of flame playing on the flange.
