Ottawa, January 2, 1947.

ORE DRESSING AND METALLURGICAL LABORATORIES.

Investigation No. 2159.

Deterioration of Aluminium Tubing.

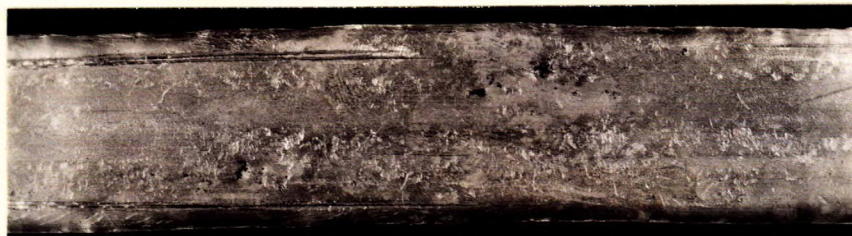
(a) Outer Surface.

Typical pieces of deteriorated tubing were cut down one side and flattened in order to compare inner and outer surfaces. In a number of cases holes passing completely through the tube wall were observed (see Figures 1a and b and 2a and b). In some cases they were larger on the inner surface than on the outer surface. In other cases they were smaller on the inner surface than on the outer surface.

FLATTENED DETERIORATED ALUMINIUM TUBE, SHOWING HOLES
WHICH EXTENDED ENTIRELY THROUGH THE WALL.

The use of aluminium in contact with cinders or a fairly highly alkaline medium cannot be recommended.
