Ottawa, January 27, 1947.

R E P O R T
of the
ORE DRESSING AND METALLURGICAL LABORATORIES.

Investigation No. 2169.

Investigation of Two Pieces of Cyanided
Steel Engraving Plate.

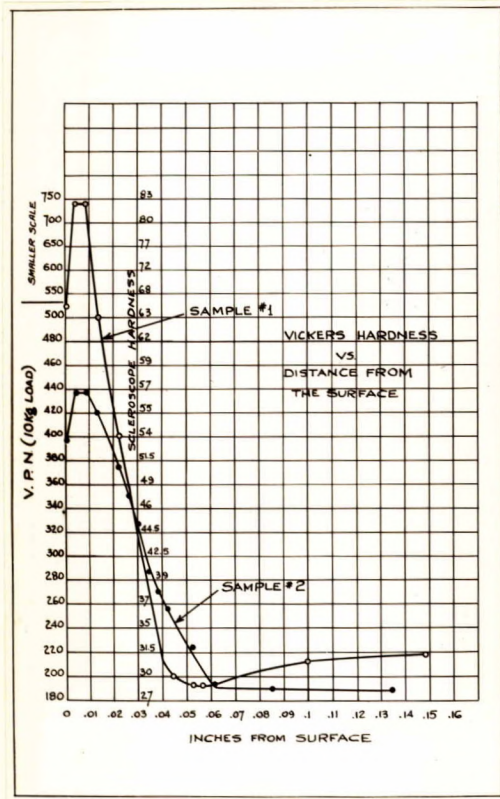
Microspecimens were cut from each piece of plate. These were mounted in bakelite and hardness readings were taken across the face so that a complete hardness survey was obtained from the centre to the surface of each piece. The Tukon Knoop hardness numbers were translated to Vickers and Sceleroscope readings. These are plotted on the chart shown in Figure 1.

VICKERS HARDNESS VS. DISTANCE FROM SURFACE.

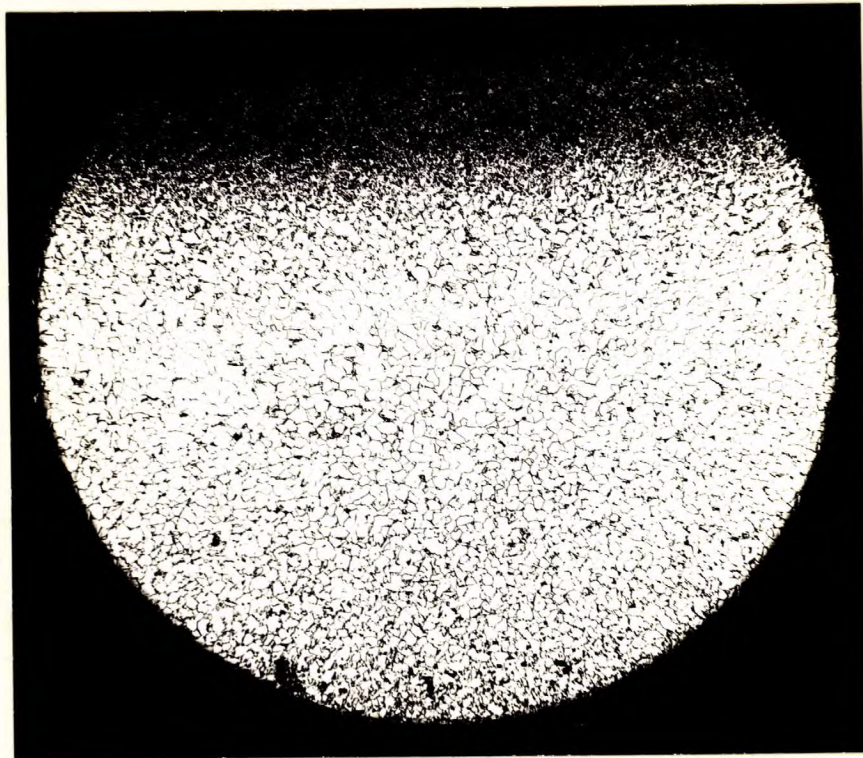
Figure 2.

Microspecimens were cut from each sample. These were polished, etched in 2 per cent nital, and examined under the microscope. Figure 2 (X100) illustrates the 0.007 inch (approx.) depth of case obtained for Specimen No. 1. Immediately below the case, an extensive low-carbon area is observed. Figure 3 (X100) is a photomicrograph taken of Specimen No. 2. A much shallower case was obtained on this part of the plate (0.002 to 0.003 inch).

X100, nital etch.

SAMPLE NO. 1.

0.007 inch (approx.) case depth.

The chemical analysis indicates a variation in carbon content of the plate. The photomicrographs also verify this, since more pearlite is present per unit area in Figure 3 of Sample No. 2 than is shown by Figure 2 of Sample No. 1. This difference in carbon content is probably due to unequal decarburization of the original plate. Figure 2 indicates that the decarburization has considerable depth at the top of the plate.

The case depth of 0.007 inch having a hardness of roughly 82 Scleroscope 0.004 inch below the surface is too thick and too hard to withstand the bending stress without cracking. As a control test it would be advisable to have extra metal at one side of the plate which could be removed and examined by microscope should any irregularities occur in the heat treatment of the plate. If a plate does not give proper results after the first hardening treatment, a specimen could be cut from it and examined to determine whether or not the case depth is sufficient for the subsequent operations and/or whether decarburization is obscuring the proper hardness of the surface, etc.

6. The plate cracked at the point where Sample No. 1 was taken, due to the case being too thick and too hard.

If possible, extra metal should be left on the plate when it is cyanided. Should irregularities occur, a microscopic check could then be made to determine what action to take.

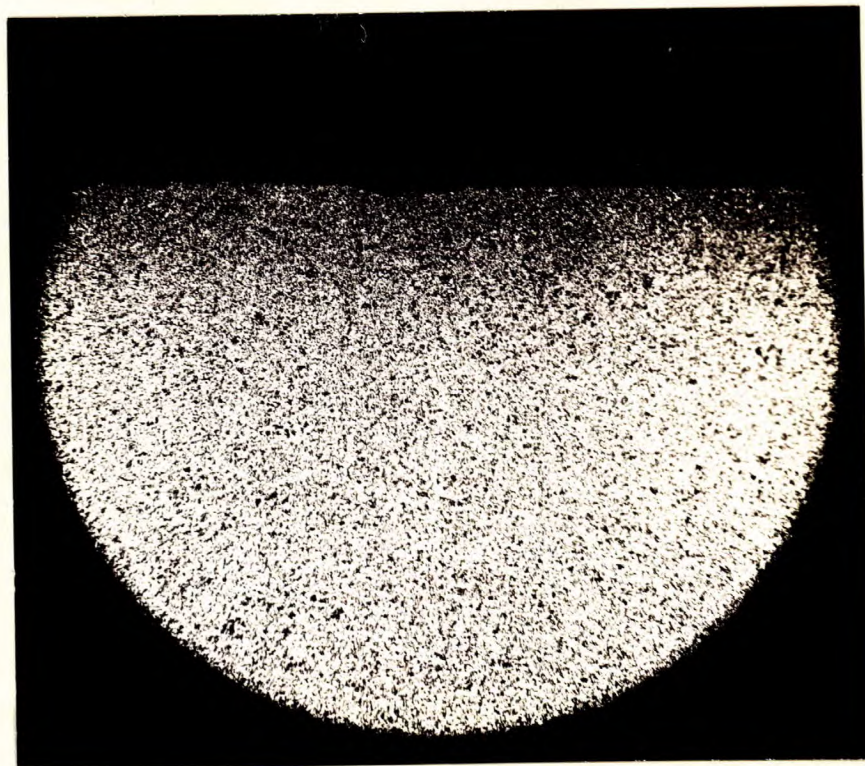
Figure 3.

X100, nital etch.

SAMPLE NO. 2.

0.002 to 0.003 inch case depth.

4. A case of 0.007 inch depth, approximately, was obtained on Sample No. 1 whereas one of 0.002 to 0.003 inch was obtained for Sample No. 2.
