DEPARTMENT OF MINES AND RESOURCES
BUREAU OF MINES
CANADA

Investigation No. 2170.

Investigation of the Premature Failure
of an SAE 4340 Fan Shaft.

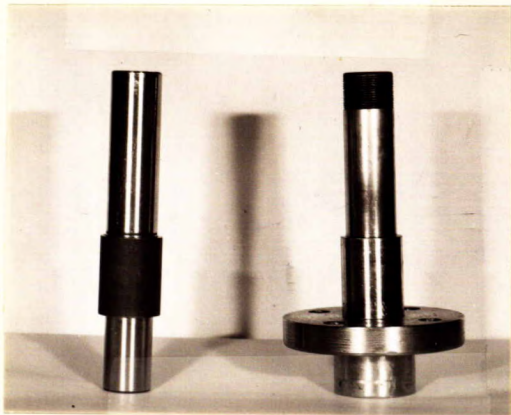
Figure 1.

FAN SHAFT AND ASSEMBLY.

(Showing mismachined shaft at the left and the fan hub insert and shaft assembly at the right.)

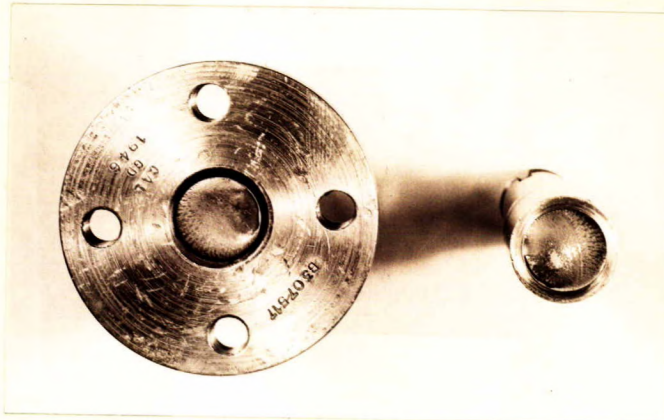
Figure 2.

FRACTURED SHAFT.

(Note the conchoidal fracture and its location at the 90° collar adjacent to the insert.)

In the visual examination, it was noticed that the broken shaft had a conchoidal, or "oyster-shell", type of fracture (see Figure 2). This type of fracture is typical of a fatigue failure where the rate of propagation of a crack preceding the final break is not constant. Consideration of the fan assembly and shaft design (see Figures 3 and 4) reveals the following significant facts. The finished shaft has an integral collar with sharp, 90° faces. High stress concentrations may therefore be expected at either end of the collar. A press fit is used to secure the hub to the shaft and a sharp right angle exists between the hub face and the shaft. Hence at the shaft collar, a definitely critical area, there will be a further increase in stress concentration due to the "notch" effect of such design features. It will be noted that failure occurred at this point.

5. The fracture of the fan shaft is attributed to fatigue failure arising from the "notch" effect of the design features and the presence of a soft surface deposit at a critical area.

1. It is recommended that changes be made in the design, to incorporate fillets at areas of high stress concentration. A solid hub and shaft component, with a generous fillet at the junction of the hub face and shaft, should eliminate many of the stress-raising features of the present design.

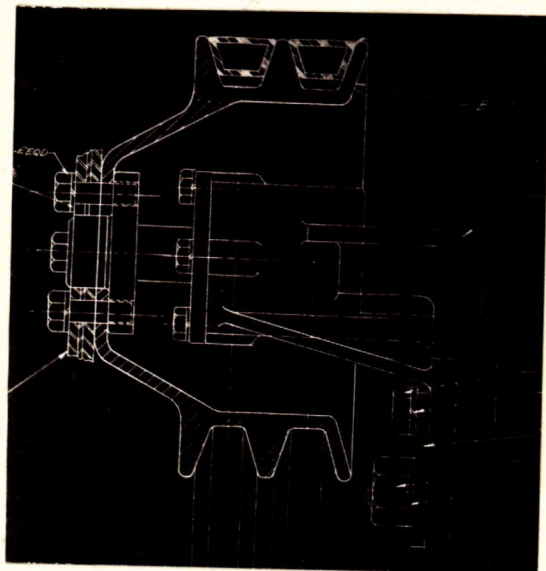
Figure 3.

FAN DRIVE ARRANGEMENT.

(Showing location of fan hub insert and shaft.)

4. Several features in the design were noticed which would have a stress-raising effect in localized areas. These features, consisting chiefly of a press fit and sharp 90° angles at critical areas, are outlined in the discussion.

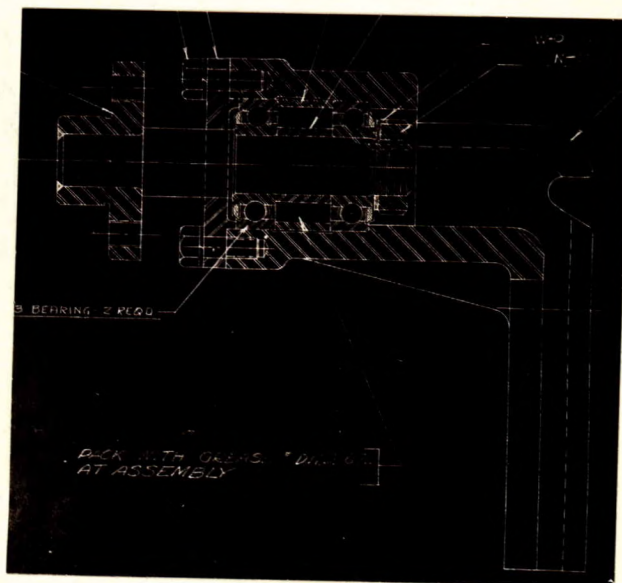
Figure 4.

BRACKET ASSEMBLY.

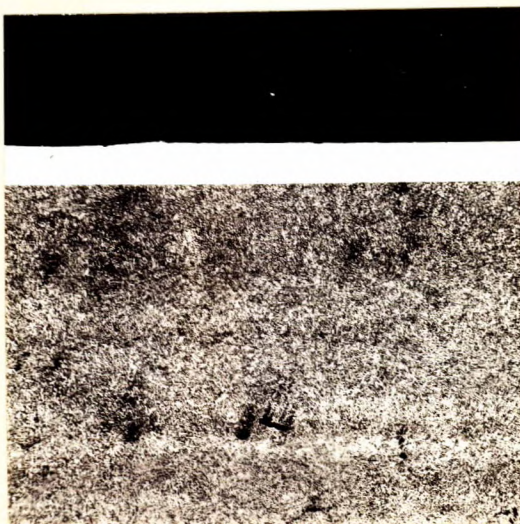
Figure 5.

LONGITUDINAL SECTION OF THE
HUB END OF THE SHAFT.

Note nickel deposit (white area). Thickness of
deposit, 0.002 inch; hardness of deposit,
Rock^WC" 12.

Metallographic examination revealed the presence of a surface deposit, 0.002 inch thick, on a specimen representing that part of the shaft which fitted into the hub. The hardness of this deposit, which was identified as nickel, was Rockwell "C" 12 (converted from a Knoop number 217 taken

The presence of the nickel layer at such a critical area undoubtedly had an adverse effect on the endurance limit of the part. Since the maximum stress developed is at the surface of the fan shaft, the presence of a soft weak skin would favour the initiation of a fatigue crack. On continued service, such a crack would propagate into the harder core. The fatigue failure is attributed to the stress-raising "notch" effect of the design in conjunction with this soft surface deposit.

2. In this assembly the use of nickel plating to rebuild a misfitting fan shaft should be discontinued. Any shafts thus plated should be removed from service.

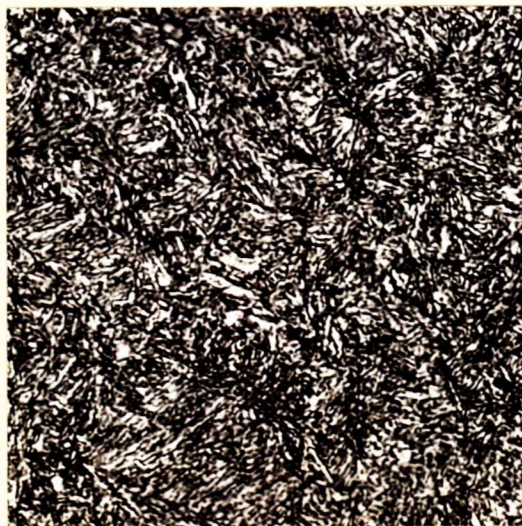
Figure 6.

TEMPERED MARTENSITE - TYPICAL STRUCTURE
OF THE SHAFT.

Hardness values average Rock^WC" 38 to 41.

Hardness values of Rockwell "C" 38 to 41 were obtained across the diameter of the unplated shaft. These values were above the maximum of the reported specified limits of Rockwell "C" 35 ± 3. The hardness values obtained are not considered to be a contributing factor towards failure in this instance.
