Ottawa, January 31, 1947.

R E P O R T
of the
ORE DRESSING AND METALLURGICAL LABORATORIES.

Investigation No. 2171.

Cause of Defects in "Hot Dip" Galvanized Parts.

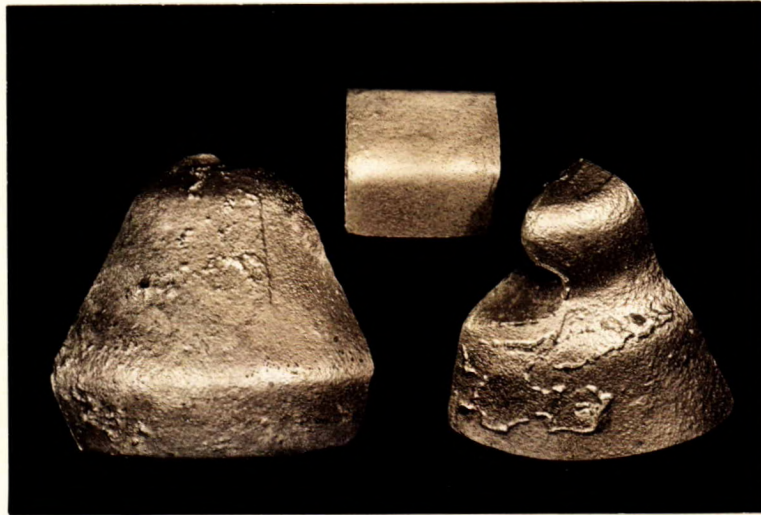
A good-looking coating and two coatings with "eruptions" are shown in Figure 1. Blisters occurring on the under side of a typical part having eruptions are shown in Figure 2. Good and erupted surfaces were examined under the microscope. While the good surfaces showed typical diffusion between iron and zinc, the diffusion seemed to have been interfered with in the neighbourhood of the eruptions. Iron rust appeared under the blisters.

A piece of coated iron with eruptions similar to those shown in Figure 1(b) was made anode in caustic soda solution. After the zinc was removed the area surrounded by the eruptions was almost black in colour. This black material proved to be iron oxide (Fe_3O_4) when inspected by the X-ray diffraction method.

5. The roughness of the other small parts and the eruptions on the castings are due to the presence of iron oxide on the iron.

SAMPLES OF HOT GALVANIZED MALLEABLE
IRON CASTINGS.

(a) and (b) with eruptions.
(c) without eruptions.

1. Great care should be taken to ensure that iron oxide scale is completely removed from all surfaces before the parts are moved on to the next step of the galvanizing process.

2. After the pickling operation the parts should be thoroughly rinsed in cold water to remove all trace of acid and iron compounds.

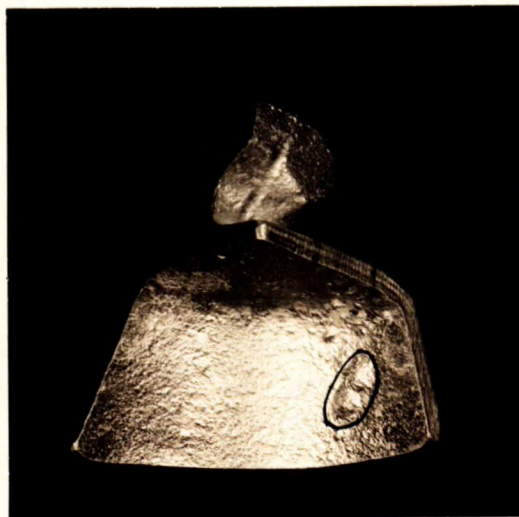
Figure 2.

SAMPLE OF HOT GALVANIZED MALLEABLE IRON
CASTING SHOWING BLISTERS.
