MINES BRANCH INVESTIGATION REPORT IR 66-95

METALLOGRAPHIC EXAMINATION AND HEAT TREATMENT OF CASTINGS FOR FLEXIBLE RADIOGRAPHY CABLES

DECEMBER 5, 1966

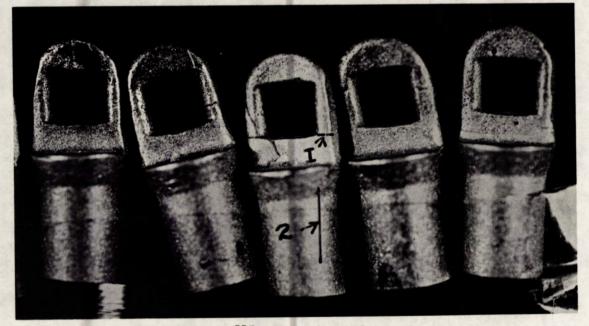
The appearance of female (link) as-cast reject couplings is illustrated in Figure 1. Other reject castings were submitted that had failed in test or in service. All fractured links showed cup-cone tensile fractures preceded by considerable bending on the critical section. The critical section is shown by the arrow 1 in Figure 1. Arrow 2 in Figure 1 illustrates the location where splits sometimes occurred. The splits were possibly caused by excessive crimping pressure or by thin walls due to misalignment of the drilled hole.

Figure 1. As-Received, Cast AISI-420, Female Links.

The as-cast hardness, approximately $R_c 50$, is reduced to $R_c 21$ by furnace annealing at 40°F per hour. The base is then drilled to accept the cable and the cable is fastened by crimping. Arrows 1 mark the "critical section" where tensile rupture and bending occur. Arrow 2 marks the location where splitting can occur during crimping. These castings were rejected for dimensional errors and casting flaws.

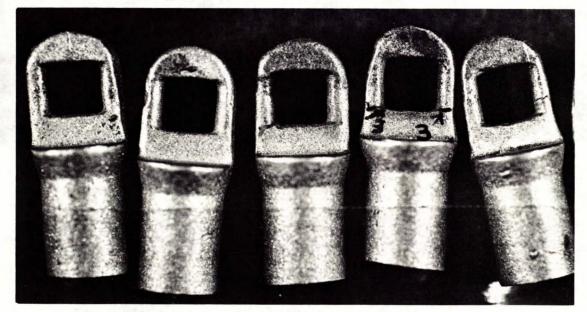
Figure 2 shows the reverse surface to that of Figure 1 and illustrates the as-cast surface and the sharp corners, sometimes undercut and oxidized, where tensile failure occurs. These corners, arrows 3, sometimes show evidence of hot tears that reduce the metal thickness of the critical section. A design modification of the casting pattern is being made to achieve a stiffer and thicker loop section and to ensure a better radius at each corner of the hole.

Figure 2. Reverse Surface of Link Castings. This picture illustrates the square corners which sometimes contain hot tears. These defects when present in the corners (arrows 3) reduce the metal section and can act as stress-raisers.

Dimensional variation, hot tears and sharp corners were observed in the critical section. Service failures appeared to have occurred in tension with evidence of bending. Design modifications were discussed having the object of stiffening the link, increasing the corner radius and increasing the section.

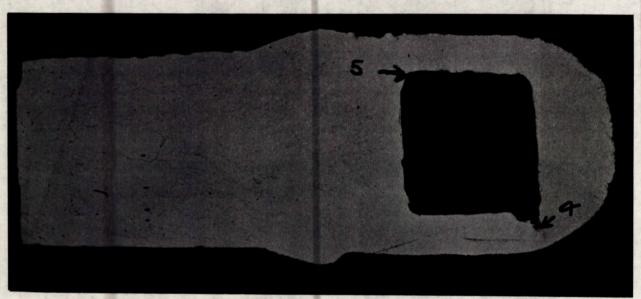
Two female links were chosen with surface defects. Figure 3 illustrates one of the castings having a hot tear in a second critical section where failure may occur when the link ruptures and opens.

Figure 3. Metallographic Section Female Link, showing an oxidized hot tear, arrow 4, aligned with a critical section. The section has been reduced approximately 50% by the oxidized hot tear.

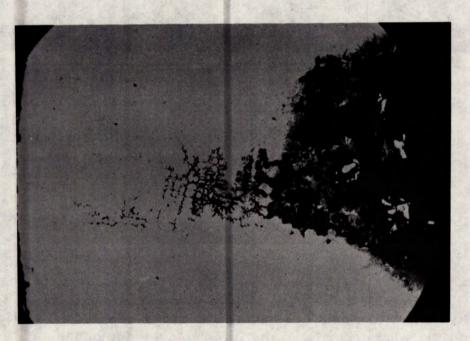
Figure 4 illustrates the section, arrow 4 Figure 3, at higher magnification showing high temperature oxide which indicates that the crack formed and was open at high temperature, that is, during solidification of the casting.

Figure 4. Hot Tear Marked by Arrow 4, Figure 3. Intergranular oxidation has occurred, indicating that the rupture has been exposed to air while at high temperature. This defect appears to be a "hot tear" casting defect.
