MINES BRANCH INVESTIGATION REPORT IR 66-101

**SURFACE DEFECTS ON ANODIZED
ALUMINUM ALLOY EXTRUSION**

J. J. SEBISTY

DECEMBER 7, 1966

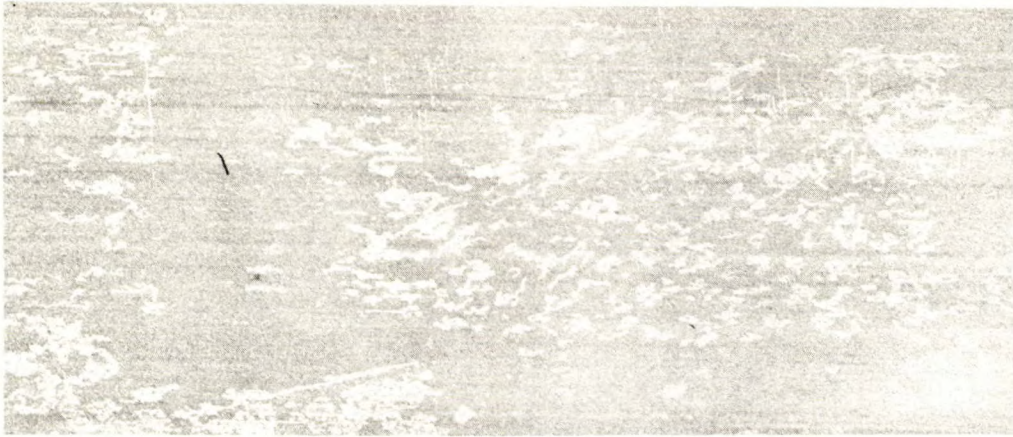
The sample was a rectangular U-shaped architectural section with three internal ribs and a wide external flange on each leg. The surface defects occurred as individual spots of irregular shape frequently concentrated in randomly distributed colonies. All exterior surfaces, including both sides of the protruding flange, were affected in varying degrees with the greatest concentration being apparent on the outer side wall. A heavily spotted area on the latter is illustrated in Figure 1. On the interior surface of the extrusion, the end of each leg outermost from the rectangular rib, and the rib itself, also showed evidence of spotting. Except as hereafter noted, the remainder of the interior surface was unaffected.

Figure 1. Appearance of surface defects on exterior surface of extrusion, X 1-1/2.

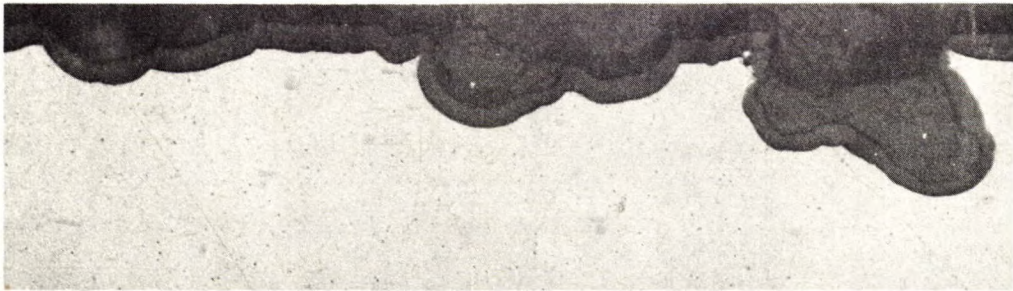
Observation with a low-power binocular microscope revealed that the spotting visible to the naked eye was due to pitting attack of the surface. This was confirmed in metallographic examination of cross section specimens as illustrated by a typical microstructure along the outer surface in Figure 2. The rounded indentations and cavities varied in size, shape and depth and the maximum penetration found approached 0.0025 in. On adjacent areas, and within the shallower pits on the outer extrusion surface, the anodized layer was of a uniform thickness of about 0.00028 in. The layer was generally thinner on the interior walls at around 0.00017 in. and still thinner in the vicinity of the internal spherical-shaped ribs.

The microstructure of the substrate metal in the several pieces examined was representative of a normal quality extrusion and there were no indications of any structural abnormality which may have contributed to the pitting attack. The alloying constituent distribution was uniform at and remote from the surface and this applied also to the recrystallized grain size revealed by prolonged etching of the polished specimens. As illustrated in Figure 2, no evidence of intergranular penetration was apparent at the base of the heavily pitted areas.

Figure 2. Microstructure of pitted exterior surface. Etched in 0.5% HF, X500.

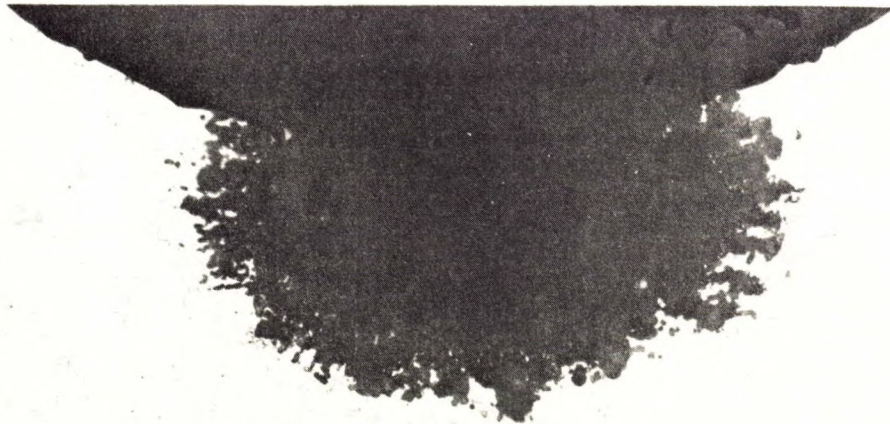
Although not of direct concern to surface appearance requirements, evidence of more gross pitting was also observed in the recessed corners adjacent to two of the internal spherical ribs. This took the form of a line of closely-spaced pinholes up to 0.015 in. in diameter which were covered by a black powdery deposit. These were oval-shaped in cross section with an irregular serrated boundary as shown in Figure 3. The location and gross size of the holes, in combination with yellowish stain deposits in the affected corners, is again suggestive of improper operation at some stage in the coating process.

Figure 3. Microstructure of typical gross pit in recessed corner adjacent to internal spherical rib. Etched in 0.5% HF, X500.
